Groundwater Risk Assessment

Report compiled by:	Gareth Hill	Environmental Focus Ltd
Customer:	Jonathan Pallas	Recover Blaenavon Ltd
Requirement:	Groundwater RA	New application
Date of Submission:	19 th May 2023	
Signature:

Recover Blaenavon Ltd is applying for a Bespoke Environmental Permit to upgrade their site, to take an increased level of material and cease operating as an exempt activity. The site wishes to apply for the external storage of baled plastic packaging waste with internal treatment plant designed for processing to reach end of waste status. The site wishes to store approximately 1,000T at any one time but have the capability to store approximately 1,500T through times of factory shut down etc, with a total throughput of 20,000T per year.

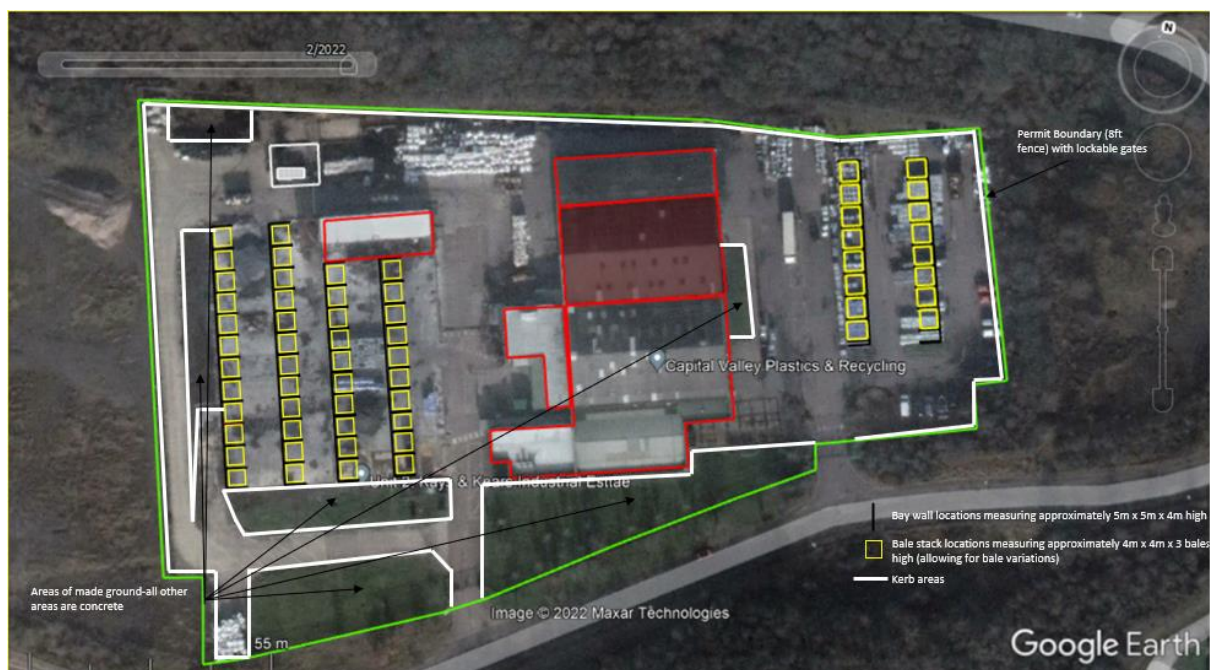
The below plan shows the layout of the site regarding the soft landscaping areas and so the potential pathways to groundwater, also shown are the areas where there is a kerb boundary and the locations of the waste storage bays.

However, within the permitted boundary are 5 areas of soft landscaping (that are separated by the 150mm kerb), that have the potential to receive water from the site and allow it infiltrate to the groundwater system located under the site and in the wider area, this groundwater is a Source Protected Zone 1 (SPZ1) and therefore requires detailed risk assessment.

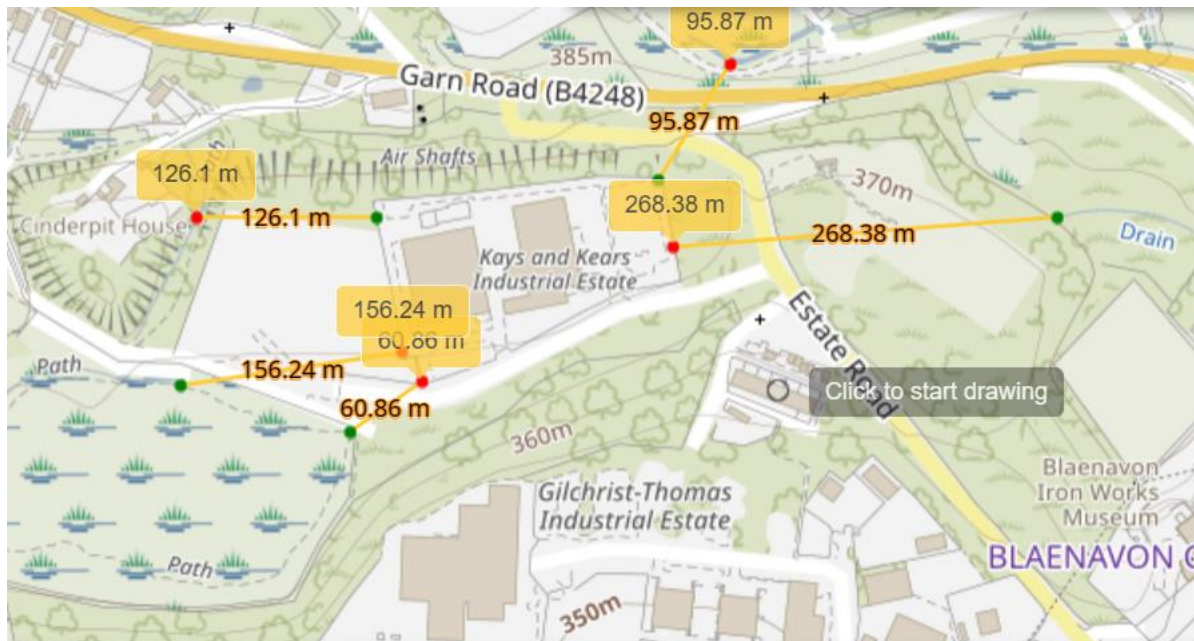
The plan below shows the local watercourses that are within a reasonable distance to the site. The map shows that the closest watercourses are at 95m to the Northeast and 126m to the West, with an area of marshland being 60m to the Southwest. From a risk perspective of flooding from a small watercourse, these are the closest and so pose the highest risk.

From a surface water perspective, the site is bordered by a very steep bank to the North, this can be seen in the map above as 'Air shafts', the areas directly to the East and West are an old inert recycling yard and an area of scrubland/trees respectively. To the South is the highway that leads to the site and beyond is a steep downward slope to the next industrial area. Out of these points, the highest risk is from the slope to the North where in prolonged periods of heavy rain, could see surface water flooding into the site. There would be no/low risk from the side areas and a non-existent risk from the land and road to the South.
