DRAWING REFERENCES:  
4021359-BUK-ZZ-00-DR-C-00002 SITE PLAN  
4021359-BUK-ZZ-00-DR-C-00009 DETAILS SHEET 2 OF 2  
4021359-BUK-ZZ-00-DR-C-00010 TYPICAL CROSS SECTIONS

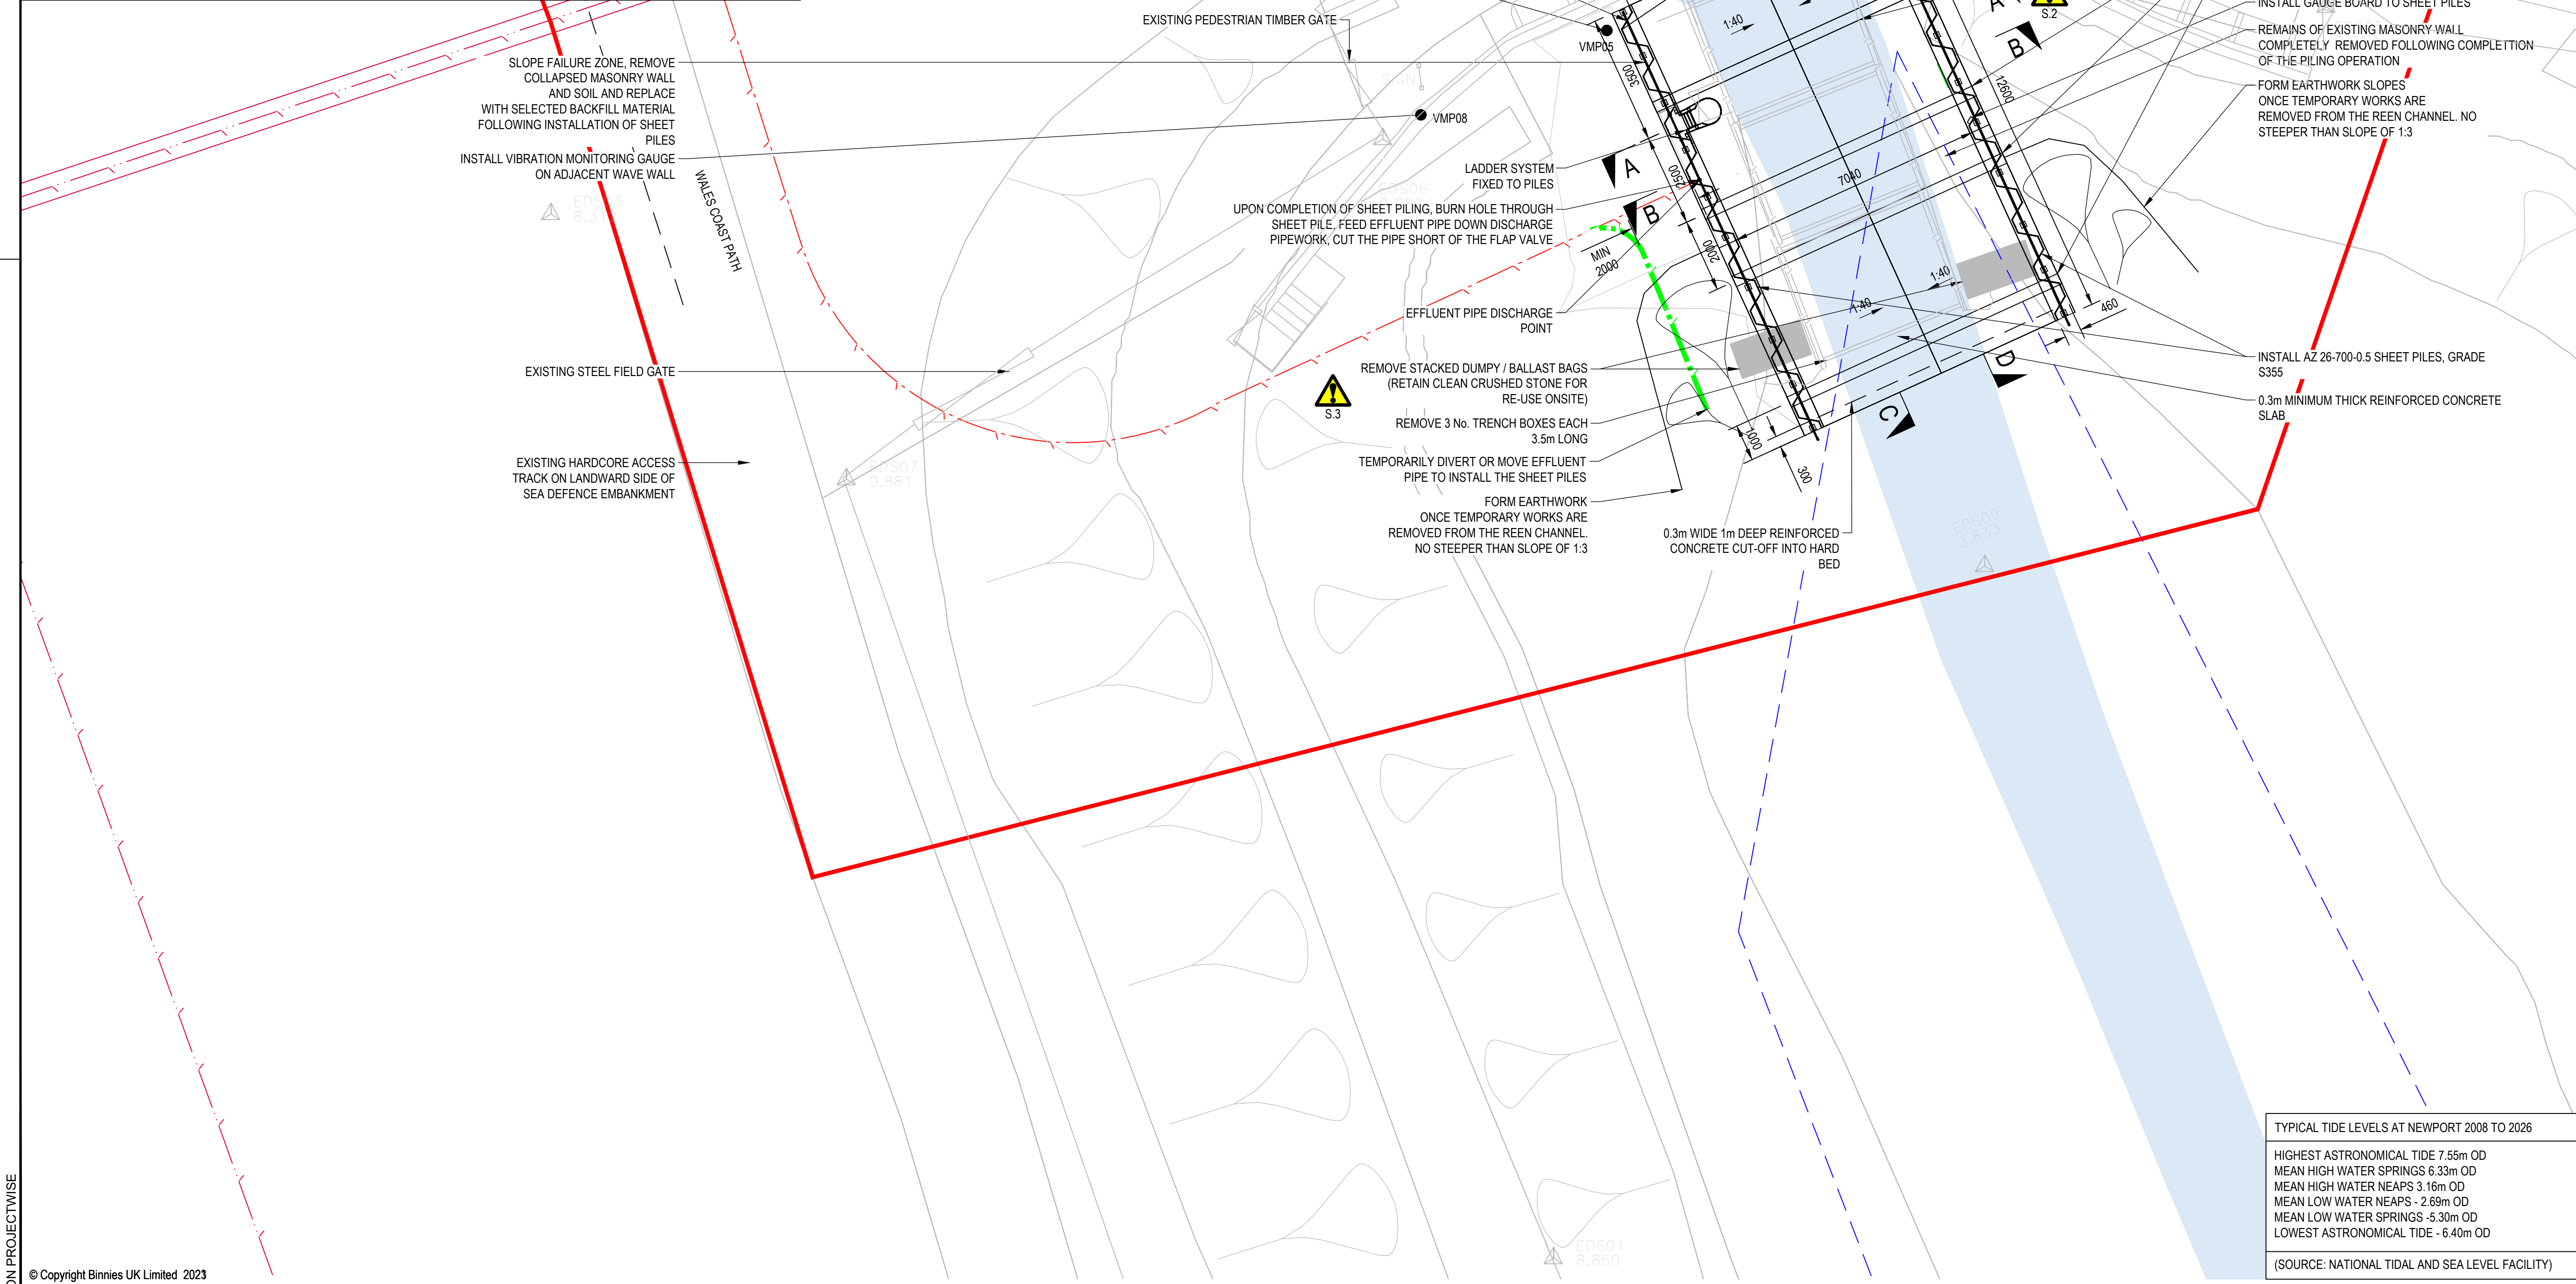
- EXISTING SERVICES LEGEND:
- RISING MAIN
  - EFFLUENT PIPE DIVERSION
  - WATER MAIN - POTABLE
  - BT
  - BT
  - ELECTRIC - LOW VOLTAGE
  - ELECTRIC - HIGH VOLTAGE
  - UNKNOWN SERVICE
- LEGEND:
- SETTING OUT POINTS (SOP)
  - VIBRATION MONITORING POINT (VMP)
  - MEAN HIGH WATER SPRINGS (MHS)
