Marine Characterisation Research Project (MCRP)

**Morlais_Phase_One_Navigation_Risk_Assessment
_Issue03**

MORLAIS MAGALLANES PHASE ONE INSTALLATION NAVIGATION

22UK1877

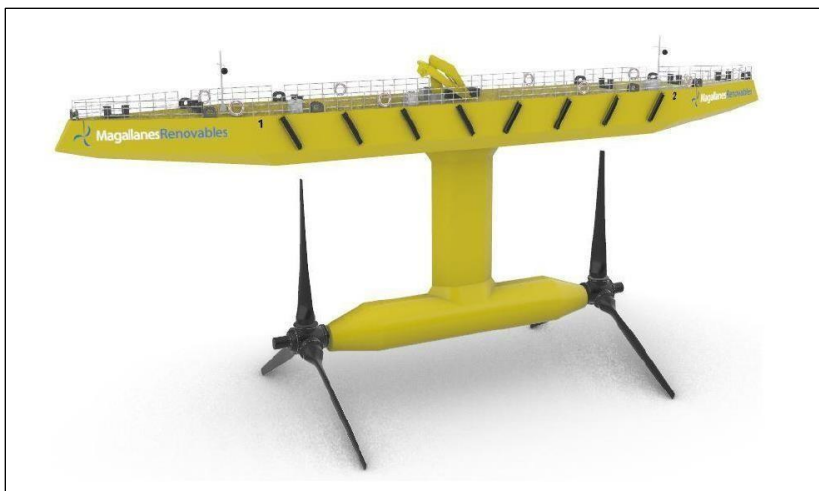
Figure 3: Image of the Morlais Die

The devices will be located to the east side of the "Green" zone within the MDZ; the area where any device specification have been consented to deploy (See Figure 2 for position and Table 2 for coordinates). Each device is 53.6m by 7m (see Annex A, Figure 17 for General Arrangement); energy created by the devices will be transferred from the devices via two dynamic cable hubs, to a central electrical hub which will then be connected to one export cable that extends towards Abraham's Bosom to the east of the site (the cable route is shown on Figure 2 in black, with the cable corridor shown in brown). The devices consist of two rotors, each with a blade of 21 diameters. The devices will have a draft of 24m with the blades in operation (19.9m when being transported) and will sit approximately 1.97m above sea level (4m with masts included). The devices are due to be installed with 4-point moorings (mooring arrangement is illustrated in Annex A, Figure 16). The Aids to Navigation for the devices have been agreed with Trinity House which have been outlined below. An indicative illustration of the device can be seen in Figure 3.

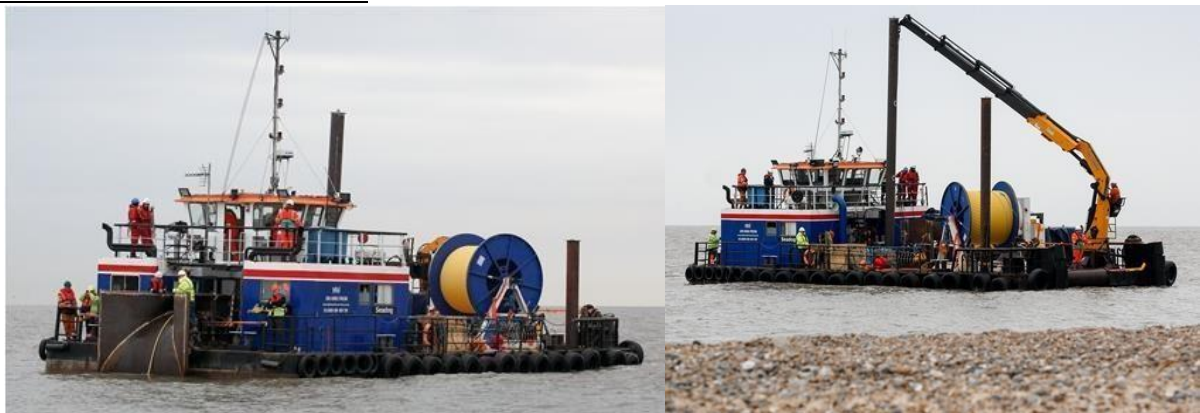
Figure 5: Multicat Vessel Equipped for Cable Installation

The export cable will be loaded on to the cable installation vessel - anticipated to be DP capable multicat type vessel. The offshore end of the cable will be pre-terminated with a connector system / hub and 2 cable tails. Two separate 'dynamic cable hubs' will later be connected to these cable tails.²

The vessel will sail to the landfall site and set up on anchors or spud legs. A messenger line from the landfall site will be sent out by a small boat. The messenger line will be used to draw out the main pull-in line from the onshore winch. The pull-in line will be attached to the cable end. The cable will then be pulled onshore and through the HDD duct by means of a cable winch and connected to the onshore cable(s) in a transition pit. The vessel will then move to the offshore deployment location paying out the cable onto the seabed as it goes, along the pre-determined cable route. Once at the offshore site, the main connector system / hub and cable tails will be connected to marker buoys and lowered onto the seabed for retrieval later.

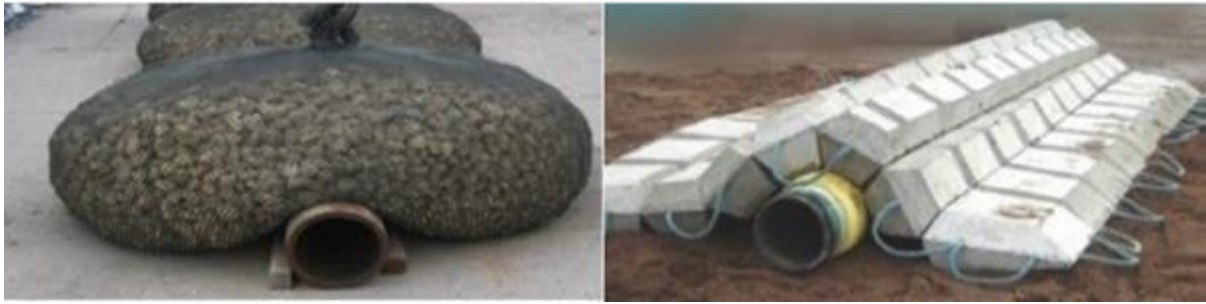
Figure 7: Examples of Rock Bags and Concrete Mattresses

Cables will be surface laid only, as it is unlikely that much burial can be achieved due to a lack of surface sediment. The export and umbilical cables will be secured / stabilised with the use of rock bags (consisting of graded rock in a mesh 'bag') or mattresses (a 'flexible' matrix of linked concrete blocks). In the intertidal area, articulated split pipe / cable shells may also be used to further stabilise the cable and add additional protection in this high energy zone.

The rock bags or concrete mattresses will be laid over the cables in pre-determined positions and undertaken using a multicat vessel with a crane or A-frame. The bags / mattresses will be lowered into the sea and positioned manually over the cables using a drop camera and vessel crane or possibly aided by divers or a Remotely Operated Vehicle (ROV).

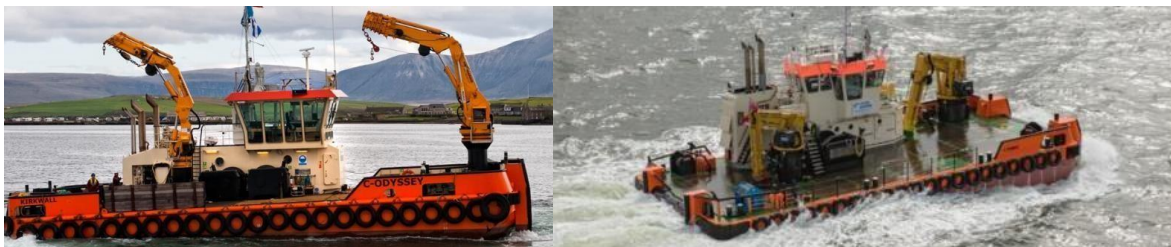
Figure 9: Multi-cat vessels MV C-Odyssey (left) and MV C-Fenna (right)

Most works will involve a single multicat vessel with 1 or 2 smaller support vessels. Some works may involve 2 multicat vessels or a multicat and Tug.

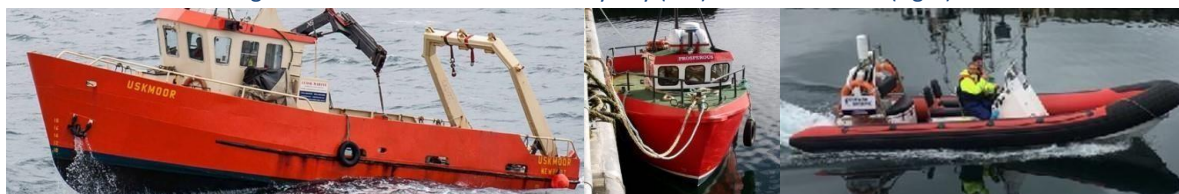
Figure 10: Typical Support Vessels (MV Uskmoor, MV Prosperous and MV Explorer)

During the installation and subsequent offshore commissioning period, there will also be a daily requirement for a small workboat or RIB (e.g. MV Explorer) for return journeys between the site and Holyhead for transfer of personnel and equipment.
