Marine Characterisation Research Project (MCRP)

**Morlais_Demonstration_Zone_Navigation_Risk_Assessment_
Issue01**

**MDZ BIENNIAL SITEWIDE NAVIGATION RISK ASSESSMENT
2023**

Report Number: 22UK1877
Issue: 01
Date: 01 July 2023

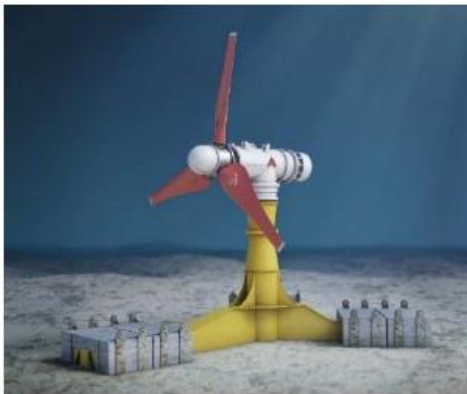
Sub-Category	Exemplars (Developer or Device Names)	
Category 1 : Seabed Mounted Sub-Surface Devices		
Large rotor(s) (>10 m diameter)	<ul style="list-style-type: none"> • SIMEC Atlantis Energy • Andritz Hydro Hammerfest

<p>Developer: SIMEC Atlantis Energy Source: (https://twitter.com/simecatlantis/status/534996023178178560)</p>
Small (<10 m diameter) rotors	<ul style="list-style-type: none"> • Verdant Power • QED Naval SubHub • Nova Innovation • Sabella

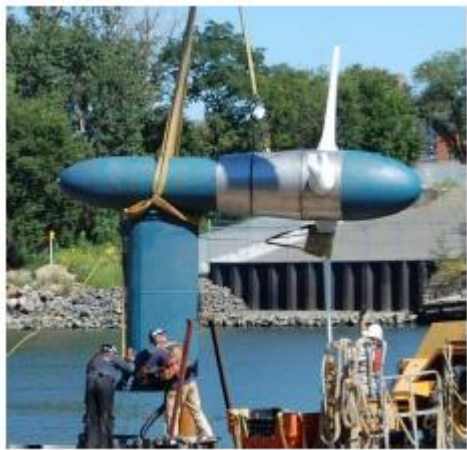
<p>Device/Developer: Gen5Tidal/Verdant Power</p>

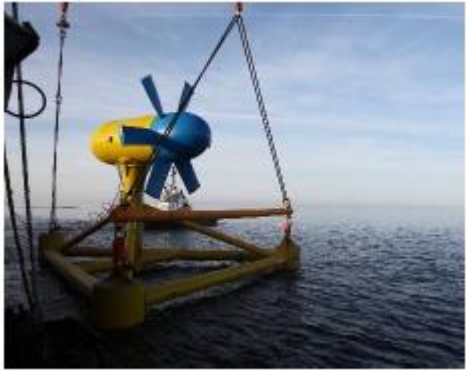
<p>Device/Developer: D10-1000/Sabella</p> <p>Source: Sabella</p>
Vertical Axis Turbine	<ul style="list-style-type: none"> Repetitive Energy

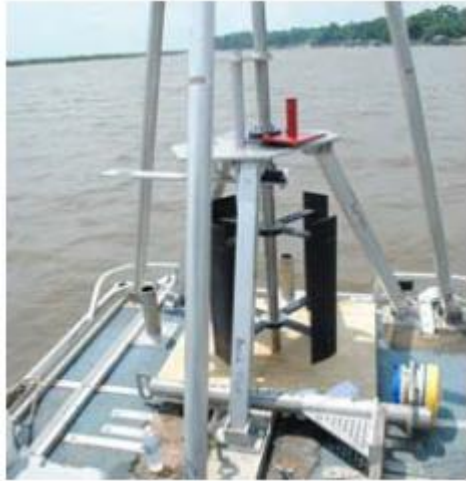
<p>Developer: Repetitive Energy</p> <p>Source: http://www.repetitiveenergy.com/ourtechnology</p>
Category 2: Mid-water Column Devices		
Multiple small (<10 m diameter) rotor upon submerged buoyant platform	<ul style="list-style-type: none"> SME PLATO platform or similar with Tocardo or Schottel TECs Renewable Devices Marine Ltd.

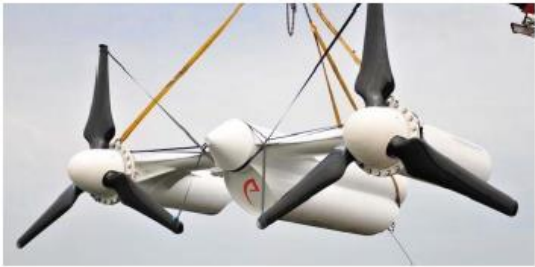
<p>Developer: Renewable Devices Marine Ltd.</p> <p>Source: https://www.theenergytimes.com/distributedenergy-ecosystem/scots-push-new-tide-turbine-tech</p>

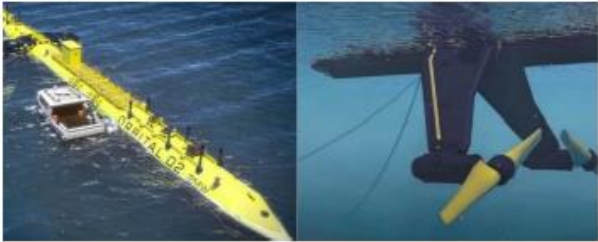
Sub-Category	Exemplars (Developer or Device Names)	
Category 3: Floating or Surface Emergent Devices		
Large rotor (>10 m diameter) floating or emergent devices	<ul style="list-style-type: none">Orbital Marine PowerMagallanes	<div>

</div> <div>Developer: Orbital Marine Power</div> <div>Source: https://marineenergy.biz/2018/11/16/orbitalmarine-unveils-o2-turbine-blueprints/</div>
Small rotor (<10 m diameter) floating devices	<ul style="list-style-type: none">Tocado TFS	<div>

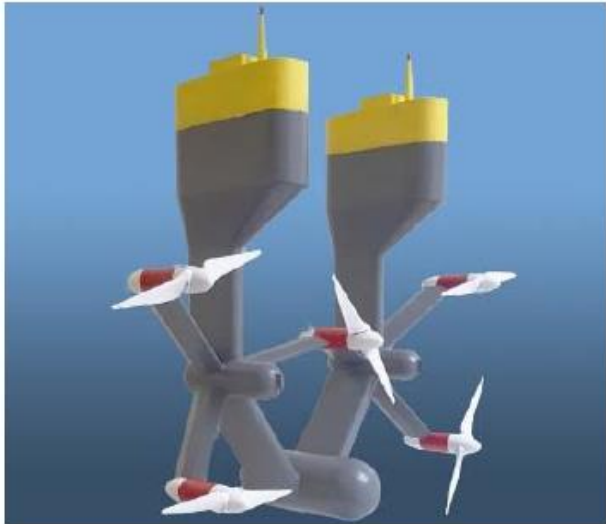
</div> <div>Developer: Tocardo</div> <div>Source: https://marineenergy.biz/2018/06/06/-tocardo-strengthens-management-with-financeappointments/</div>
		<div>

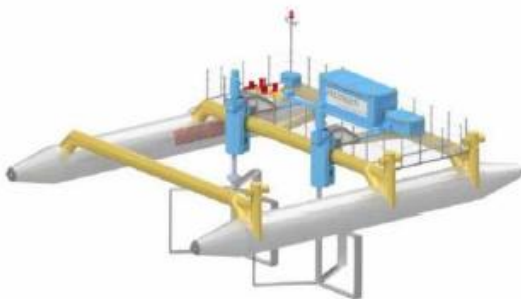
</div> <div>Developer: Instream</div> <div>Source: https://www.marineenergywales.co.uk/-</div>

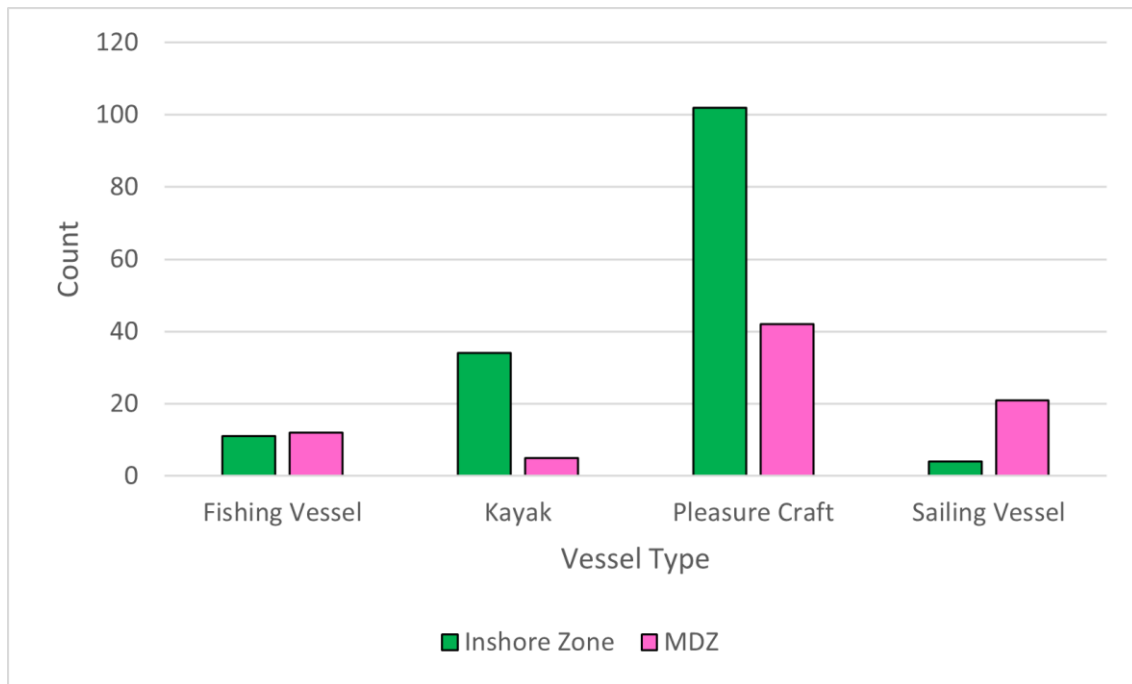
Figure 17: Non-AIS Vessels by Type within Summer Data

This radar target data is also supplemented by the visual observations during the survey periods. **Figure 17** and **Figure 18** demonstrate the visual counts of vessel types during both summer and winter observations that transited either within the MDZ or the inshore passage. During the summer two-week period of observations 231 vessels were seen, whereas only 3 vessels were observed in the winter period. Visual observation dates slightly differ to radar records so may produce different counts.

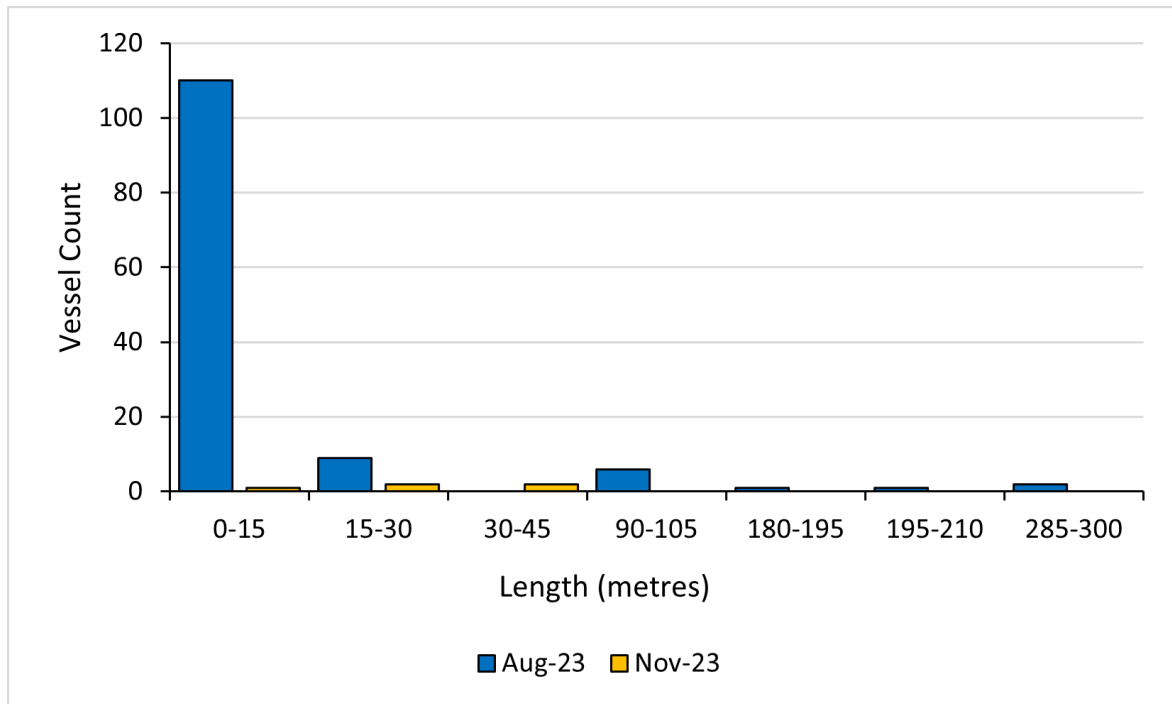
Figure 23: Vessel transits by LOA

Length of vessel transiting the sitewide gate are shown in **Figure 23**. The majority (85%) of vessels are less than 15m LOA in the summer period, with the largest vessels being cruise ships recorded entering the MDZ. 5 vessels were recorded transiting in the winter period with lengths no greater than 45m.

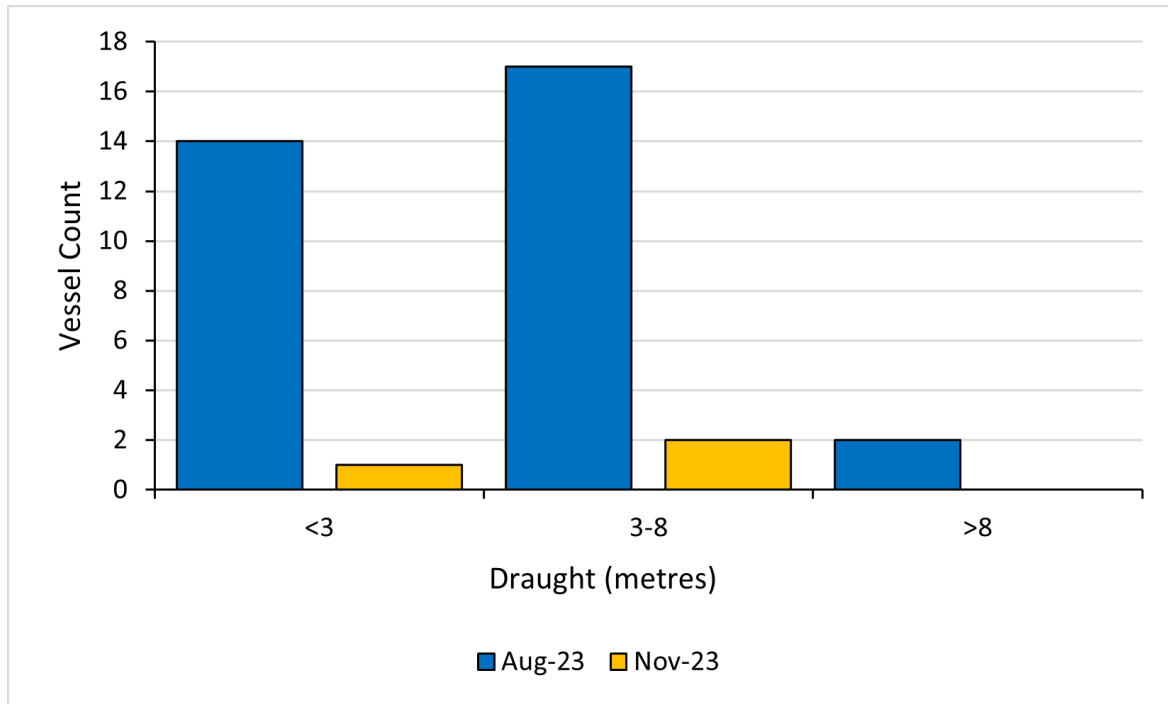
Figure 24: Vessel transits by Draught

Draughts of the sitewide gate are shown in **Figure 24**. The most common summer draught was between 3m and 8m accounting for 52% of transits, there were two vessels with recorded draughts greater than 8m, both of which were cruise ships.

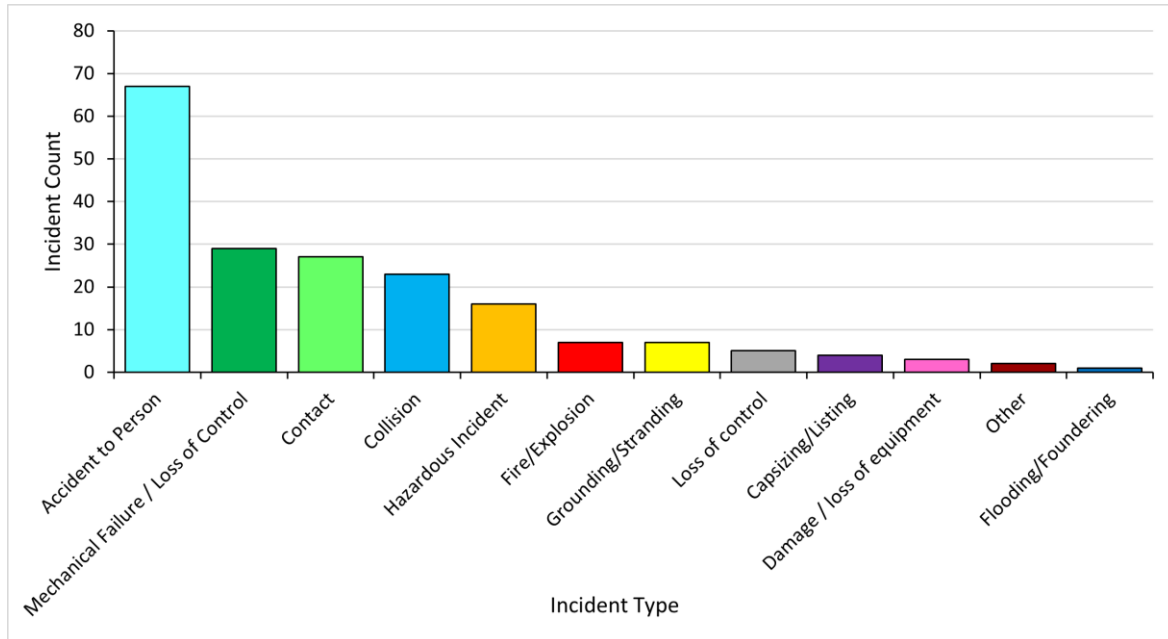
Figure 27: MAIB Incidents by type within 5nm of MDZ

The types of recorded incidents are seen within **Figure 27**, demonstrating the profile of risks within the surrounding areas. Accident to Person was the largest count of incident type and made up 35% of recorded events.
