Fugitive Emissions Summary Report 2024

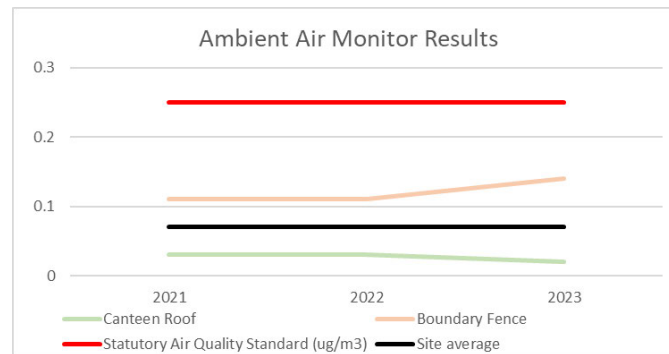
There are 2 ambient air monitors on the site, one located at the boundary fence and the other at the canteen fence. The filters from these monitors are collected and sampled by an external contractor. For 2023 the site average was 0.07 $\mu\text{g}/\text{m}^3$. The average reading from the canteen roof monitor was 0.02 $\mu\text{g}/\text{m}^3$, a decrease of 0.01 $\mu\text{g}/\text{m}^3$ on the previous year. The average reading from the boundary fence monitor was 0.14 $\mu\text{g}/\text{m}^3$, an increase of 0.03 on the previous year. All of these readings are below the Statutory Air Quality Standard ELV of 0.25 $\mu\text{g}/\text{m}^3$. The graph below shows the trend over the last 3 years.
