MENTER MÔN

**MDZ BIENNIAL SITEWIDE NAVIGATION RISK ASSESSMENT
2023 (REVISED JULY 2025)**

Report Number: 22UK1877
Issue: 02
Date: 10 July 2025

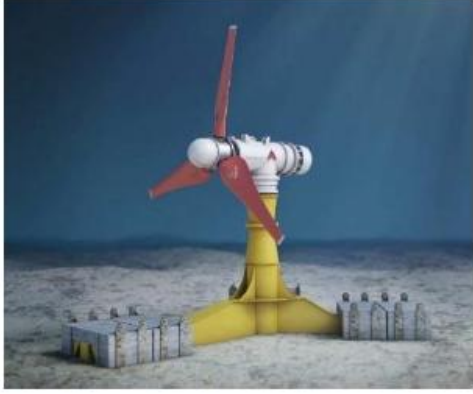
Sub-Category	Exemplars (Developer or Device Names)	
Category 1 : Seabed Mounted Sub-Surface Devices		
<p>Large rotor(s) (>10 m diameter)</p>	<ul style="list-style-type: none"> • SIMEC Atlantis Energy • Andritz Hydro Hammerfest

<p>Developer: SIMEC Atlantis Energy Source: (https://twitter.com/simecatlantis/status/534996023178178560)</p>
<p>Small (<10 m diameter) rotors</p>	<ul style="list-style-type: none"> • Verdant Power • QED Naval SubHub • Nova Innovation • Sabella

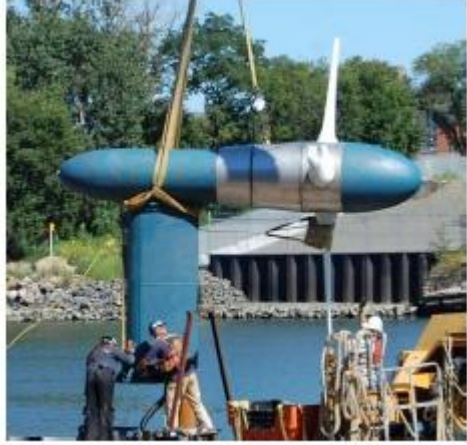
<p>Device/Developer: Gen5Tidal/Verdant Power Source: Verdant Power</p>

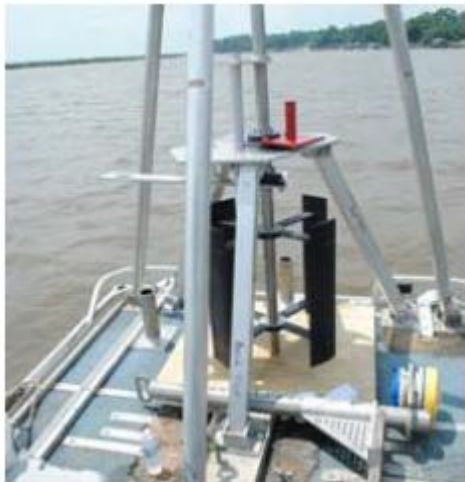
<p>Device/Developer: D10-1000/Sabella Source: Sabella</p>
Vertical Axis Turbine	<ul style="list-style-type: none"> • Repetitive Energy

<p>Developer: Repetitive Energy Source: http://www.repetitiveenergy.com/ourtechnology</p>
Category 2: Mid-water Column Devices		
Multiple small (<10 m diameter) rotor upon submerged buoyant platform	<ul style="list-style-type: none"> • SME PLATO platform or similar with Tocardo or Schottel TECs • Renewable Devices • Marine Ltd.

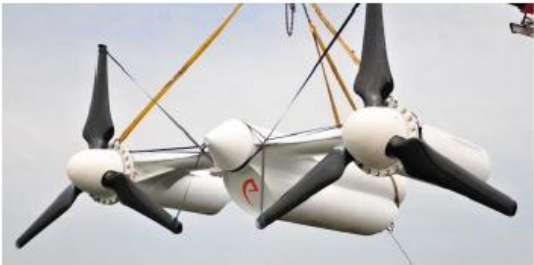
<p>Developer: Renewable Devices Marine Ltd. Source: https://www.theenergytimes.com/distributedenergy-ecosystem/scots-push-new-tide-turbine-tech</p>

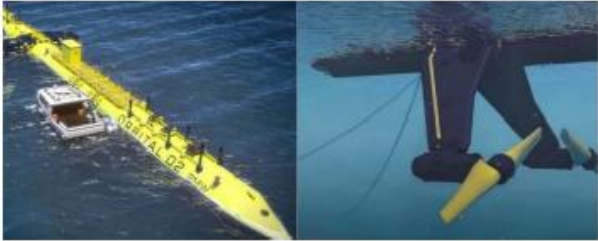
Sub-Category	Exemplars (Developer or Device Names)	
Category 3: Floating or Surface Emergent Devices		
<p>Large rotor (>10 m diameter) floating or emergent devices</p>	<ul style="list-style-type: none"> Orbital Marine Power Magallanes

<p>Developer: Orbital Marine Power</p> <p>Source: https://marineenergy.biz/2018/11/16/orbitalmarine-unveils-o2-turbine-blueprints/</p>
<p>Small rotor (<10 m diameter) floating devices</p>	<ul style="list-style-type: none"> Tocado TFS

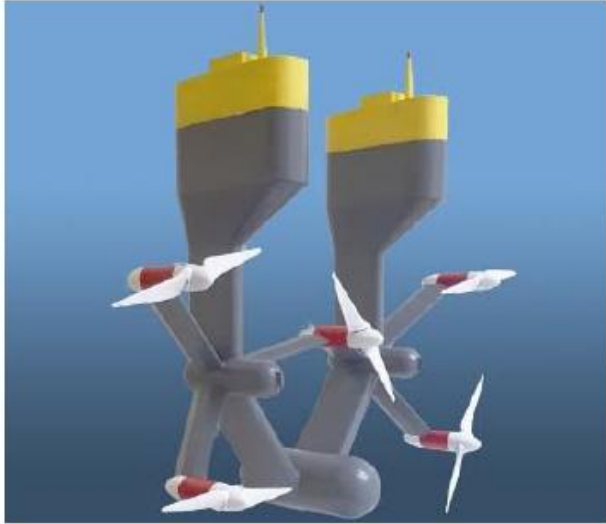
<p>Developer: Tocardo</p> <p>Source: https://marineenergy.biz/2018/06/06/-tocardo-strengthens-management-with-financeappointments/</p>

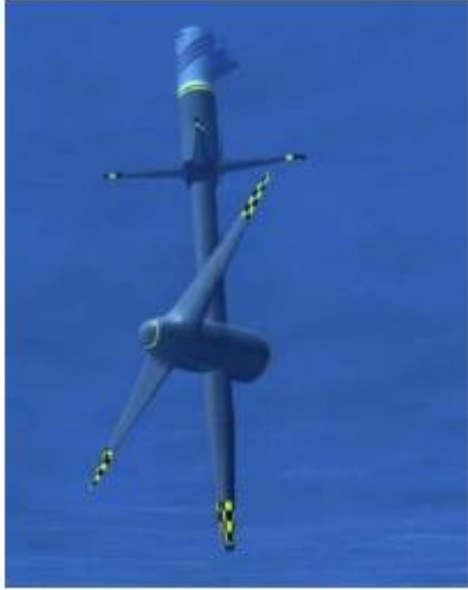
Sub-Category	Exemplars (Developer or Device Names)	
<p>Large rotor (>10 m diameter) surface emergent spar buoy</p>	<ul style="list-style-type: none"> Aquantis 	<p>instream-and-itspennergised-full-scale-demonstrator/</p>

<p>Developer: Aquantis Source: https://www.f6s.com/aquantisinc</p>

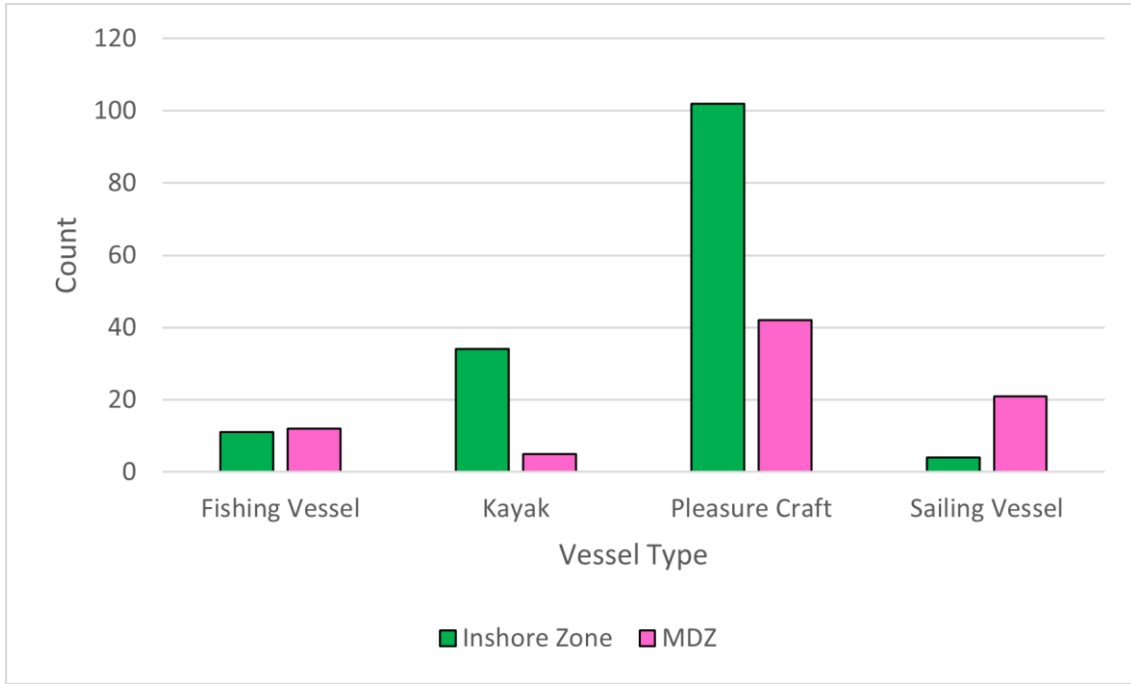
Figure 17: Non-AIS Vessels by Type within Summer Data

This radar target data is also supplemented by the visual observations during the survey periods. **Figure 17** and **Figure 18** demonstrate the visual counts of vessel types during both summer and winter observations that transited either within the MDZ or the inshore passage. During the summer two-week period of observations 231 vessels were seen, whereas only 3 vessels were observed in the winter period. Visual observation dates slightly differ to radar records so may produce different counts.

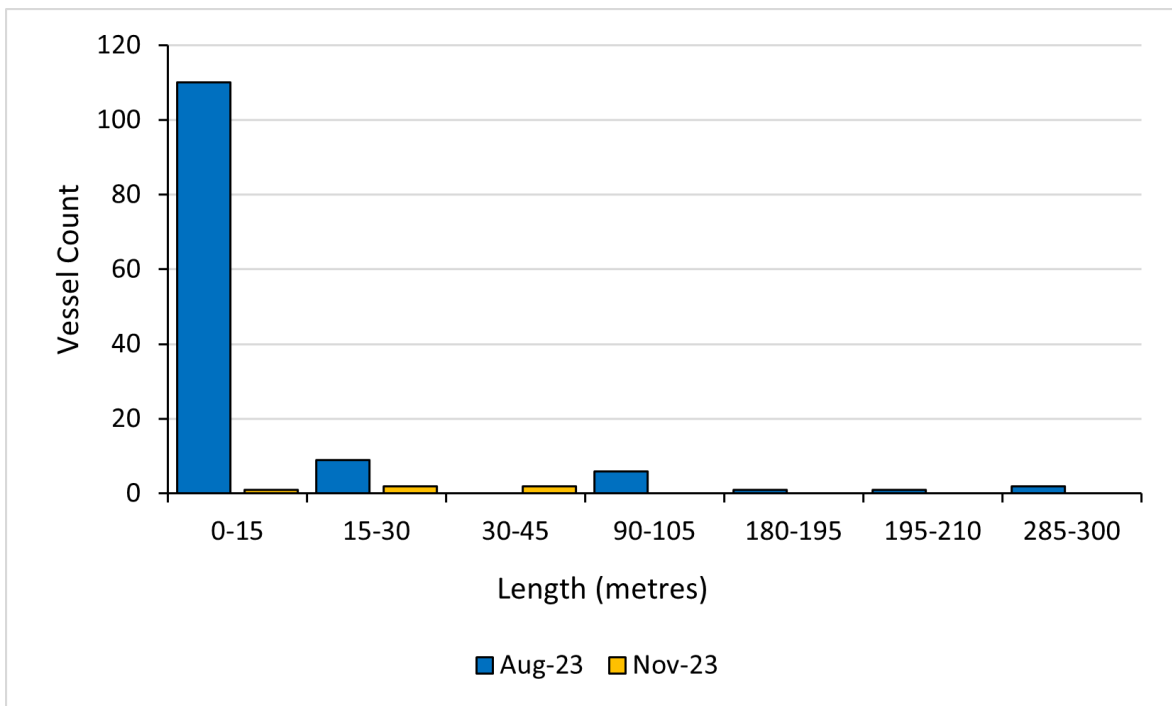
Figure 23: Vessel transits by LOA

Length of vessel transiting the sitewide gate are shown in **Figure 23**. The majority (85%) of vessels are less than 15m LOA in the summer period, with the largest vessels being cruise ships recorded entering the MDZ. 5 vessels were recorded transiting in the winter period with lengths no greater than 45m.

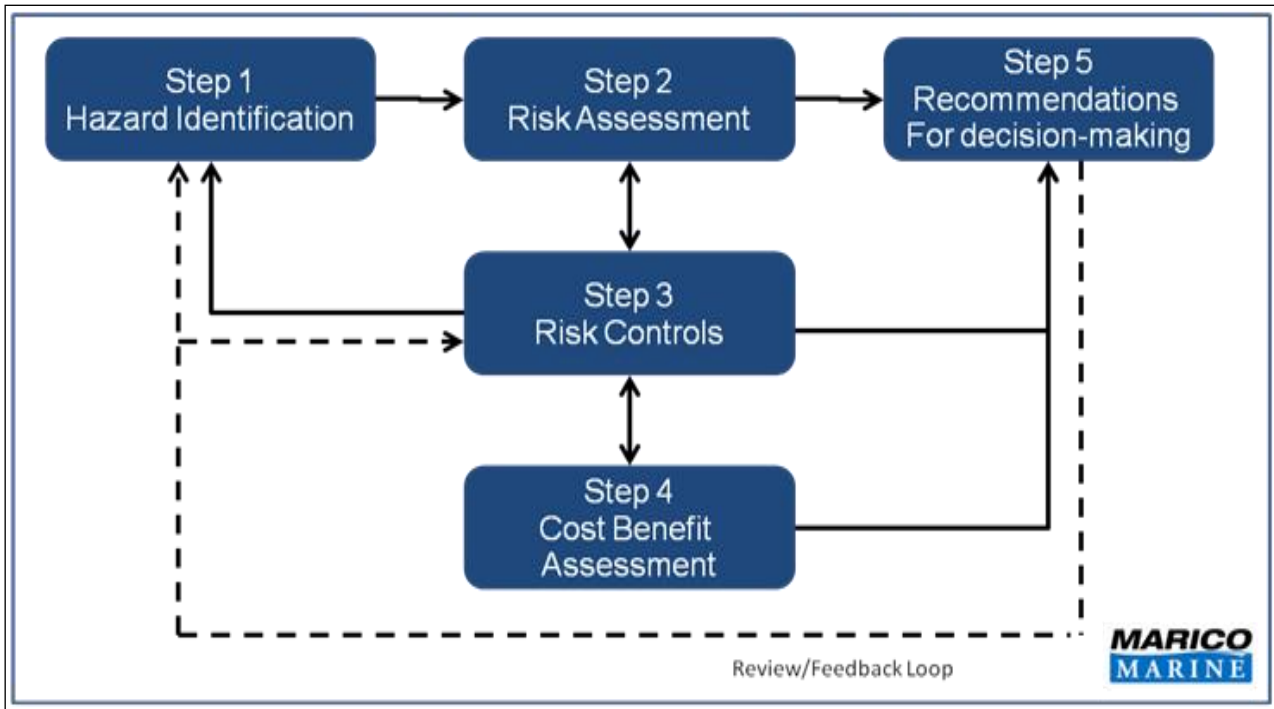
Formal Safety Assessment Risk Assessment Process.

The Navigation Risk Assessment methodology is based on the Formal Safety Assessment (FSA) methodology as adopted by IMO. Marico Marine uses a form of risk assessment that has been specifically adapted for navigational use. It is fundamentally based on concepts of “Most Likely” and “Worst Credible”, which reflect the range of outcomes arising from a shipping accident.

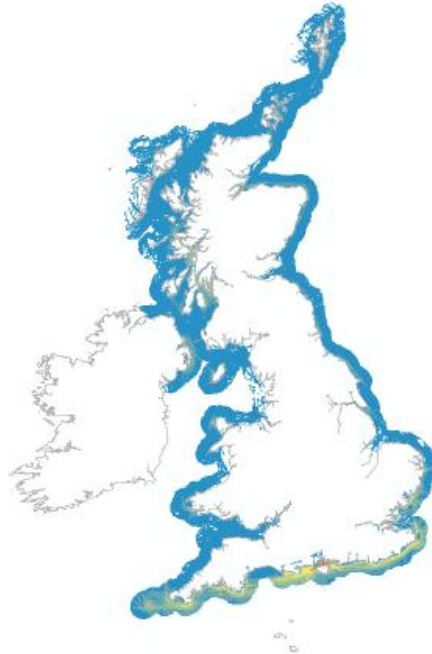
Figure 4 UK AIS with a standard scale

Coastal Atlas AIS - Standard and Log10 Scaling Source: RYA UK Coastal Atlas of Recreational Boating 2.1 User Guide
