Connah's Quay Low Carbon Power

Navigational Risk Assessment

Planning Inspectorate Reference: EN010166

Document Reference: EN010166/APP/6.15

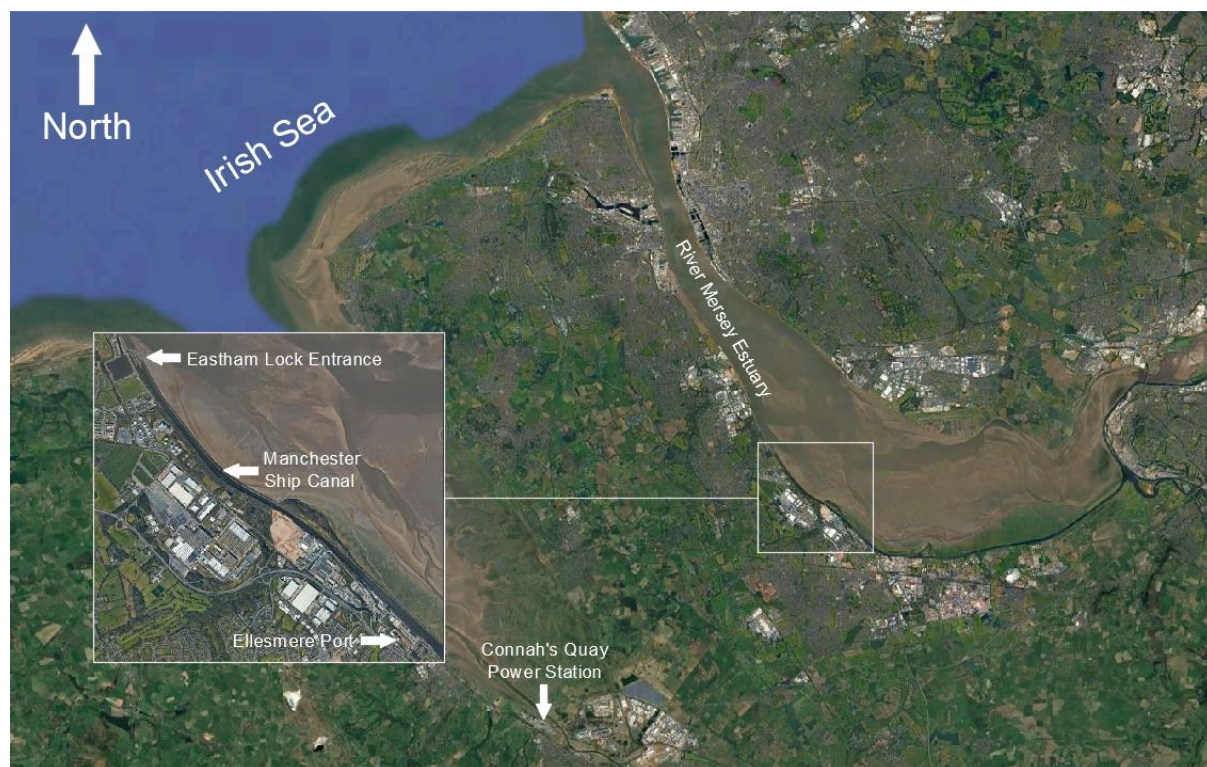
Figure 3: Ellesmere Port Navigation Route

- 2.2.3 **Figure 3** shows the geographically significant points along this route. While it is not the purpose of this report to review the transportation of the landside

- 2.2.1 The NRA for Ellesmere Port is based on a route that anticipates the AIL carrying vessel will travel from the open water into the River Mersey Estuary, where it will navigate upstream until reaching Eastham Locks on the south bank of the River Mersey. There, the vessel will pass through the locks into the Manchester Ship Canal and continue traveling in a south-eastern direction until it reaches Ellesmere Port. It has been assumed that the vessel will return following the same route it came once the AIL has been transferred over to the landside.

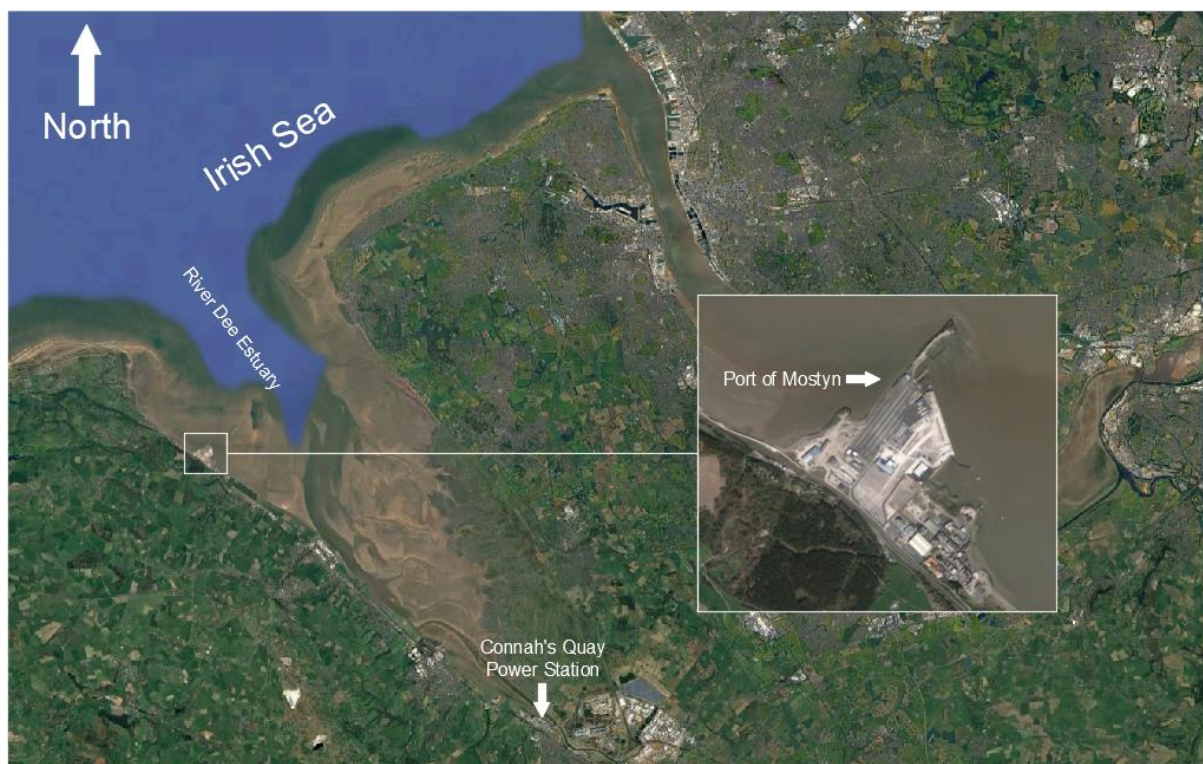
Figure 4: Port of Mostyn Navigational Route

- 2.3.3 **Figure 4** shows the geographically significant points along this route. The Port of Mostyn is located near the mouth of the River Dee, resulting in a shorter upstream navigation distance compared to the other two options.

- 2.3.1 The NRA for the Port of Mostyn is based on a route that anticipates the AIL carrying vessel will travel from open water into the River Dee Estuary where it will navigate to the Port of Mostyn and transfer the AIL for landside transportation. It has been assumed that once the vessel has transferred the AIL to the land that it will return following the route it came.

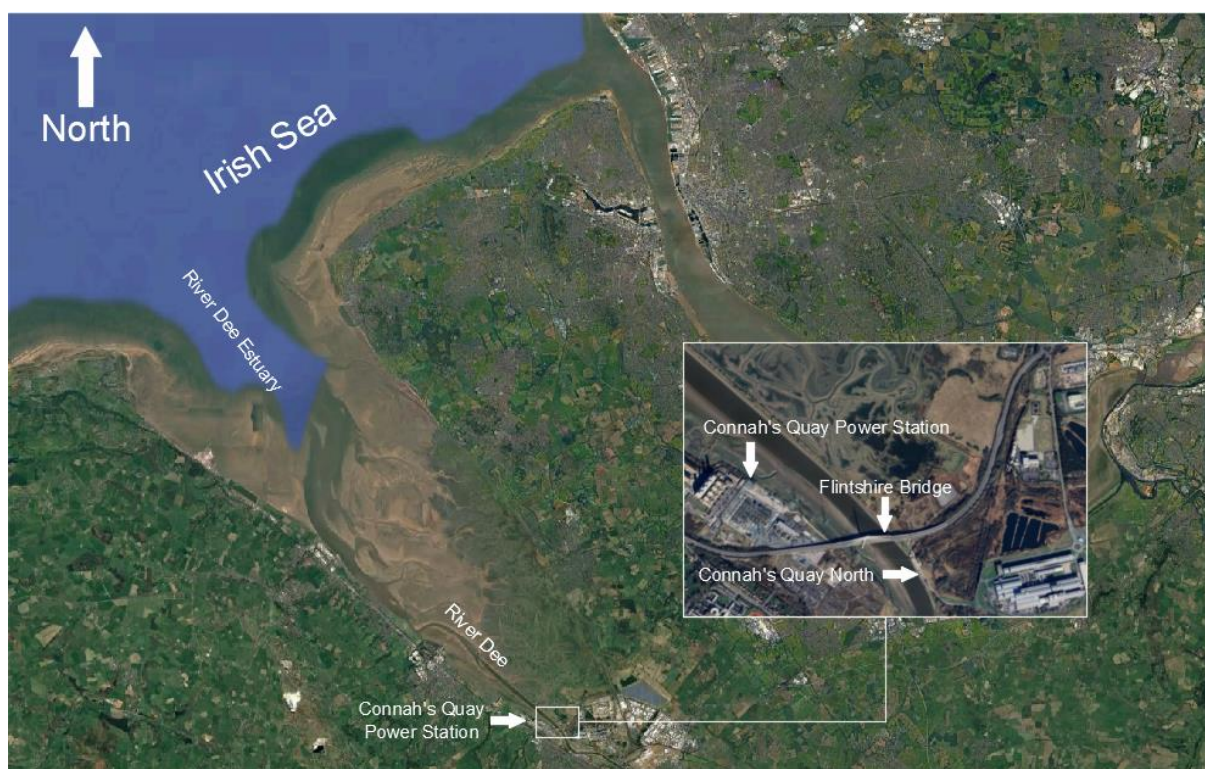
Figure 5: Connah's Quay North Navigational Route

2.4.3 **Figure 5** shows the geographically significant points along this route. While it is not the purpose of this report to review the transportation on the landside (see the **Chapter 5: Construction Programme and Management (EN010166/APP/6.2.5)** and the **Framework CTMP (EN010166/APP/6.6)** which cover landside transportation arrangements), it should be noted that Connah's Quay North is within close proximity to the Power Station, albeit on the opposite side of the river. Accordingly, the landside delivery route is considerably shorter than the other two options.

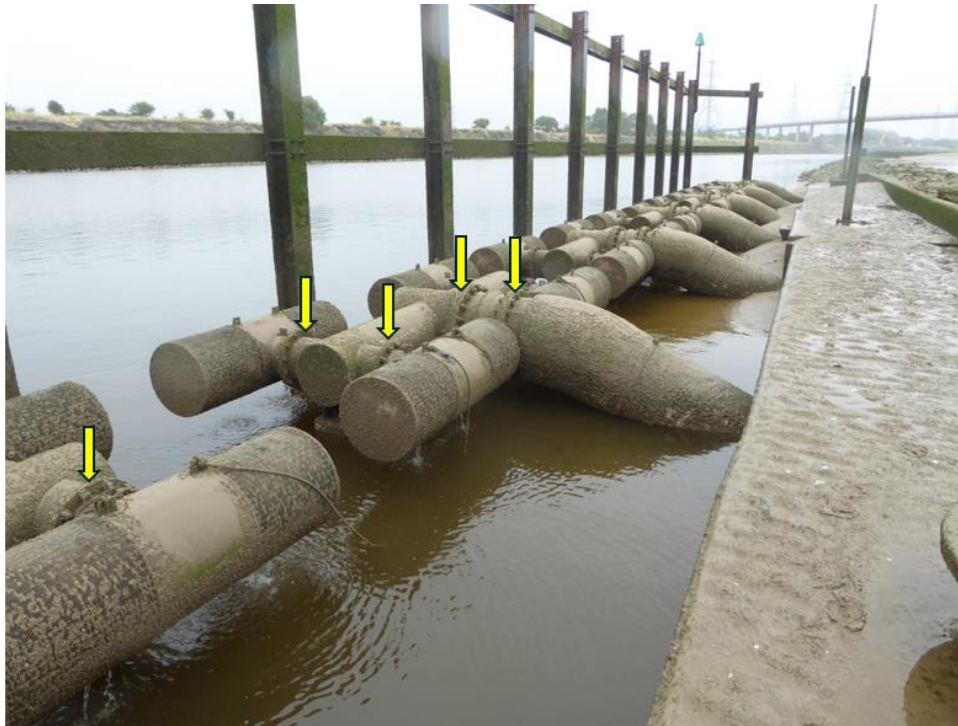
Figure 6: Eel Screens at the Water Connection Corridor

2.5.1 As referenced in the Navigation Overview Section above, part of the proposed works is the replacement of eel screens and minor refurbishment (to adhere with the Eels (England and Wales) Regulations 2009). The screens are located on the shore of the River Dee just outside the Power Station. **Figure 6** shows the current eel screens and water intakes protected by a fender structure.

- 2.5.2 The work on the intakes will involve lifting out the existing intake screen assemblies, detaching the existing screens and replacing them with finer mesh screens. The assemblies will then be lifted back into position. The estimated construction period is 3-5 months, and a crane barge is expected to be moored at site alongside the protective barrier for the duration of this period in order to lift the sections over the barrier. An additional vessel may also be required to deliver materials to site.

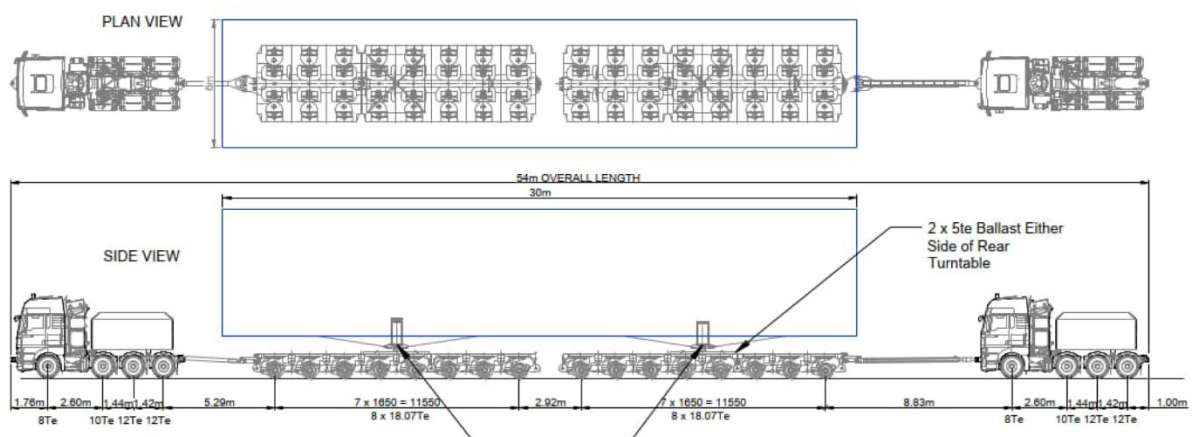
Figure 8: AIL Dimensions for Delivery Vehicles

2.6.1 As this NRA is part of a preliminary investigation, vessel specific dimensions were not able to be provided. This NRA has therefore been completed on an assumed maximum vessel length of 60 m. This number was used on the basis that the AIL dimensions will be 30 m long by 6 m wide by 6 m high as shown in **Figure 8** and as such it would be unlikely that a vessel would exceed 60 m for these requirements.
