## Fairbourne Short Sea Outfall Repair

### Outline Method Statement

March 2019

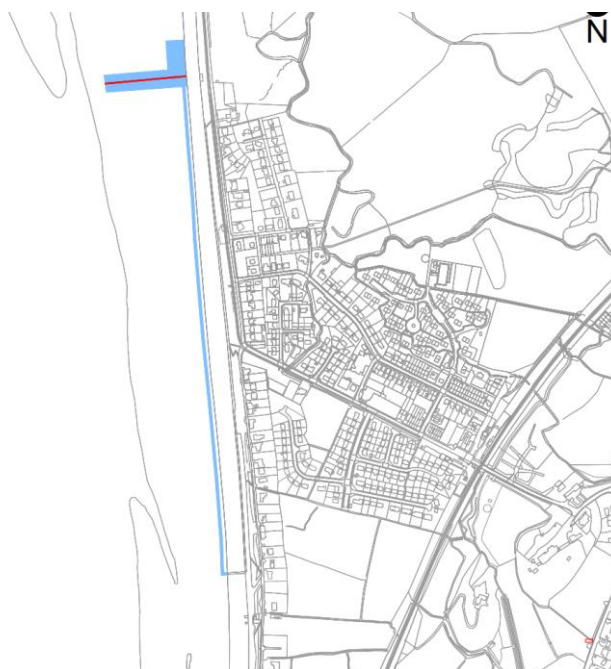
- Access and egress to the works area from the site compound shall be via the existing concrete ramp. The route to the working area shall be made by tracking down the beach parallel to the bottom of the cobble bank, as close to the bottom of the bank as practical avoiding any rock pools or other features keeping to the sand. The return route to be same avoiding any shortcuts to directly travel between points. As indicated below:

- The changed location of the compound allows the use of the existing concrete access ramp to the beach from the car park area.
- However bog mats or similar may be installed to prevent any damage to the existing surfaces in addition there is sufficient space between the tank traps to allow easy access at this point we have been informed by the local Harbour Master that this point is where plant usually access the beach
