**MENTER MÔN**

**MDZ BIENNIAL SITEWIDE NAVIGATION RISK ASSESSMENT  
2023 (REVISED JANUARY 2026)**

**Report Number:** 22UK1877  
**Issue:** 03  
**Date:** 27 January 2026

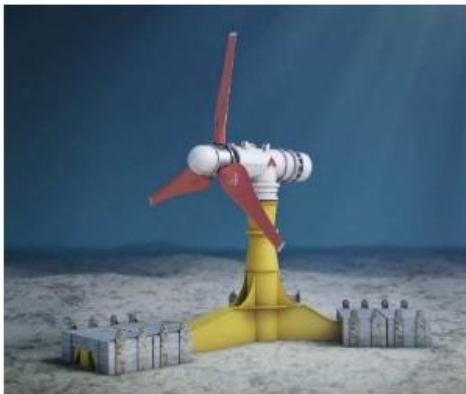
| Sub-Category | Exemplars (Developer or Device Names) | |
|---|---|---|
| Large rotor(s)<br>(>10 m diameter) | <ul style="list-style-type: none"> <li>• SIMEC Atlantis Energy</li> <li>• Andritz Hydro Hammerfest</li> </ul> | <p>Developer: SIMEC Atlantis Energy<br/> Source: (<a href="https://twitter.com/simecatlantis/status/534996023178178560">https://twitter.com/simecatlantis/status/534996023178178560</a>)</p> |

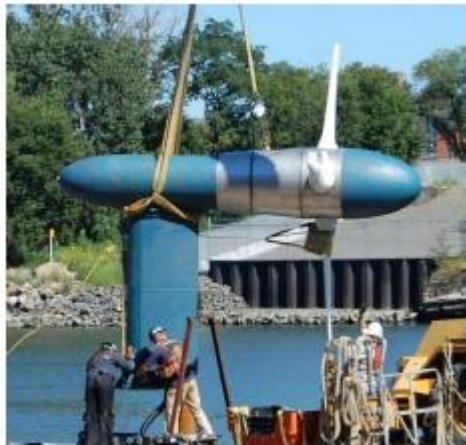
| Sub-Category | Exemplars (Developer or Device Names) | |
|---|---|---|
| Small (<10 m diameter) rotors | <ul style="list-style-type: none"> <li>• Verdant Power</li> <li>• QED Naval SubHub</li> <li>• Nova Innovation</li> <li>• Sabella</li> </ul> | <p>Device/Developer: Gen5Tidal/Verdant Power<br/> Source: Verdant Power</p> |

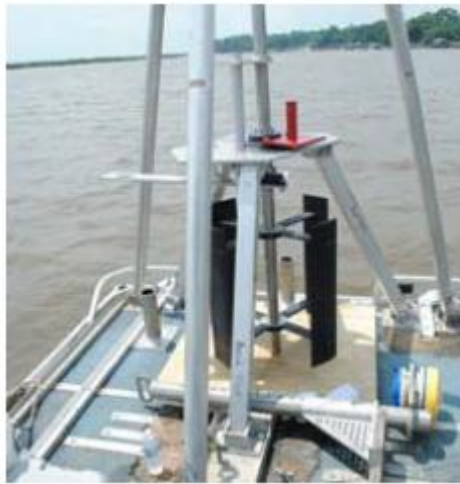
| Sub-Category | Exemplars (Developer or Device Names) | |
|---|---|---|
| Vertical Axis Turbine | <ul style="list-style-type: none"> <li>• Repetitive Energy</li> </ul> | <p>Developer: Repetitive Energy<br/>Source: <a href="http://www.repetitiveenergy.com/ourtechnology">http://www.repetitiveenergy.com/ourtechnology</a></p> |

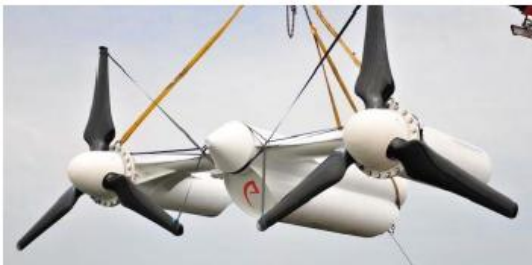
| Sub-Category | Exemplars (Developer or Device Names) | |
|---|---|---|
| Multiple small (<10 m diameter) rotor upon submerged buoyant platform | <ul style="list-style-type: none"> <li>• SME PLATO platform or similar with Tocardo or Schottel TECs</li> <li>• Renewable Devices</li> <li>• Marine Ltd.</li> </ul> | <p>Developer: Renewable Devices Marine Ltd.<br/>Source: <a href="https://www.theenergytimes.com/distributedenergy-ecosystem/scots-push-new-tide-turbine-tech">https://www.theenergytimes.com/distributedenergy-ecosystem/scots-push-new-tide-turbine-tech</a></p> |

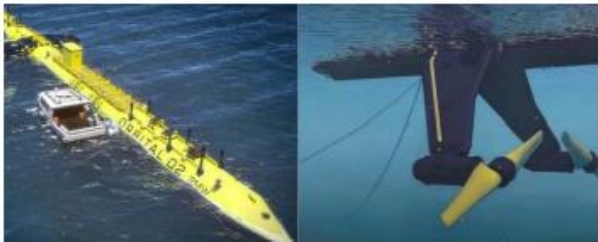
| Sub-Category | Exemplars (Developer or Device Names) | |
|---|---|---|
| Large rotor (>10 m diameter) floating or emergent devices | <ul style="list-style-type: none"><li>Orbital Marine Power</li><li>Magallanes</li></ul> | <div></div> <div>Developer: Orbital Marine Power</div> <div>Source: <a href="https://marineenergy.biz/2018/11/16/orbitalmarine-unveils-o2-turbine-blueprints/">https://marineenergy.biz/2018/11/16/orbitalmarine-unveils-o2-turbine-blueprints/</a></div> |

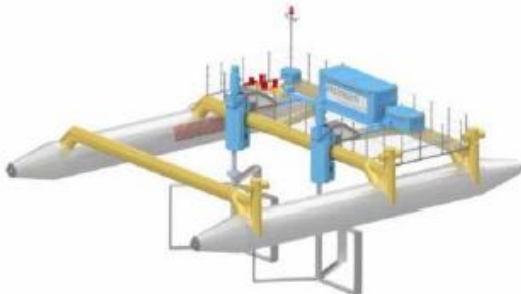
| Sub-Category | Exemplars (Developer or Device Names) | |
|---|---|---|
| | | <div></div> <div>Developer: Instream</div> <div>Source: <a href="https://www.marineenergywales.co.uk/">https://www.marineenergywales.co.uk/</a></div> |

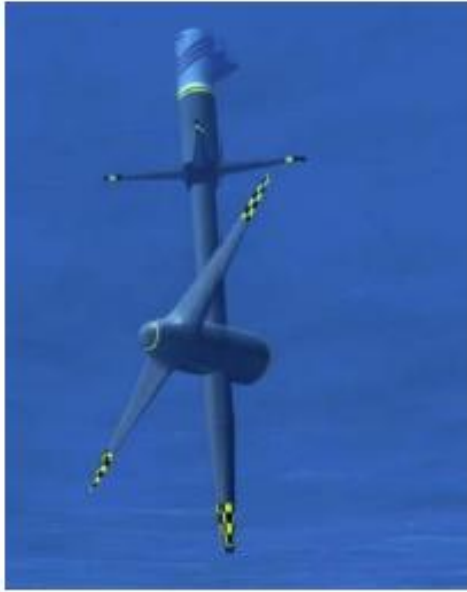
| Sub-Category | Exemplars (Developer or Device Names) | |
|---|---|---|
| Large rotor (>10 m diameter) surface emergent spar buoy | <ul style="list-style-type: none"> <li>Aquantis</li> </ul> | <p>Developer: Aquantis<br/>Source: <a href="https://www.f6s.com/aquantisinc">https://www.f6s.com/aquantisinc</a></p> |

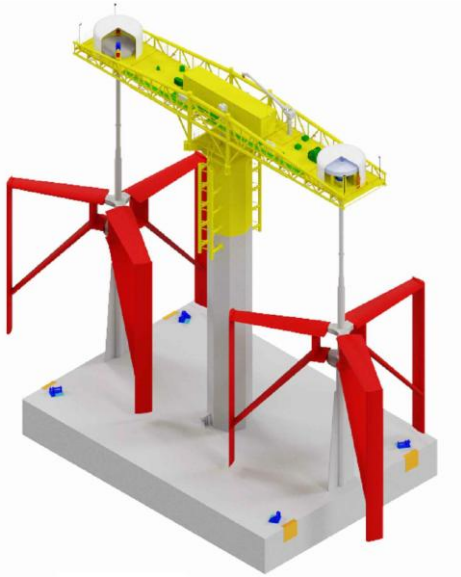
| Sub-Category | Exemplars (Developer or Device Names) | |
|---|---|---|
| Large rotor (>10 m Diameter) Hybrid Seabed Mounted / Surface Emergent Device | <ul style="list-style-type: none"> <li>Tidal Technologies Ltd</li> </ul> | <p>Developer: Tidal technologies Ltd.<br/>Source: Tidal Technologies Scoping Report, MCRP-MM-DOC-0060</p> |

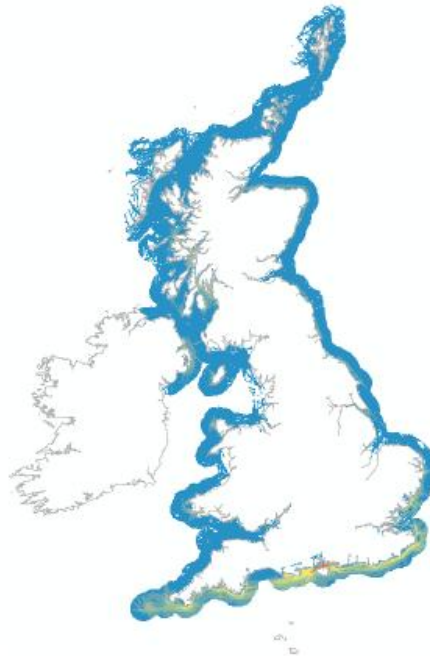
Figure 4 UK AIS with a standard scale

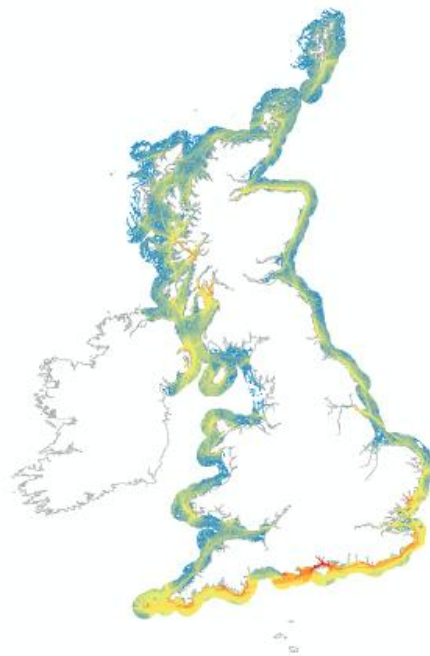
Figure 5 UK AIS with a  $\log_{10}$  scale
