# Western Breakwater, Walls of the Outer Basin and Eastern Promenade, Porthcawl Harbour, Porthcawl, Bridgend

Heritage impact assessment

A report for Ove Arup & Partners Ltd  
and Bridgend County Borough Council  
By Richard Roberts BA (Hons)

GGAT report no. 2019/029  
Project no. P1990  
National Grid Reference:  
Centre:SS 81984 76318

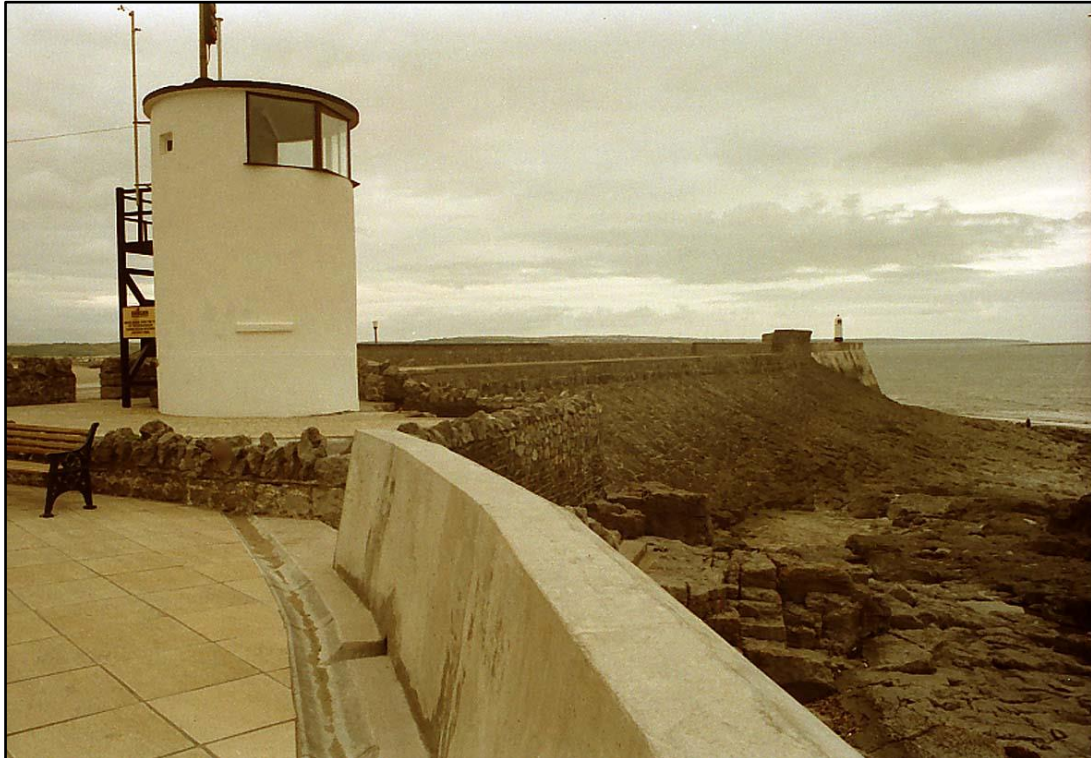
**Plate 1. The Western Breakwater: view from near the Look-out tower towards the light house**

On the landward side it is three tiered. Main quay is of stone blocks with plenty of later patching; concrete surface covers original stone quay surface. Slipway in front widened and reinforced with later concrete.

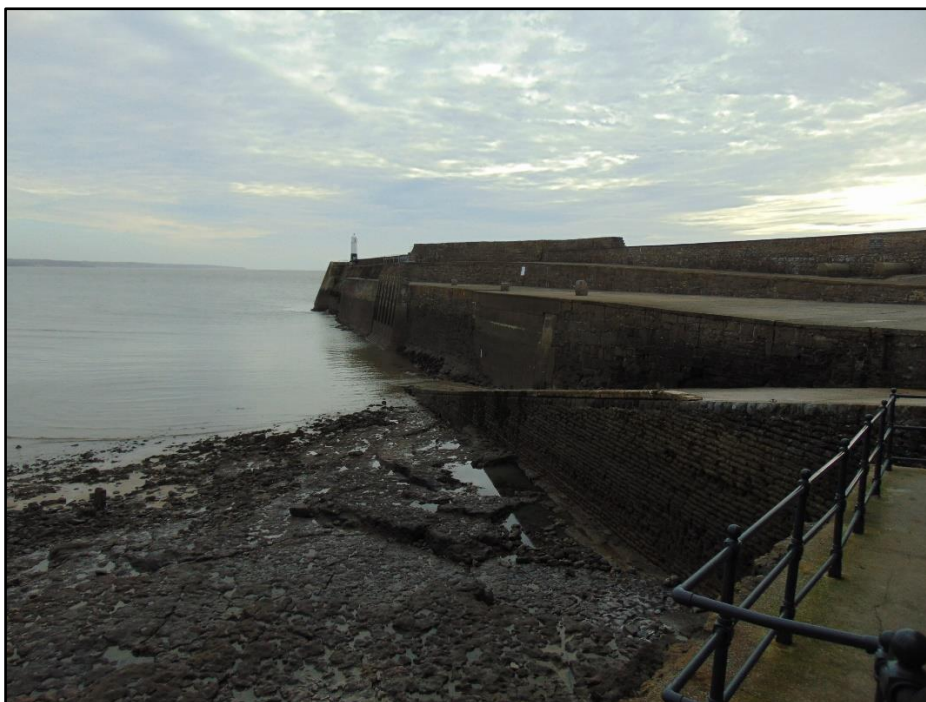
**Plate 3. The Western Breakwater: tiered layout on the landward side and adjacent slipway.  
Taken from West Quay and Jennings Warehouse.**

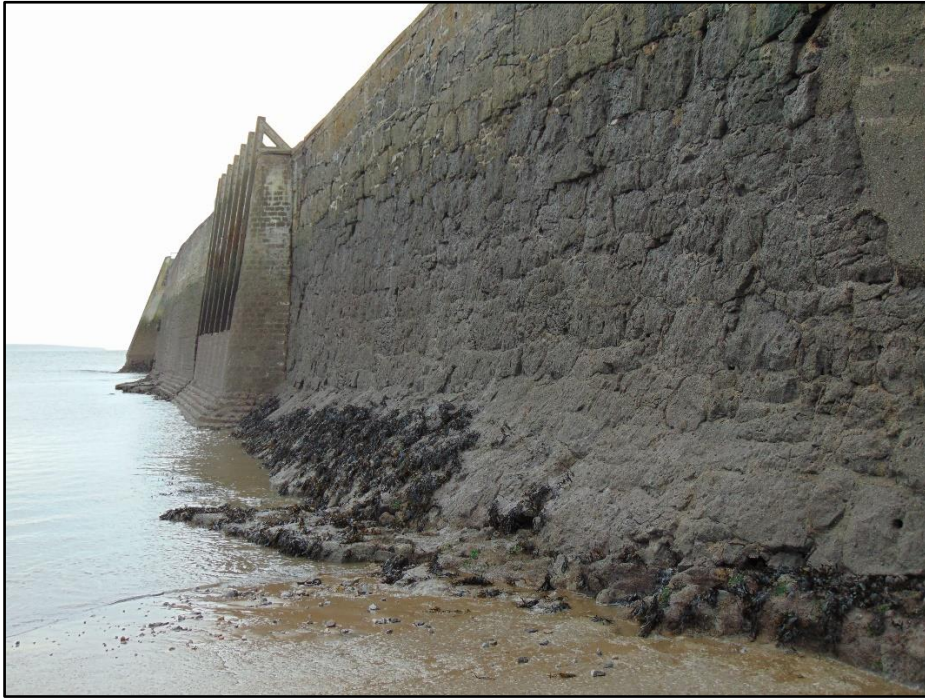
**Plate 4. The Western Breakwater: the quay (steamer berth) on the landward side.**

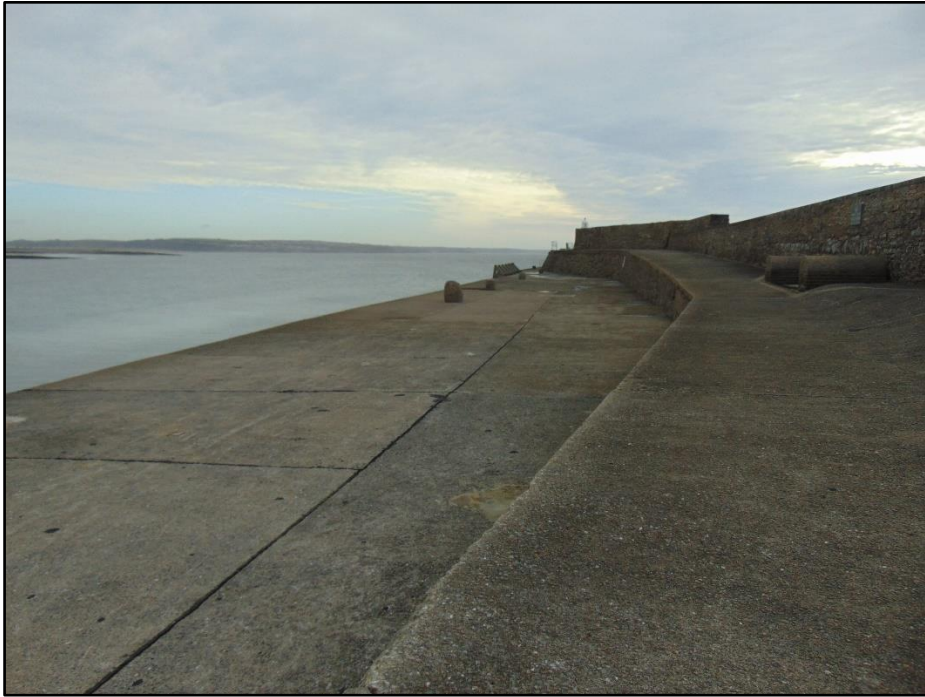
Second ramped and battered tier, also with giant blocks, incorporates a small surviving section of the Dyffryn Llynfi Porthcawl Railway imbedded in the stone surface, the rest covered in concrete. Top tier is the sea-wall mostly of smaller stone though some larger in centre, stepped up in centre; flights of stone steps join levels.

**Plate 5. The Western Breakwater: the quay (steamer berth) and the section of railway from above. Taken from near the Customs House.**

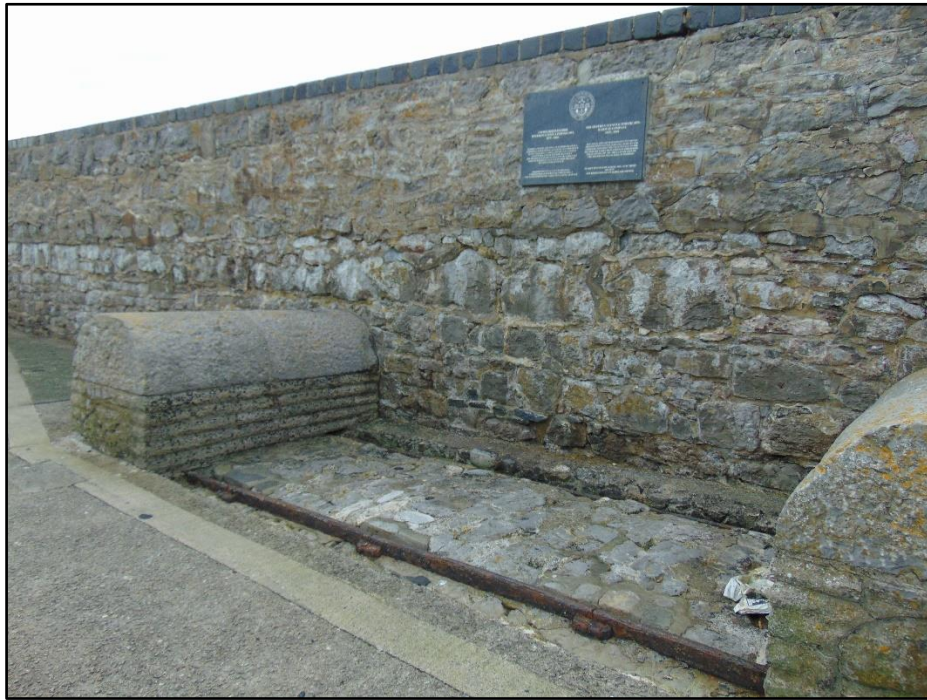
**Plate 6. Western Breakwater: section of Dyffryn Llynfi Porthcawl Railway and upper wall.**

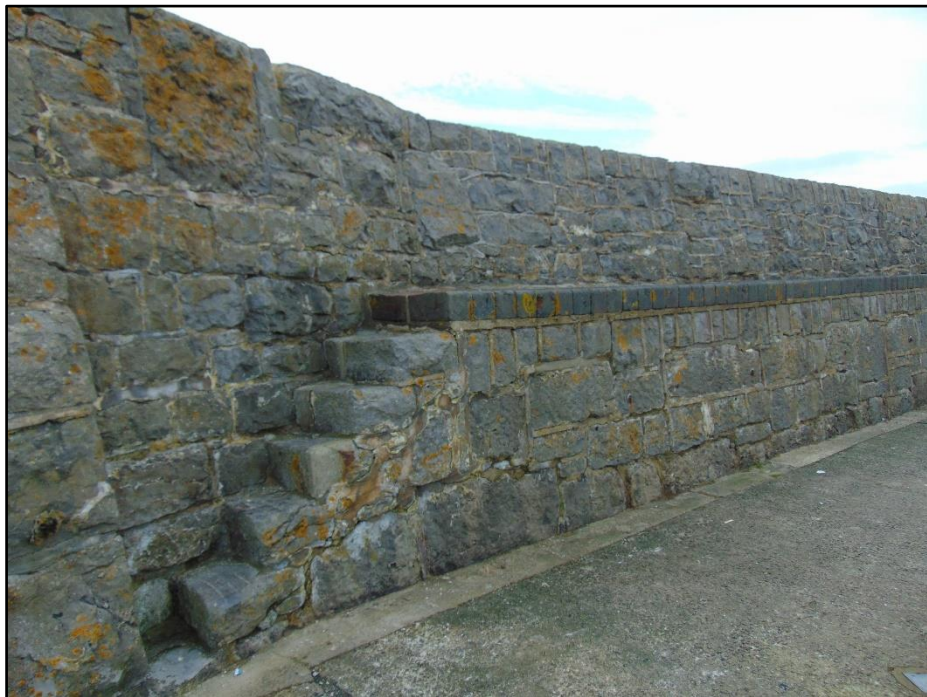
**Plate 7. The Western Breakwater: steps and upper wall, inner side of junction with the extended section of the 1860s.**

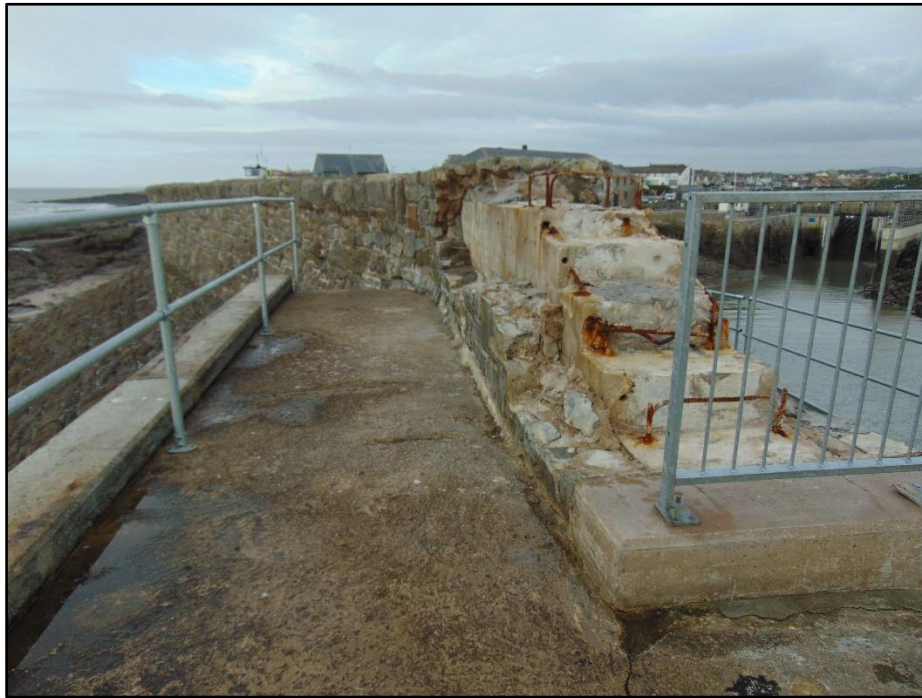
**Plate 8. The Western Breakwater: the junction between the extended section of the 1860s (foreground) and the original part of the breakwater.**

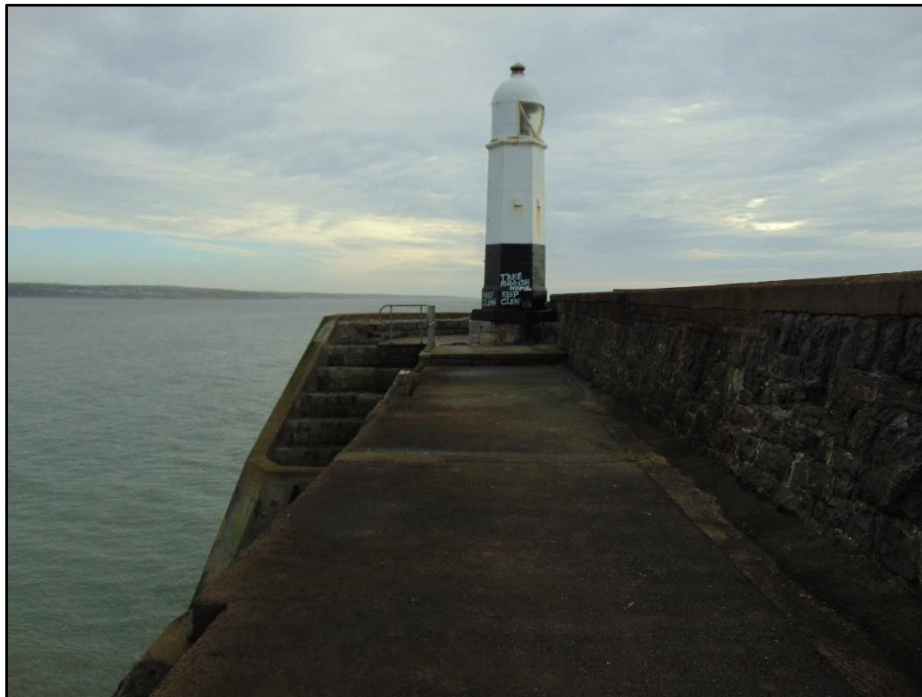
Seaward end section is battered and faced in concrete though the lighthouse has a stone surround with stone ledges; flight of steps descends at end to water.

**Plate 9. The Western Breakwater: the lighthouse and steps at the round end.**

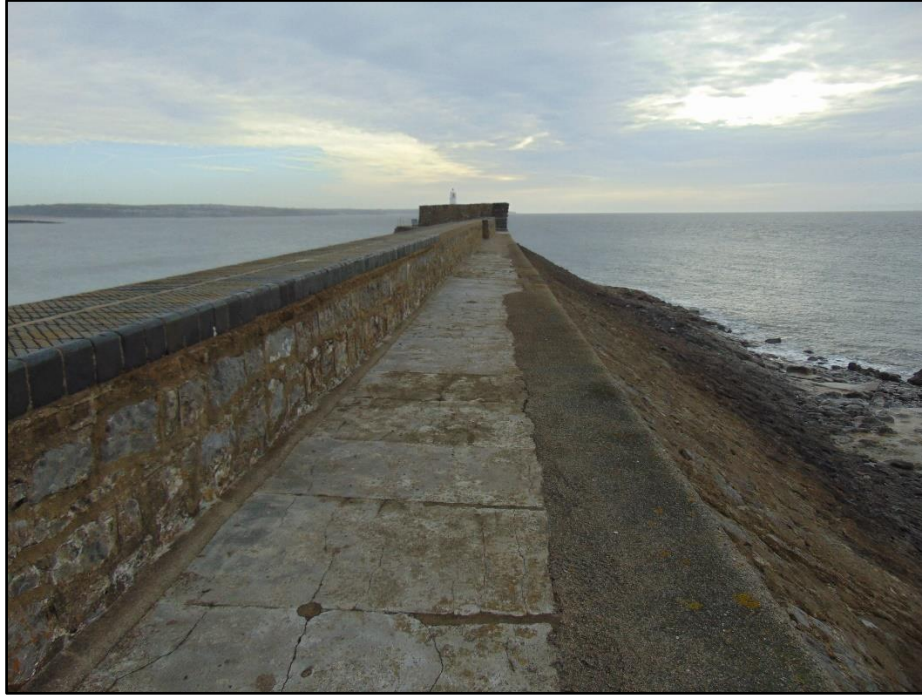
On seaward side the defences rise at roughly 45% angle comprising a slope of giant roughly hewn and mortared boulders surmounted by two vertical courses of giant dressed blocks. There is an added concrete walkway with blue brick on top. Steps rise to the single width wall, here consisting of large stone blocks at base, small at top.

**Plate 10. The Western Breakwater: wall and walkway on seaward side with sloping revetment below to the right. Taken from south of the Lookout Tower.**

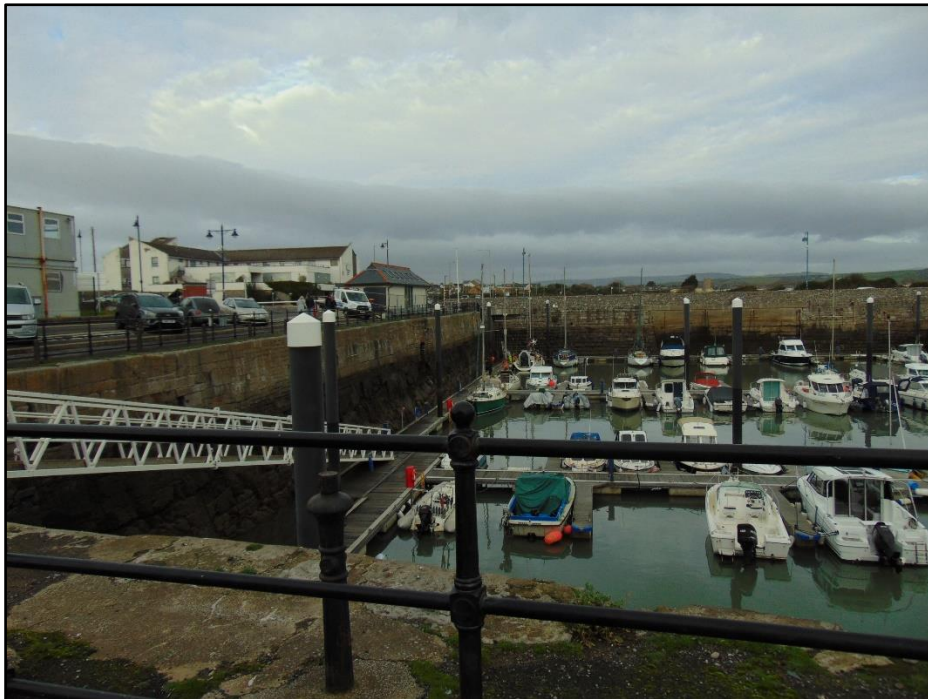
**Plate 12. The Outer Basin: north and west (left) walls**

The Outer Basin is rectangular, originally built of giant regularly coursed dressed limestone blocks, at the south and west directly onto outcropping rock; later rock faced stone and later small stone patching and repairs. The south and west walls are mainly of giant coursed blocks. The later north wall is of rock-faced stone, with clear infill where lock gates were removed when Inner Basin was decommissioned. Further alterations can be traced in masonry of the east wall. Stone quaysides, in places covered with concrete or asphalt, have iron and stone bollards and mooring rings; original steps at the northwest corner, two steps created out of each stone block; an apparently original buttress adjacent; culverts and a blocked arched opening in the west wall. The seawall to the east has blocks on inner face decoratively snecked; the seaward side is rock faced, mostly of large coursed blocks battered to base; surmounted by a raised parapet. The West Pier or Quay in front of Jennings Warehouse is built of coursed dressed blocks with a section to the south of rock-faced stone; it retains grooves for gates, which are apparently submerged and visible in silt at low water.

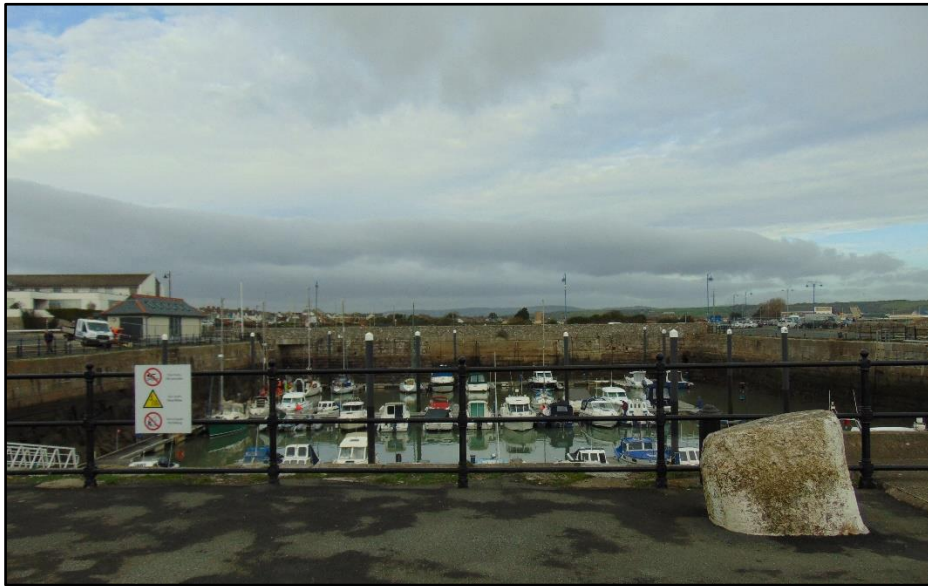
**Plate 15. The Outer Basin: view of the north wall and the blocked entrance to the former Inner Basin. Stone mooring post in foreground right**

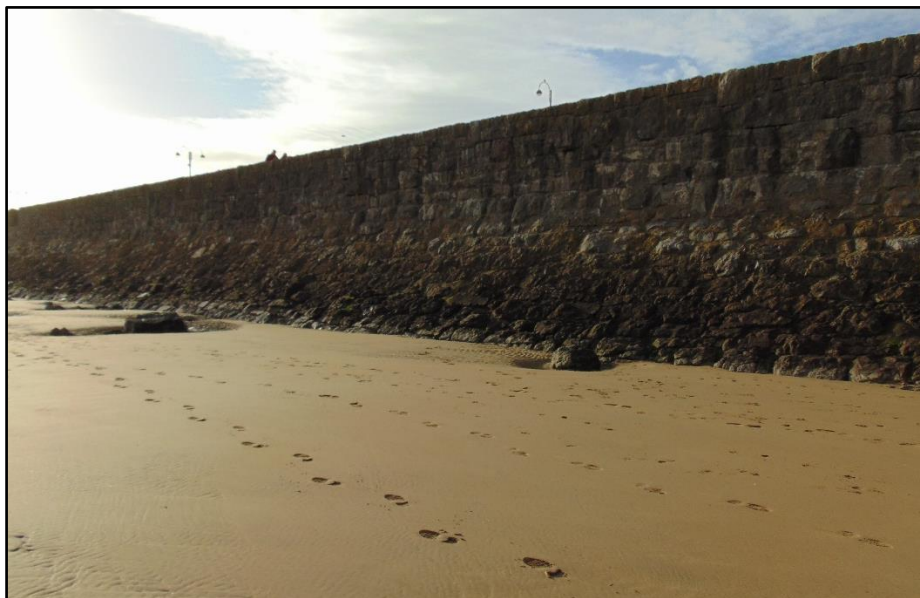
**Plate 18. Eastern Promenade: typical section of Inner Basin/promenade wall with sloping revetment toe**

It consists of a vertical sea wall of roughly faced rusticated stone masonry, with a sloping basal revetment or toe of similar style and a crest level of between 8.6 and 9.0 m AOD. The wall has a parapet which varies in height from the pedestrian side,

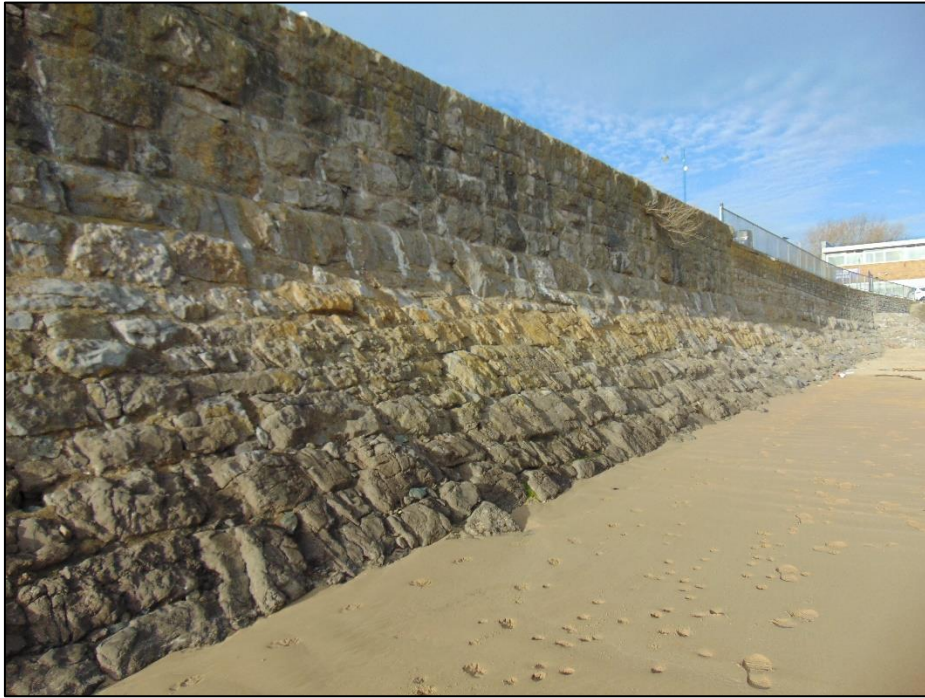
**Plate 19. Eastern Promenade: Inner Basin/promenade wall and revetment towards the Coney Beach end**

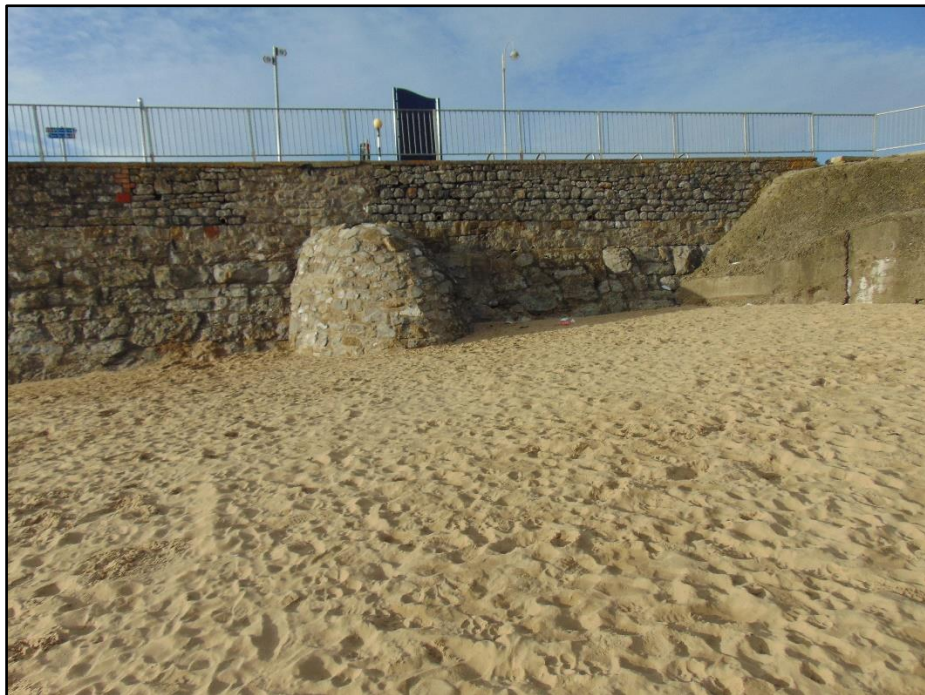
**Plate 20. Eastern Promenade: Inner Basin/promenade wall and revetment at the lower Coney Beach end**

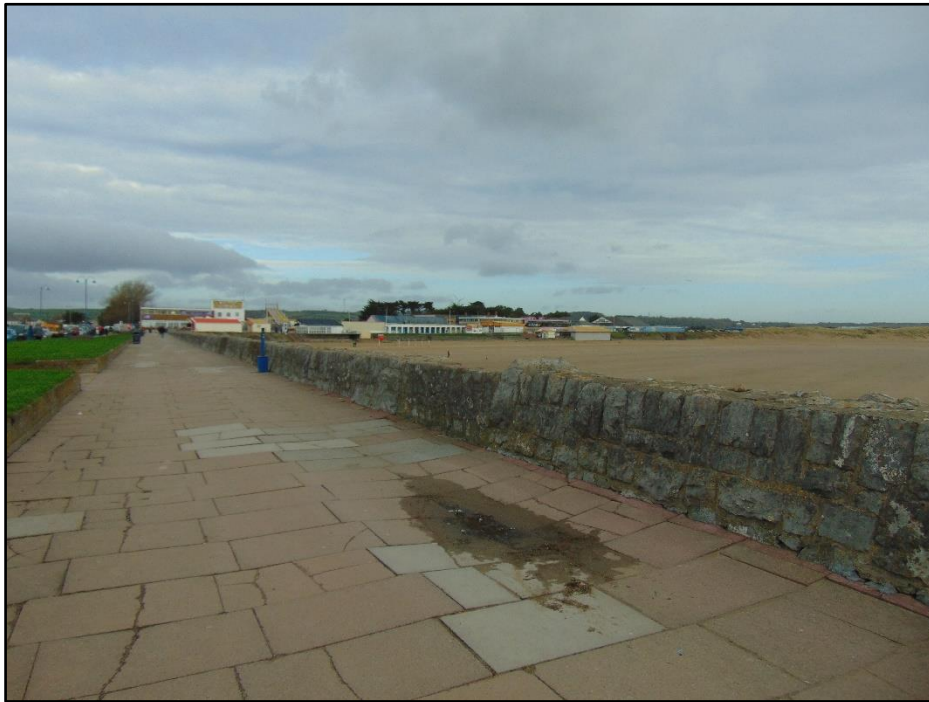
**Plate 21. Eastern Promenade: the promenade showing variations/blocked openings in the wall parapet**

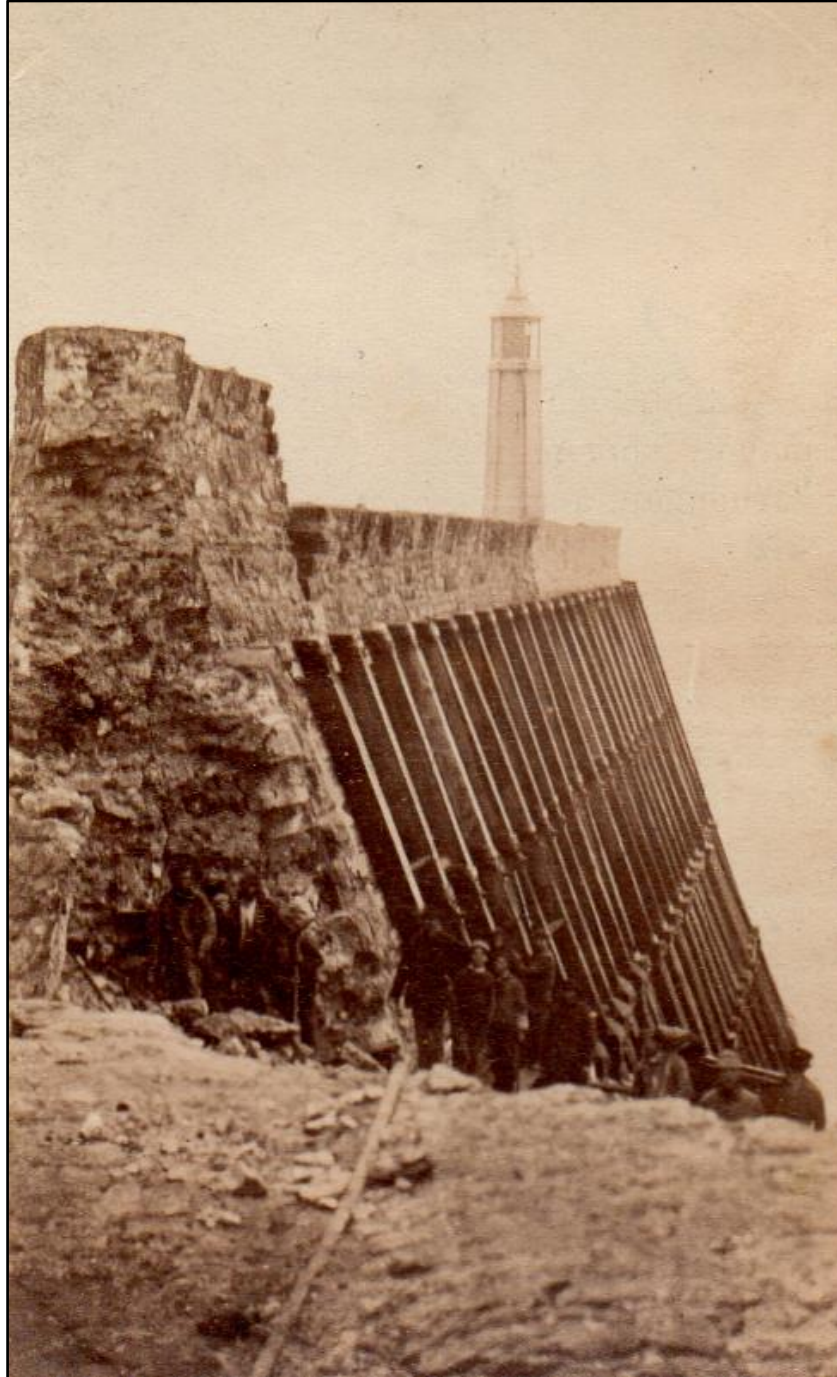
Plate 24. The Western Breakwater during later stages of construction: photograph of c. 1866.  
Courtesy of Porthcawl Museum.

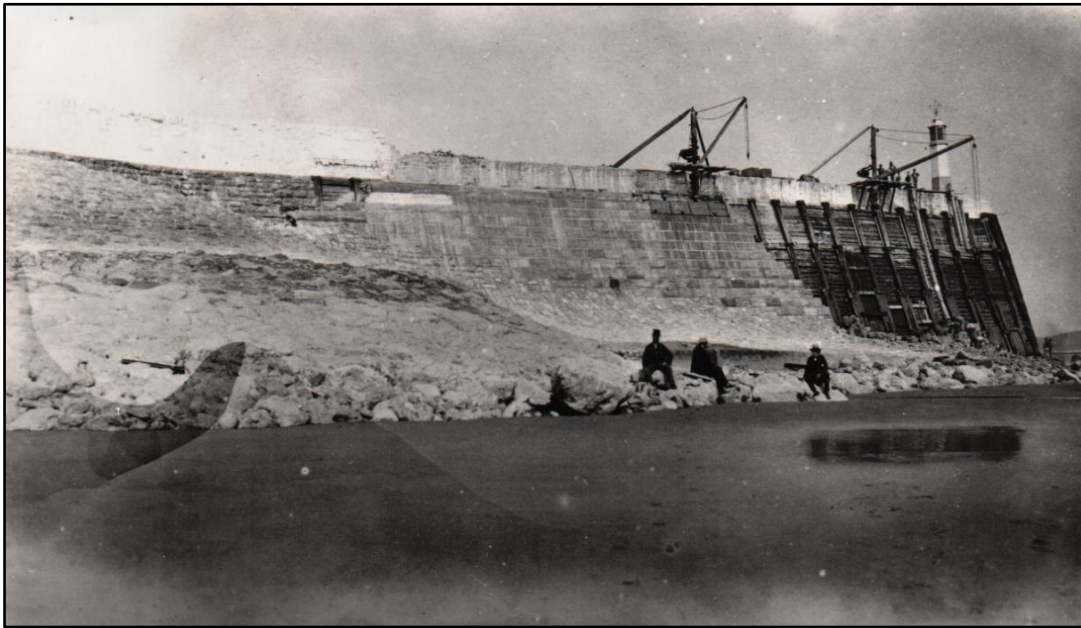
**Plate 25. The Western Breakwater during later stages of construction: photograph of c. 1866.  
Courtesy of Porthcawl Museum.**

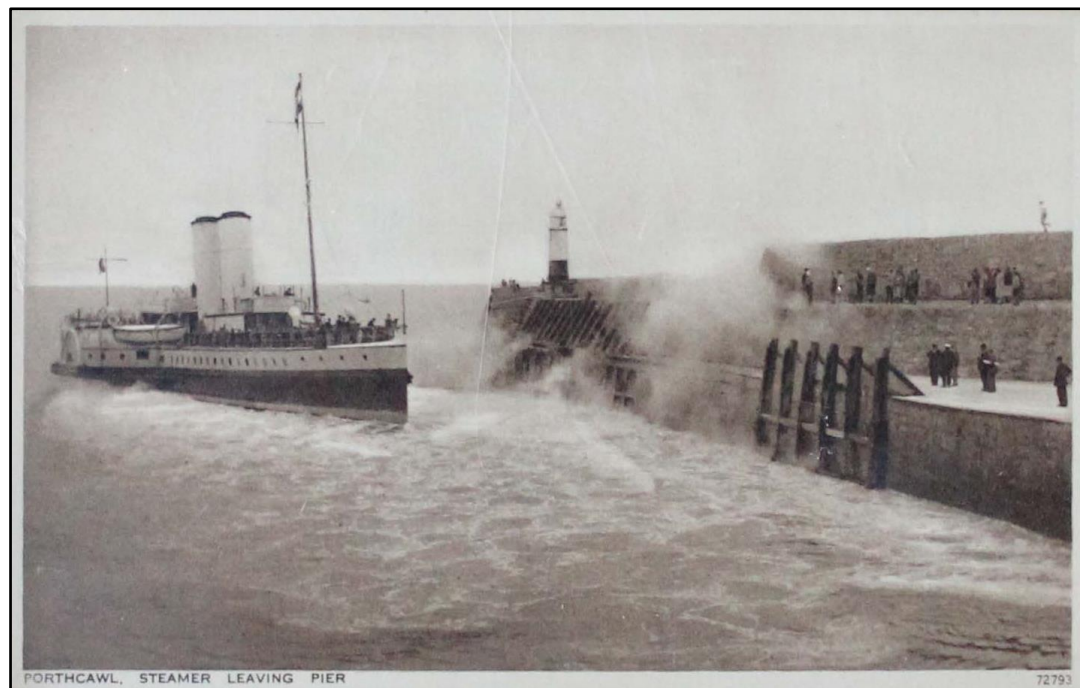
**Plate 32. The Western Breakwater: postcard showing a steamer leaving the pier, Porthcawl, c. 1920s, also shows the steamer berth on the breakwater. Courtesy of the Glamorgan Archives (GRO D57/10).**

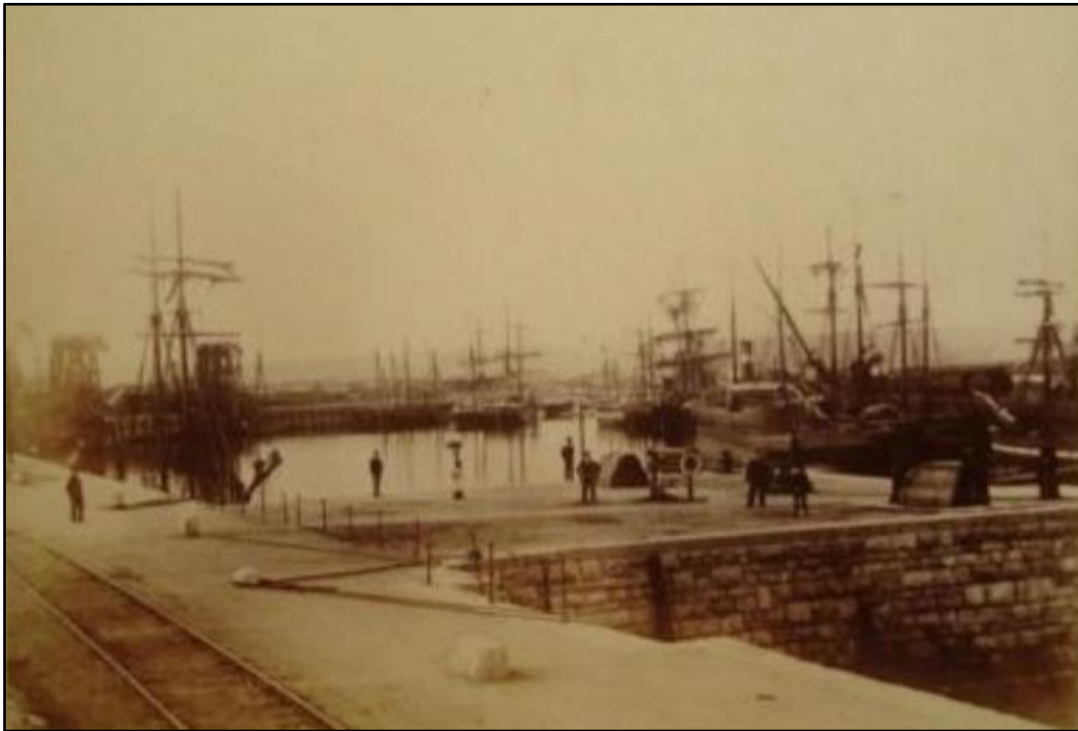
**Plate 35. View of the Inner Basin from near the entrance from the Outer Basin, mooring posts in the foreground, coal tips in the middle distance to the left and sea embankment on the right, 19<sup>th</sup> century. Courtesy of BCBC.**

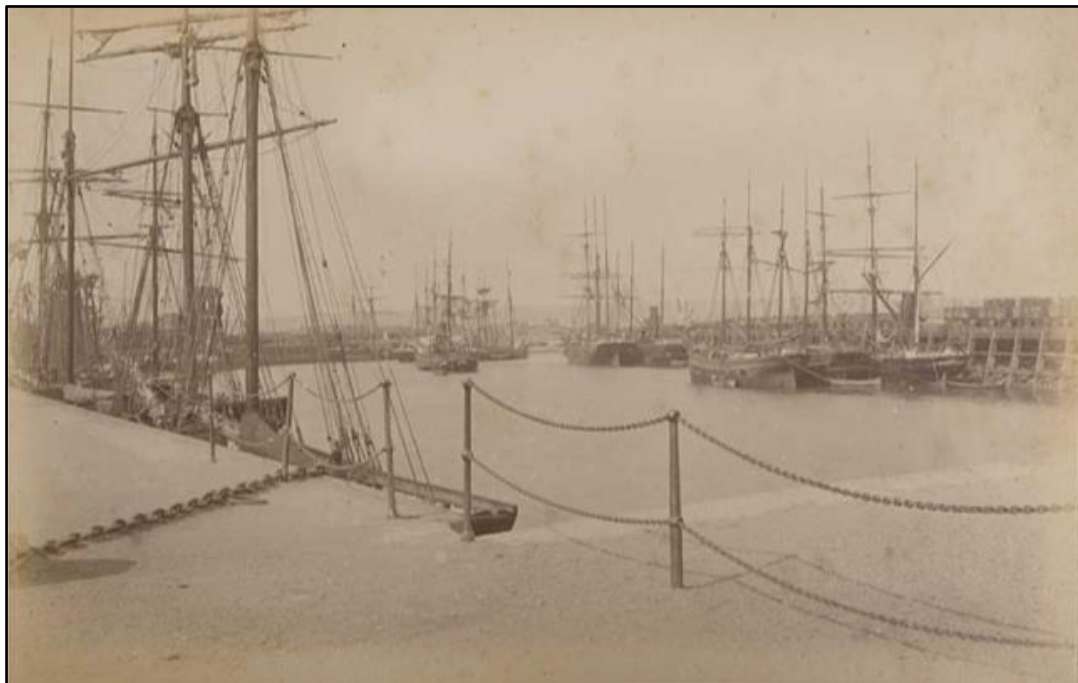
**Plate 36. Similar view of the Inner Basin from near the entrance from the Outer Basin, close-up of dock-side railing, 19<sup>th</sup> century. Courtesy of BCBC.**

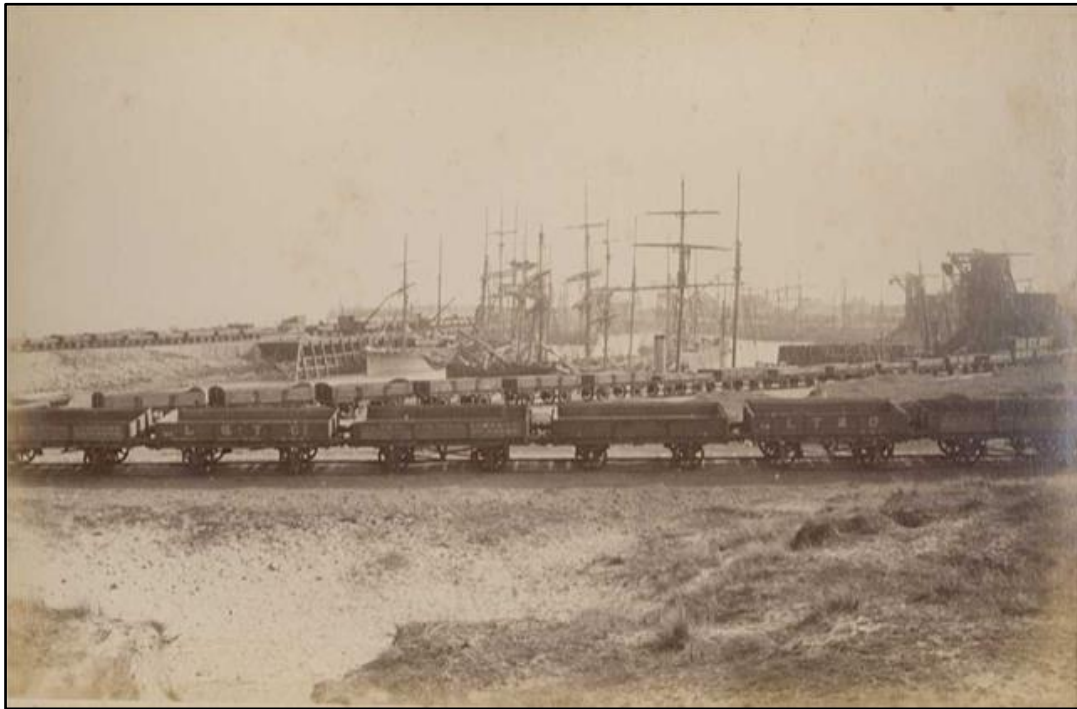
**Plate 37. View from the north end of the Inner Basin over rail sidings, coal tips to the right and sea embankment to the left, 19<sup>th</sup> century. Courtesy of BCBC.**
