PROJECT  
FRIOG CORNER SEA DEFENCE REPAIR AND IMPROVEMENT WORKS

TITLE  
CONSTRAINTS, DEMOLITION AND ACCOMMODATION WORKS PLAN

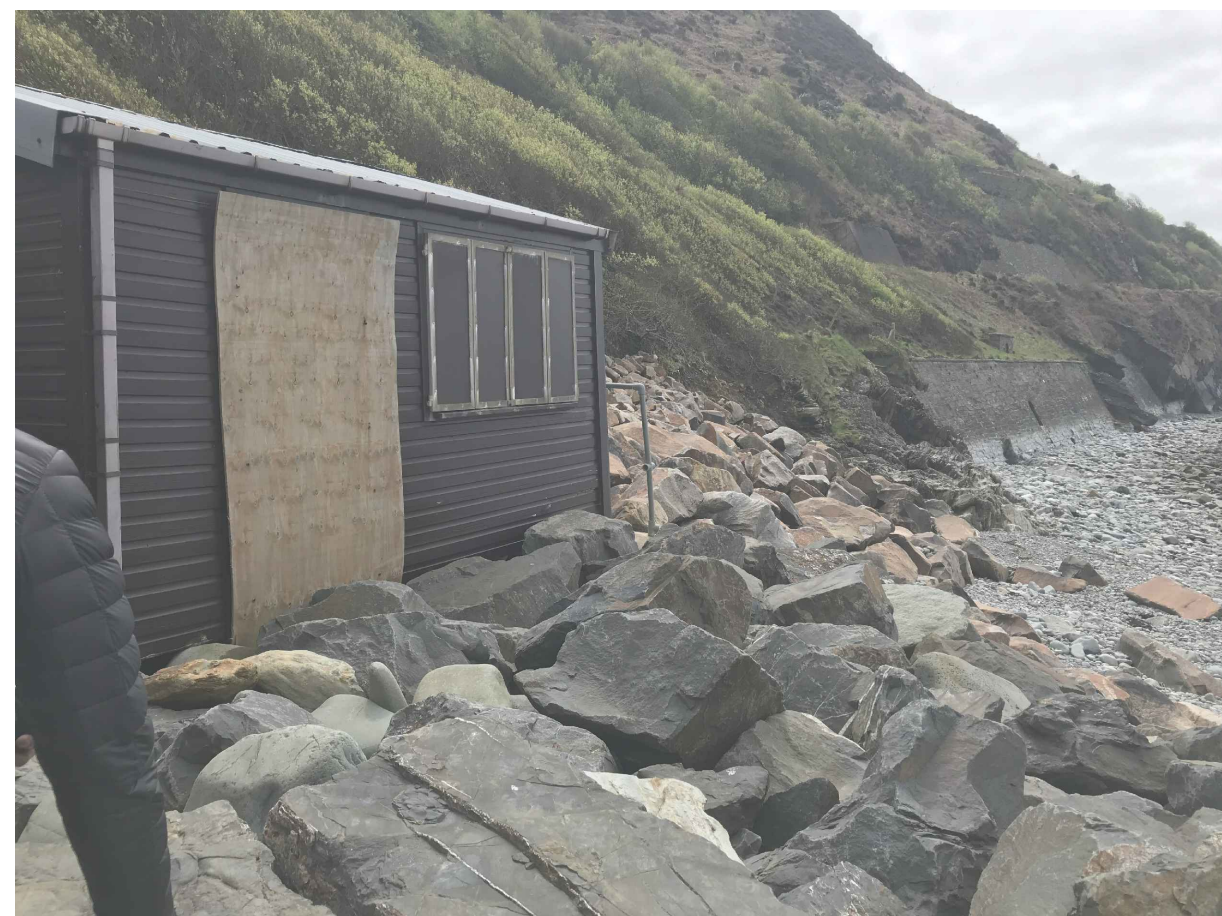
PHOTOGRAPH OF EXISTING CHALET TO BE REMOVED AND EXISTING ROCK REVETMENT

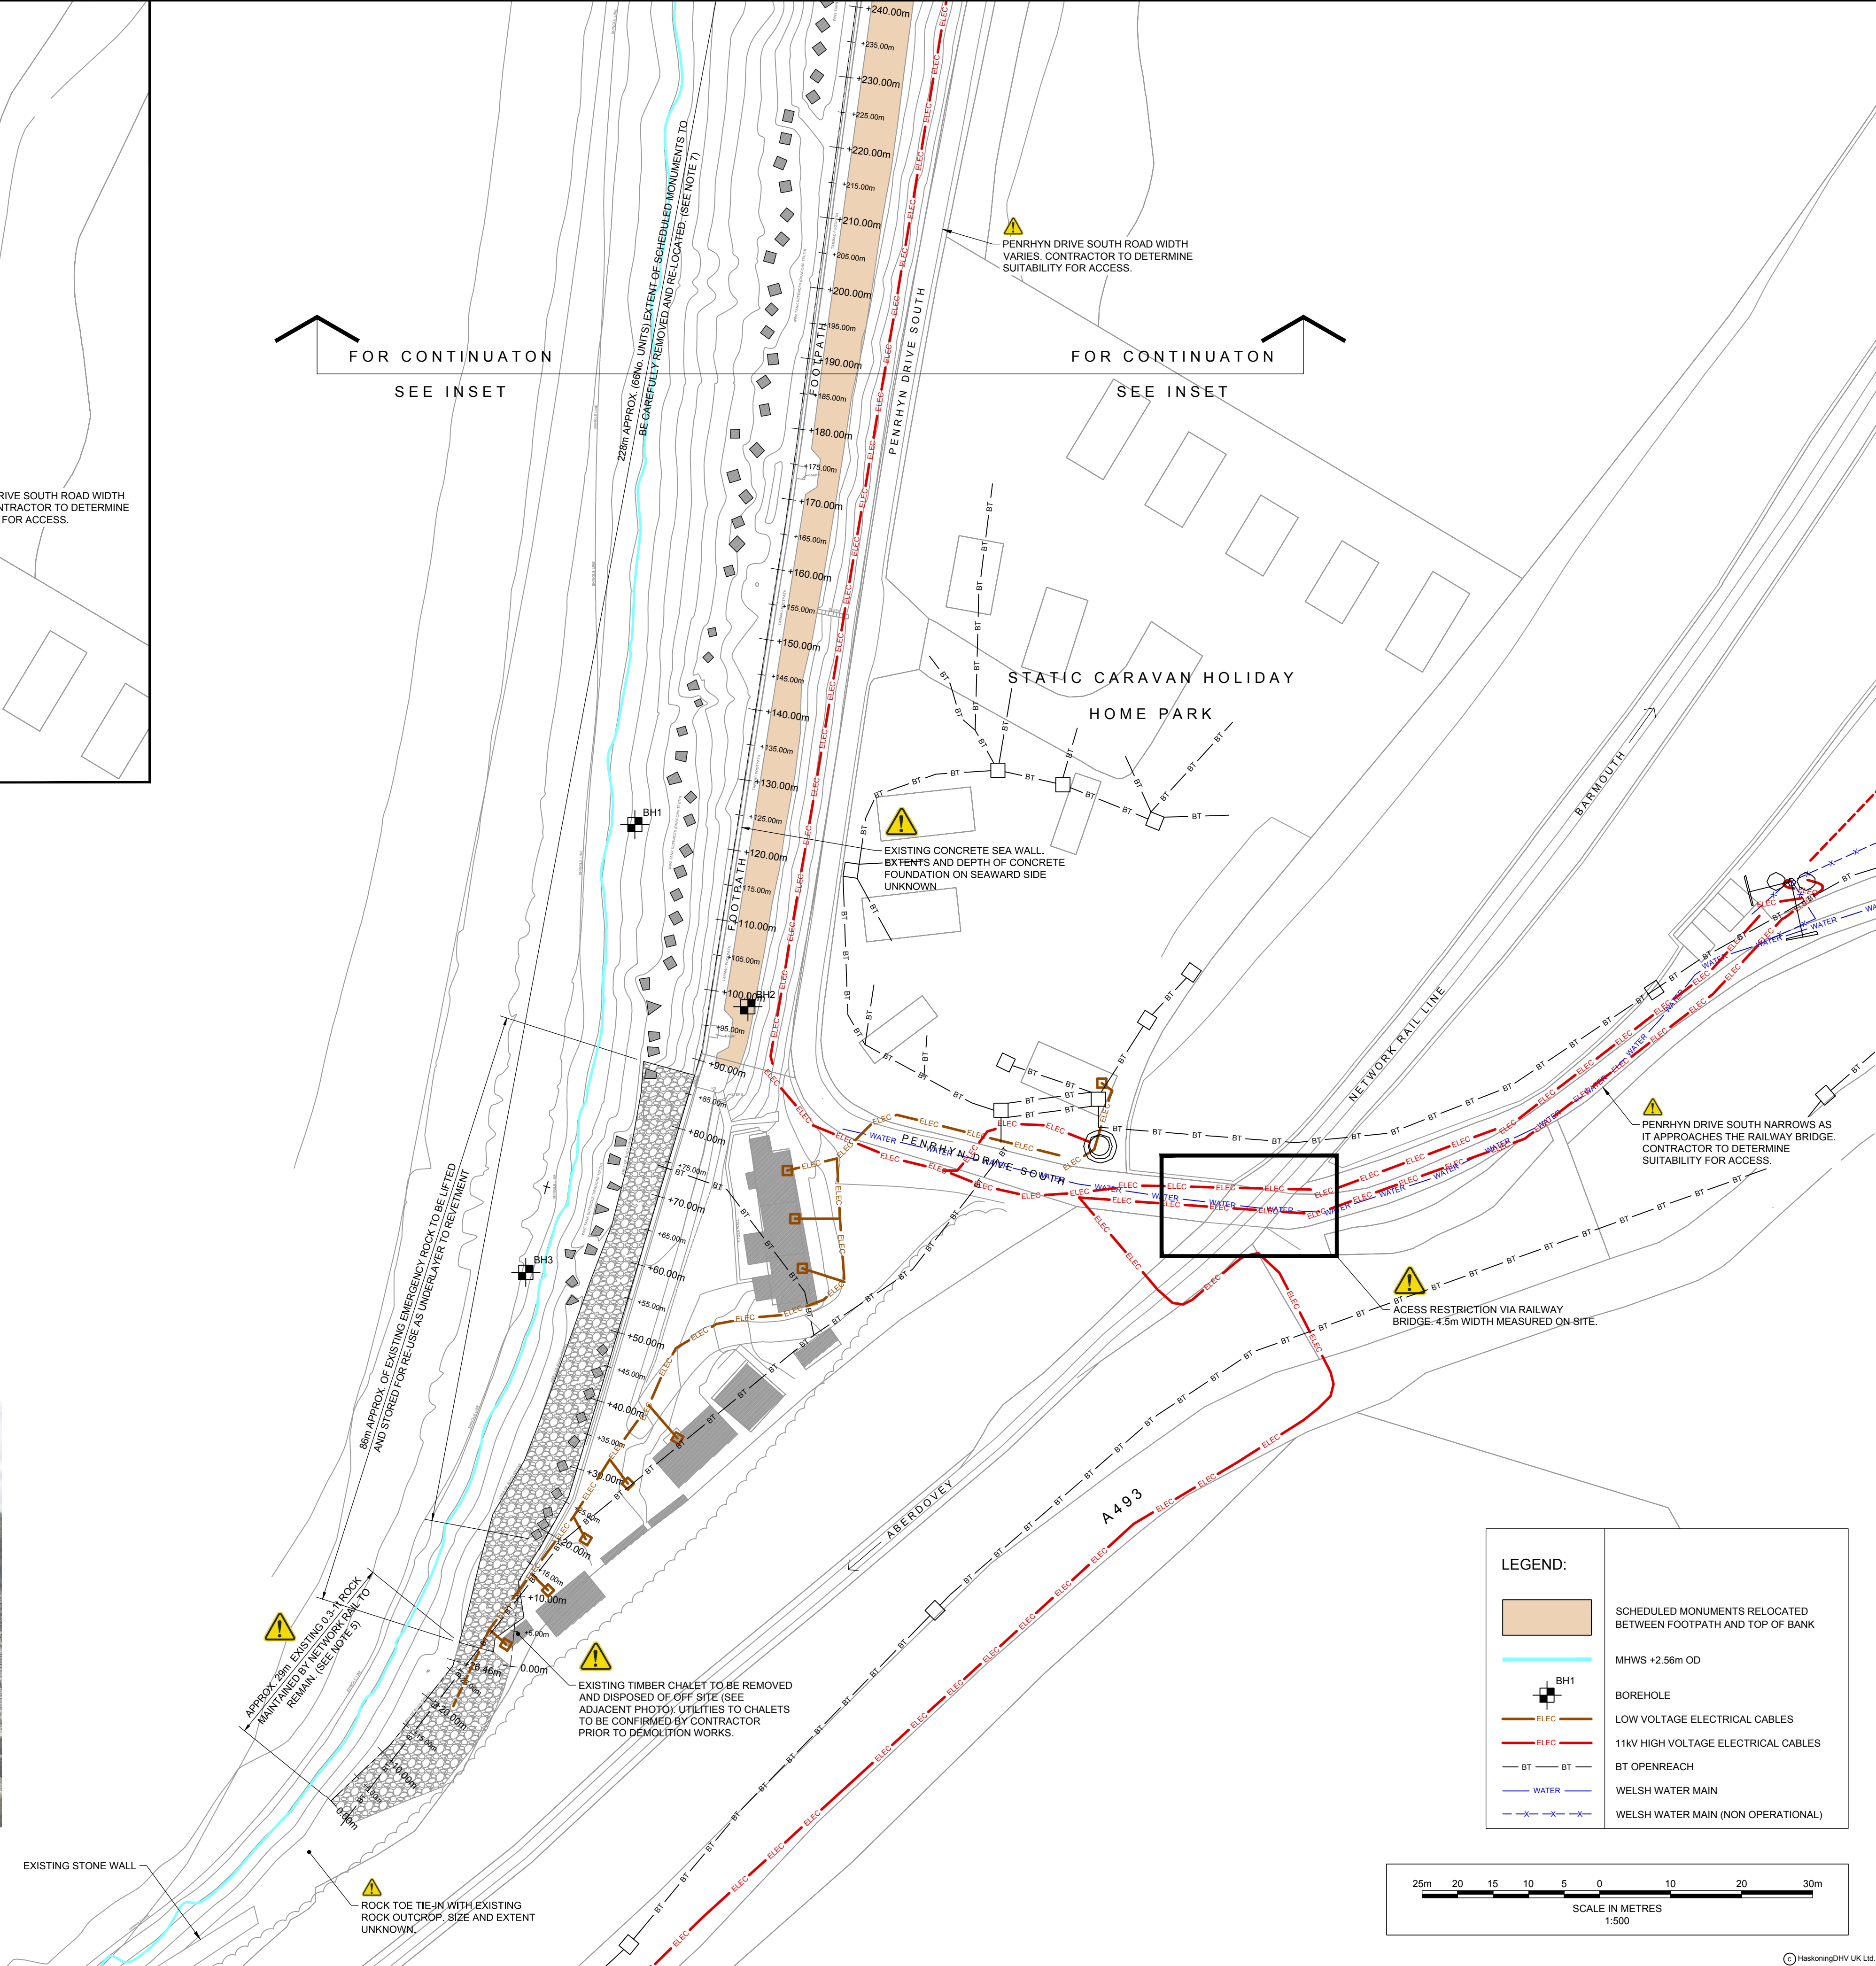
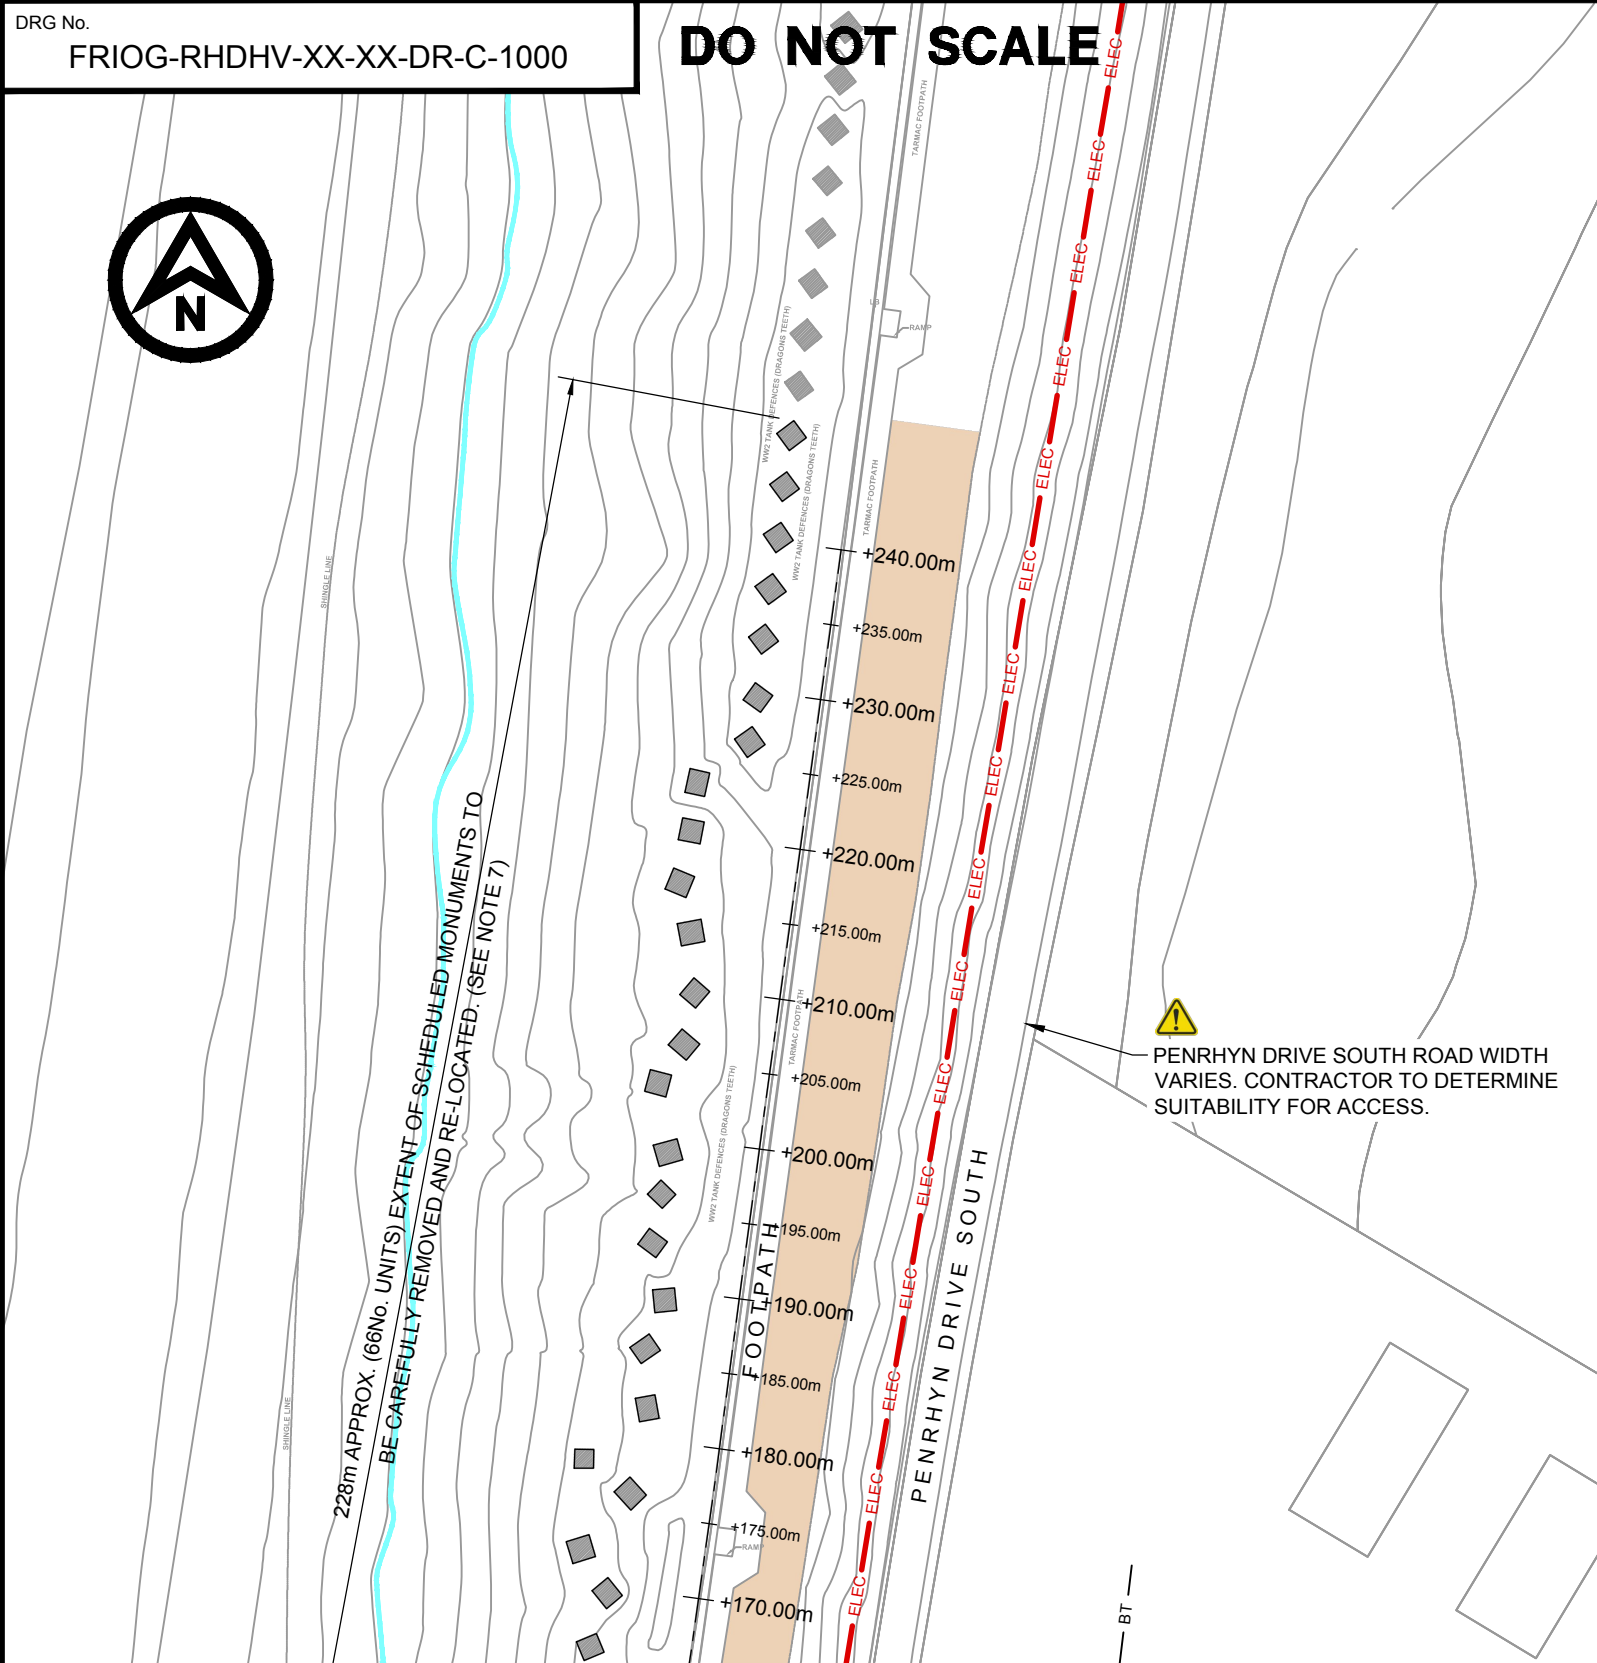
INSET CONTINUATION

IRISH SEA

EXISTING STONE WALL

4. ALL MATERIALS AND WORKMANSHIP WILL BE AS DEFINED IN THE SPECIFICATION UNLESS NOTED OTHERWISE.
5. EXISTING 0.3-1t ROCK MAINTAINED BY NETWORK RAIL TO REMAIN. WHERE NECESSARY EXISTING NETWORK RAIL REVETMENT TO BE REMOVED TO ENABLE SAFE CONSTRUCTION OF THE ROCK TOE. A METHOD STATEMENT TO BE PROVIDED BY THE CONTRACTOR FOR NETWORK RAIL APPROVAL. ALL ROCK REMOVED FROM THIS REVETMENT TO BE REINSTATED ENSURING AN INTERLOCK BETWEEN THE ROCK TOE AND NETWORK RAIL REVETMENT.

6. THIS DRAWING IS BASED UPON THE TOPOGRAPHIC SURVEY COMPLETED IN MARCH 2018 BY USK LAND SURVEY.
7. SCHEDULED MONUMENTS TO BE CAREFULLY REMOVED AND RE-LOCATED TO THE EAST OF THE FOOTPATH ALLOWING FOR APPROX. 15m WORKING AREA BEYOND THE MOST NORTHERLY POINT OF THE NEW REVETMENT WORKS. METHODOLOGY TO RELOCATE TANK TRAPS SHOULD BE APPROVED BY Cadw.
