SECTION G-G  
SCALE 1:100

PROJECT  
FRIOG CORNER SEA DEFENCE REPAIR AND IMPROVEMENT WORKS

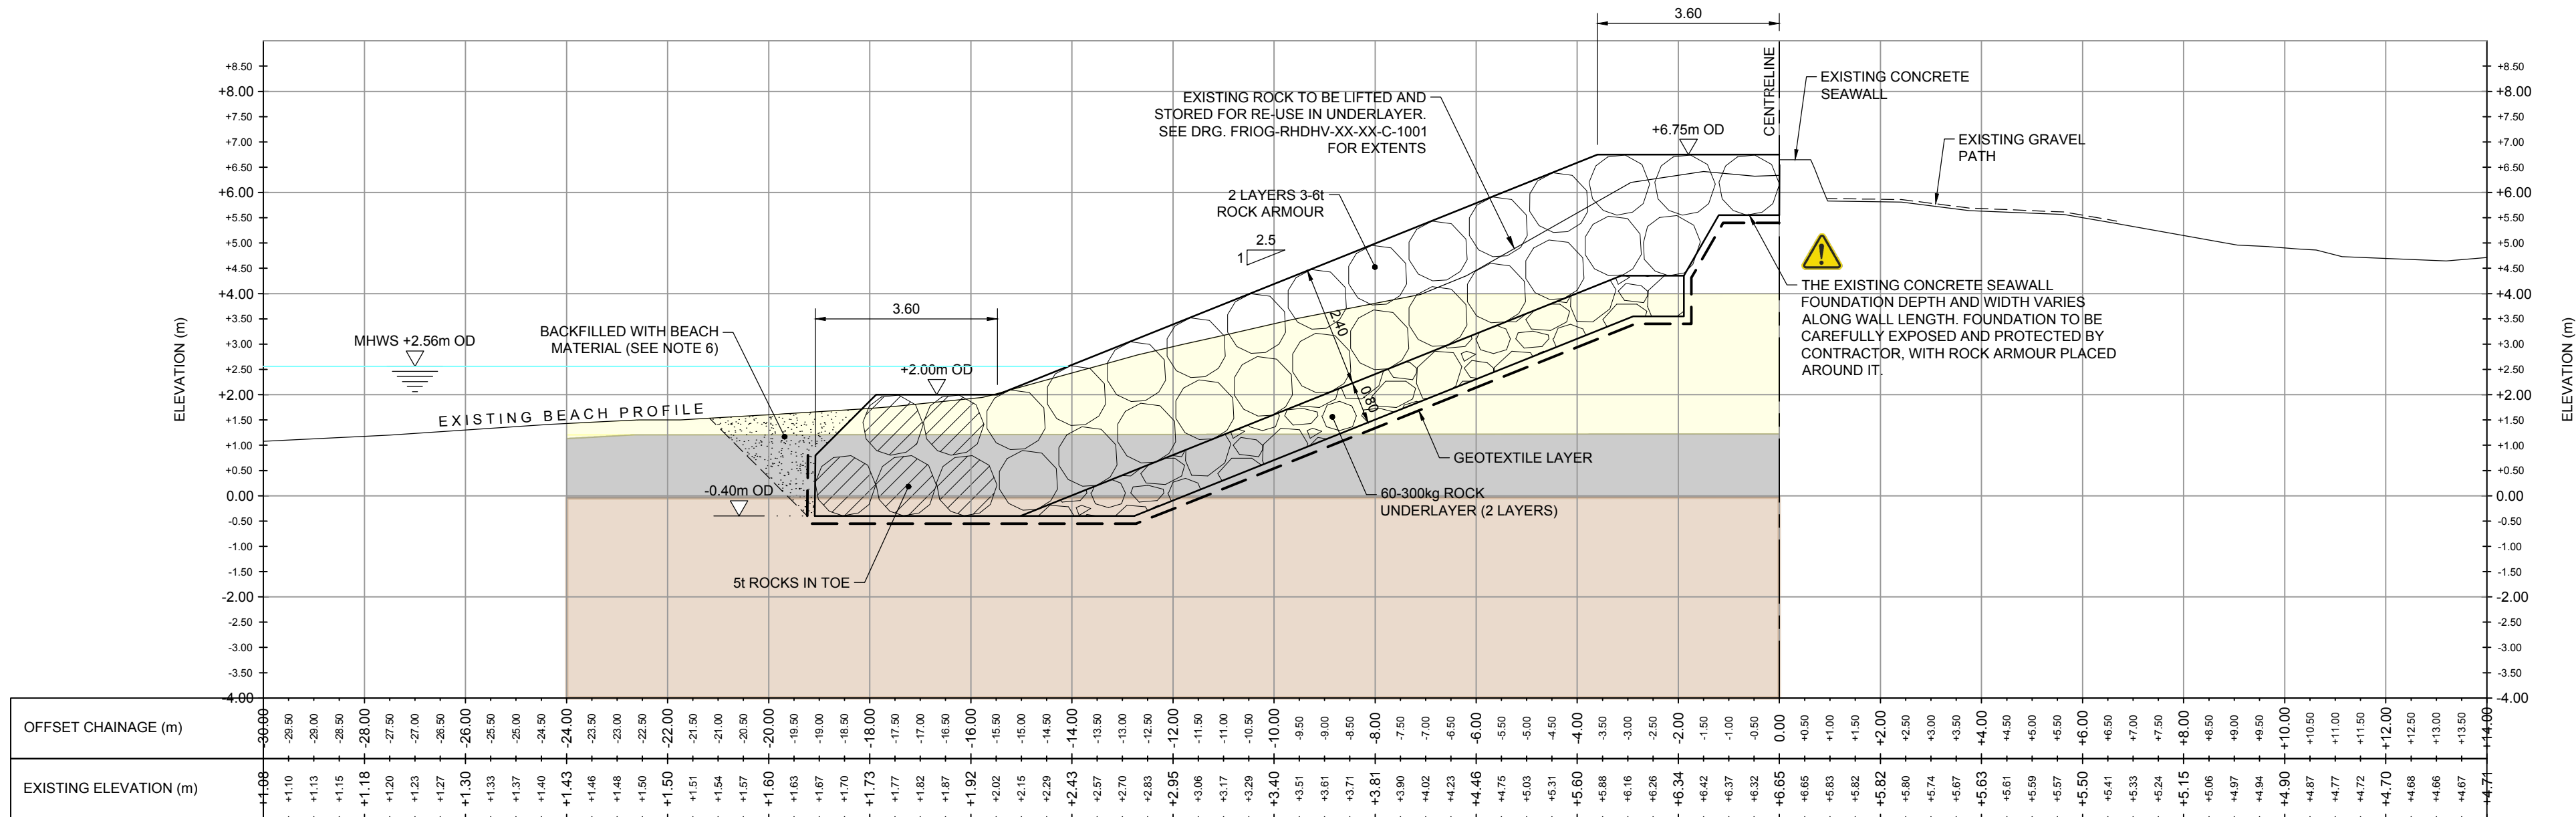
NOTE: THE GEOLOGICAL INFORMATION SHOWN HAS BEEN INTERPRETED FROM BH1 AND BH3 AND ARE INDICATIVE DUE TO LOCALISED VARIATION.

NOTE: THE ROCKS SHOWN WITHIN THE ARMOUR PROFILE ARE INDICATIVE ONLY AND THE CONTRACTOR IS TO COMPLY WITH THE ROCK REQUIREMENTS AS NOTED ON THE DRAWINGS AND IN THE SPECIFICATION.
