## **Appendix A** Holyhead Marina Pre-Application Advise (September 2019)

### **Pre-Application Advice in Relation to the Re-Building of Holyhead Marina**

**Application Reference: PAM/2019/9**

Evidence Report No. 306

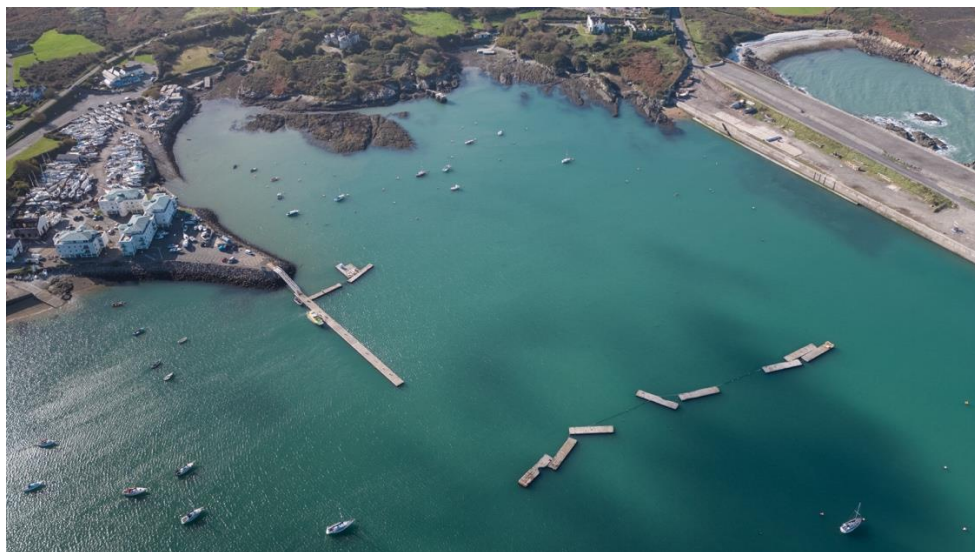
Aerial view of Holyhead marina October 2018. R. Holt

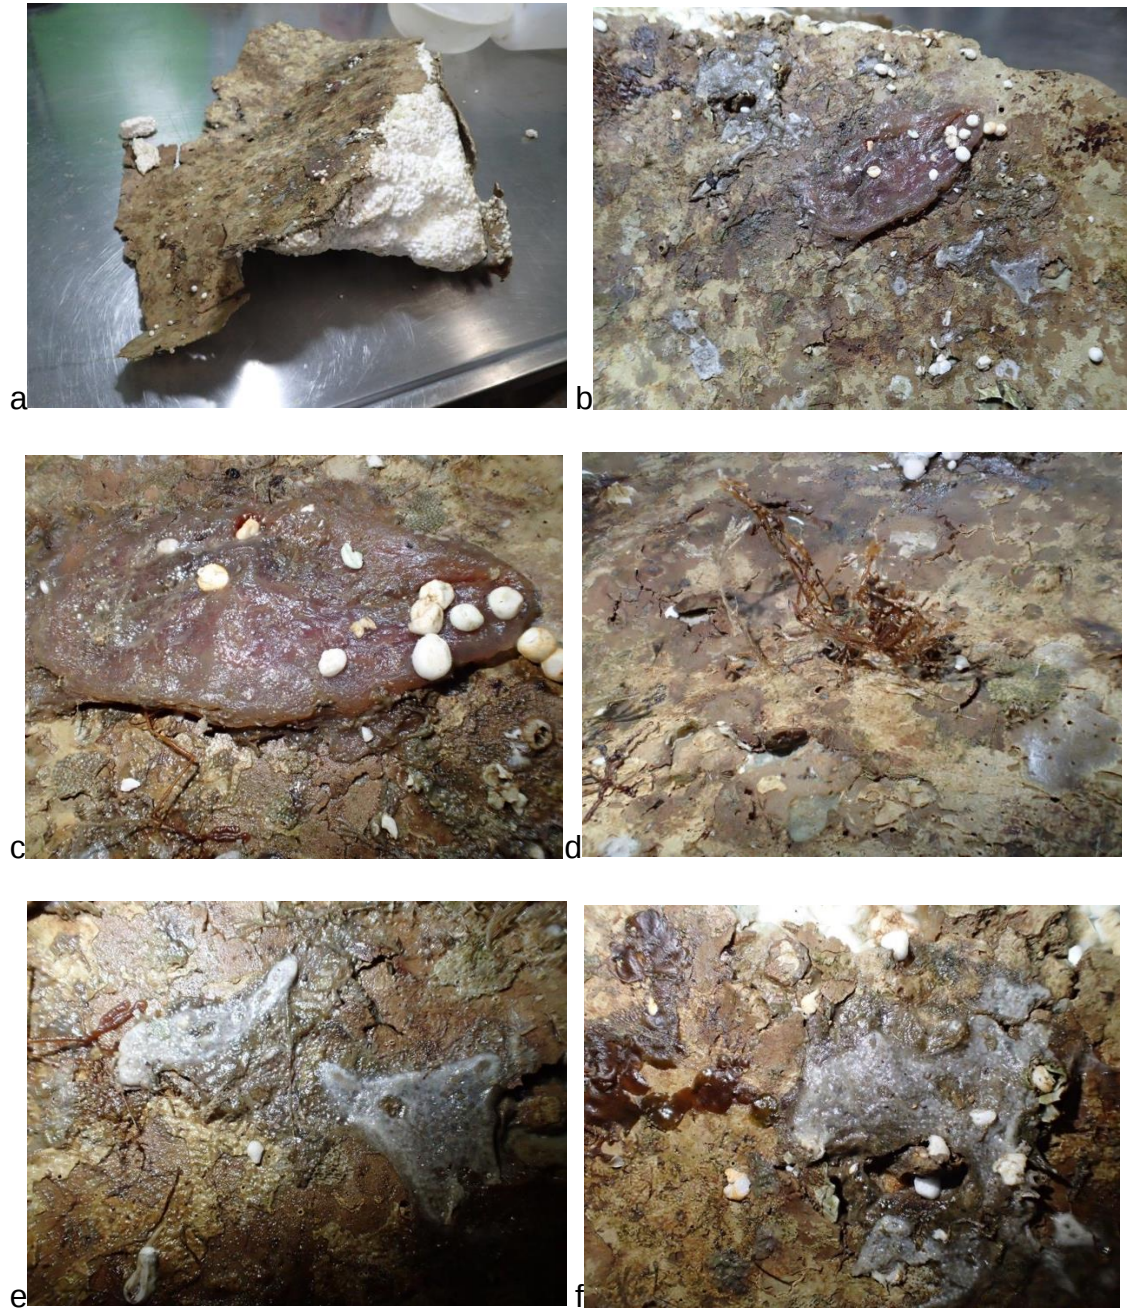
Figure 1. Fragments of polystyrene pontoon and fibreglass coating with marine life attached recovered from beaches on the NW Anglesey coast: (a) the fibreglass shell with enough polystyrene to keep it afloat; (b) fresh remains of a solitary ascidian (*Ascidia* sp.?) and colonial ascidians (*Didemnum* sp.?): (c) close view of the solitary ascidian; (d) erect bryozoan; (e) and (f) remains of encrusting ascidians, sponges and algae. Photo Paul Brazier, NRW.

Marina debris, particularly the larger concrete walkways and the fibreglass outer coating of the pontoons, made buoyant by adherent polystyrene, will have carried considerable amounts of live flora and fauna including *D.vexillum* with it. The remains of sponges, byryozoans and solitary and colonial ascidians (possibly *D.vexillum*) were found on debris washed ashore on the

beaches on the north-west coast of Anglesey (Figure 1). Some of this biological material was fresh enough to presumably have been alive when it washed ashore. Whether the mobilisation of this debris has caused *D.vexillum* to spread to new areas and natural habitats, in and beyond the harbour, is the main objective of this survey project.

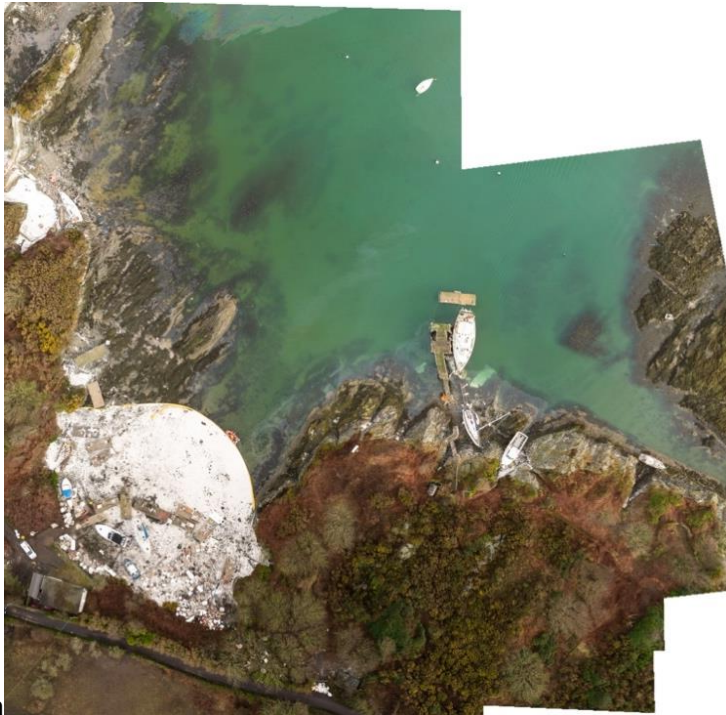
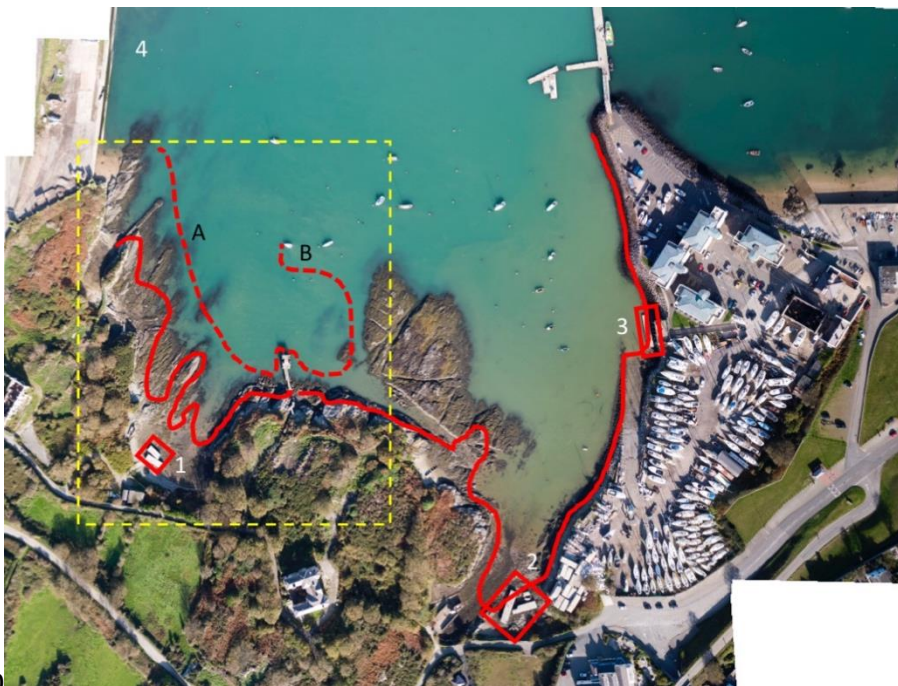
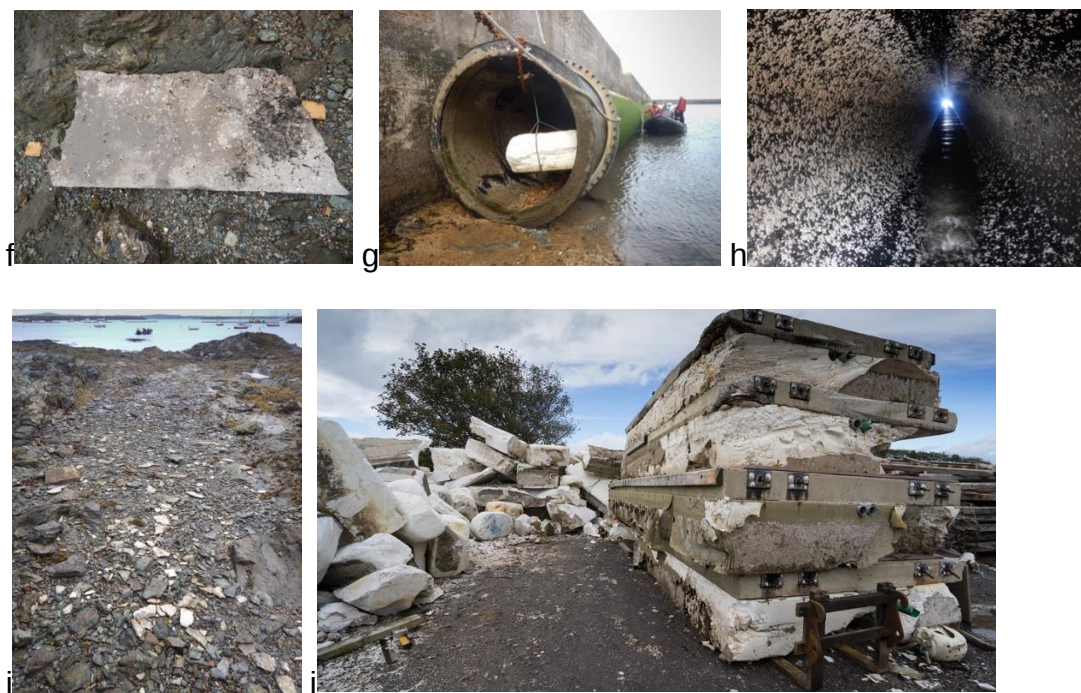
Figure 12. (a) Aerial image taken 11/3/18 of Scimitar beach showing dense accumulation of marina debris and retaining boom; (b) aerial image of areas surveyed taken 24/10/18 and approximate track followed by divers (red hatched lines A and B) and shore walk (solid red line). Yellow hatched line represents area of Scimitar beach illustrated in image a; (c) breakwater pontoons aground in Porth y Felin (point 2 on Figure b); (d) breakwater pontoon aground in Scimitar beach (point 1 on Figure b); (e) close view of pontoon sides showing remains of *Laminaria* holdfasts and dead barnacle tests; (f) fragment of fibreglass pontoon 'shell' with remains of barnacles and algae; (g) large plastic pipe moored against the breakwater wall (see point 4 on Figure 12b) with green algae on outside surfaces; (h) internal view down the plastic pipe showing barnacle cover; (i) fragments of fibreglass pontoon shell in Scimitar beach; (j) salvaged remains of the marina ashore on the hard standing in Porth y Felin. Photos R. Holt.

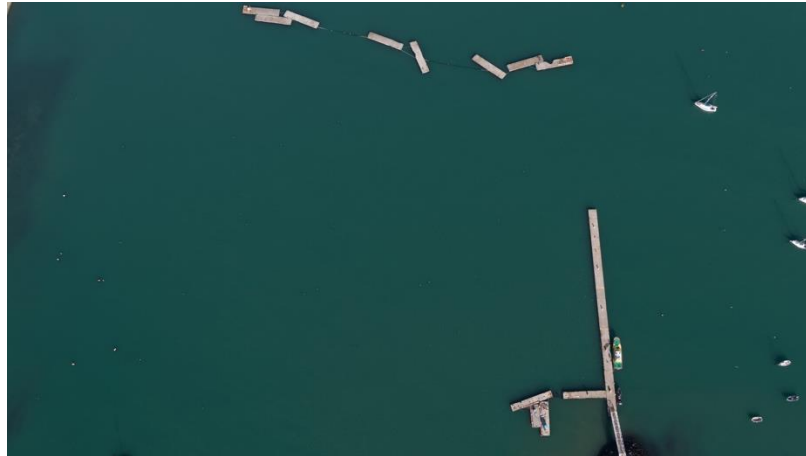
Figure 13. Aerial view of the remaining pontoons taken at the time of survey (22/10/18).  
Photo R. Holt

Aerial views of the marina area were taken on 22/10/18 by UAV. The image in Figure 13 (and front cover) shows the layout of the remaining pontoons during the survey. The remains of the E-W floating breakwater are still attached to their concrete mooring blocks by chains but have become detached from each other. The pontoon at the foot of the bridge is in its original position but the next three adjoining sections of the N-S breakwater have been re-installed during the summer and had relatively little marine growth on them.

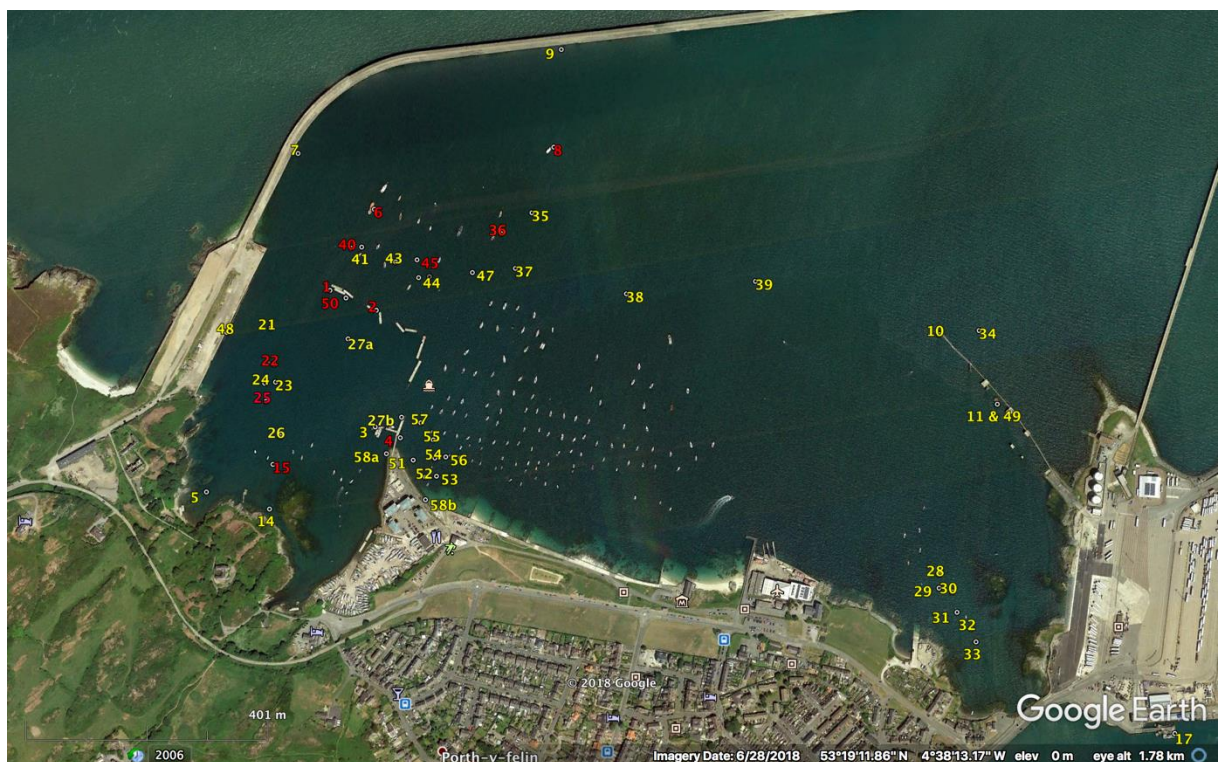
Figure 14a. Dive survey sites in the New Harbour (Google Earth). Dive sites are numbered as examined in chronological order (numbers highlighted in red = presence of *D. vexillum*; yellow numbers = absence of *D. vexillum*)

The following table (Table 11) presents a summary of the sites examined in sequence by diving. Rows highlighted in pale red are sites where *D.vexillum* was found in October 2018, those in yellow indicate that *D.vexillum* has been recorded at or close to the site during previous surveys (see also Figure 19). The survey site positions are plotted on a Google Earth map (Figure 14a and 14b; red numbers = sites with *D.vexillum*). Some of the features on this map predate (28/6/18) the survey with regard to positions of the remaining pontoons, vessels and buoys.

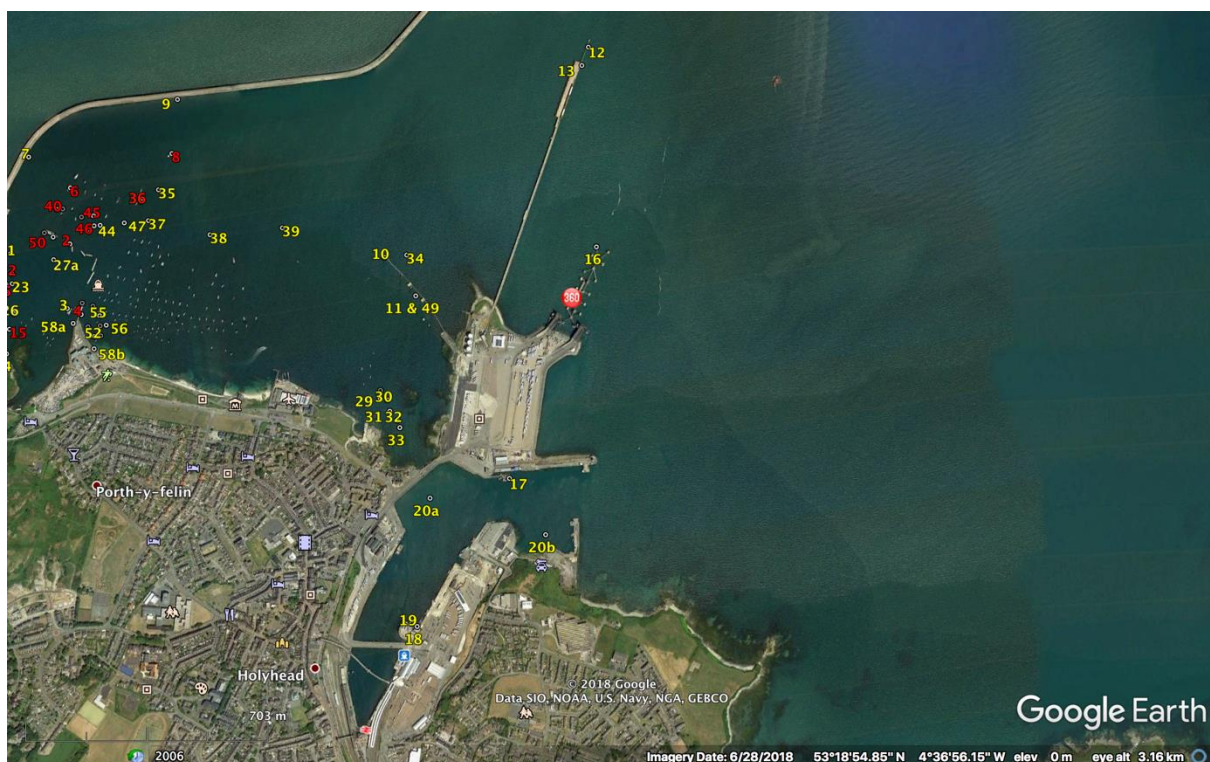
Figure 14b. Dive survey sites in the Old Harbour and commercial jetties (Google Earth) Dive sites are numbered as examined in chronological order (numbers highlighted in red numbers = presence of *D. vexillum* at the site: yellow numbers = absence of *D. vexillum* at site).

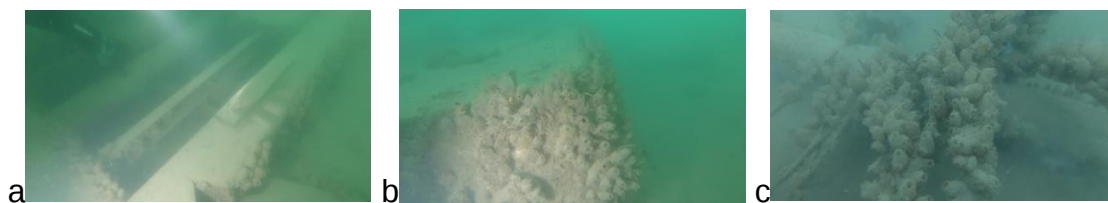
Figure 16. Video stills of wreckage on the seabed in the marina area; (a) finger pontoon deck with cleat. *Ascidiella aspersa* now overgrowing the metal frame; (b) concrete mooring block with *A. aspersa*; (c) remains of a yacht mast and sail rigging overgrown with *A. aspersa*. Video images K. Northen.

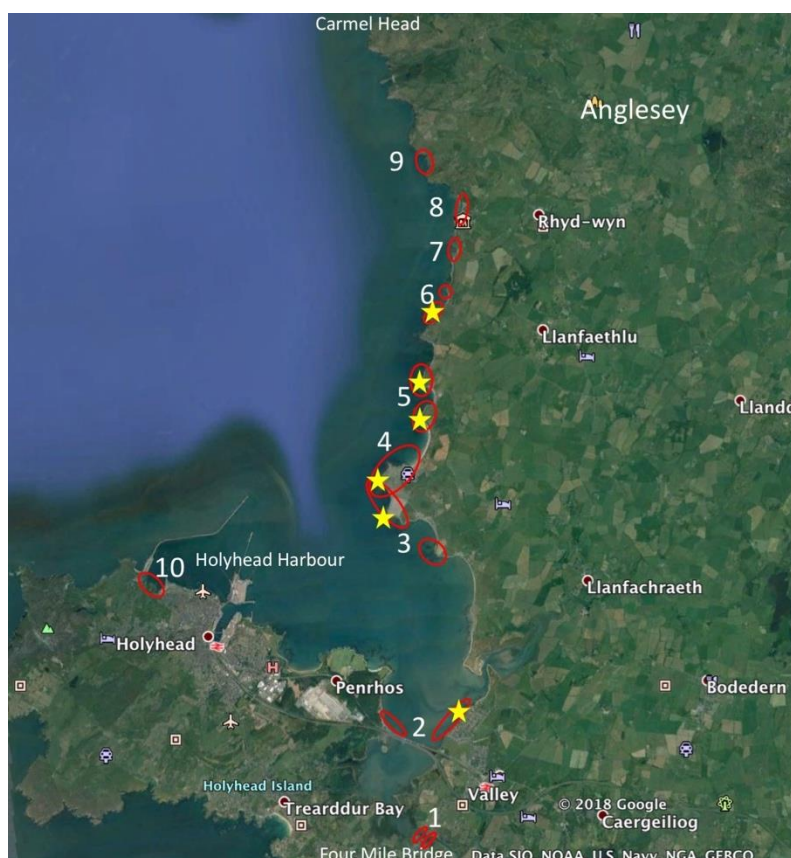
Figure 17. Shore areas (1-10) (Map Data © 2018 Google) searched for the presence of *D. vexillum* and didemnids. Yellow stars = rocky habitats with *Didemnum maculosum*

- Searches of intertidal habitats on the NW of Anglesey, where marina debris washed up after storm *Emma*, failed to find any live *D. vexillum*, even in habitats apparently suitable for didemnid ascidians (Figure 17). Fragments of polystyrene and fibreglass debris is still present on these shores, often wedged into the backs of intertidal sea caves, although none with living material carried from the marina. Eroded fragments of fibreglass with *Didemnum maculosum* were found in rockpools on one of the nearest rocky shores to the marina. However, it is likely that these fragments were colonised with this species *in situ* during the summer.

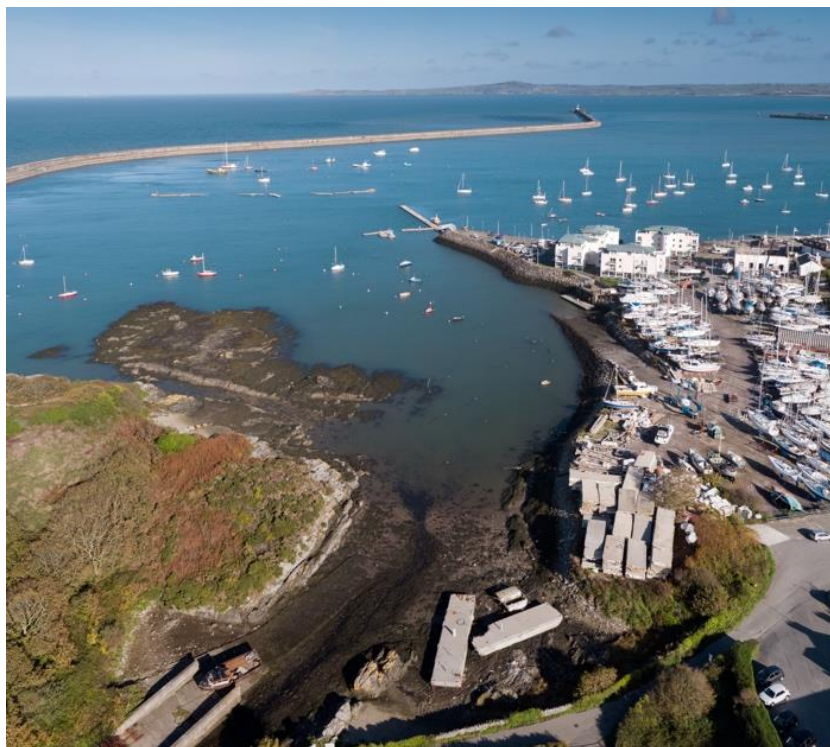
Figure 20. Aerial image of Porth y Felin. The river runs across the shore in the foreground past the remains of three floating breakwater pontoons. The recovered wreckage is on the hard standing on the right. Photo. R. Holt.

The stream flowing onto the upper shore in Porth y Felin (Figure 20) causes a localised drop in salinity around the area where the pontoons and other marina debris came ashore. This might have contributed to the lack of intertidal *D.vexillum* growth. This freshwater source may be of potential benefit against *D.vexillum* and other fully marine INNS if plans to rebuild the marina go ahead. The stream will naturally flow into the vicinity of the planned marina area and could potentially be purposefully rerouted to lower the salinity. A stone breakwater wall would reduce flushing compared to the floating breakwater system and retain more of the freshwater, particularly in shallow water where *D.vexillum* is known to thrive on floating objects in Holyhead harbour. Routine salinity monitoring near to Porth y Felin beach and at stations in the vicinity of the marina would give a more accurate indication of *D.vexillum* survivability when considering its known environmental tolerances (Jenkins et al 2010).
