Environmental Scoping Report
Holyhead Breakwater Refurbishment Scheme

Client: Isle of Anglesey County Council

Reference: PB9014-RHD-BW-XX-RP-C-0142

Appendix C Level 4 Building Study of Holyhead Breakwater

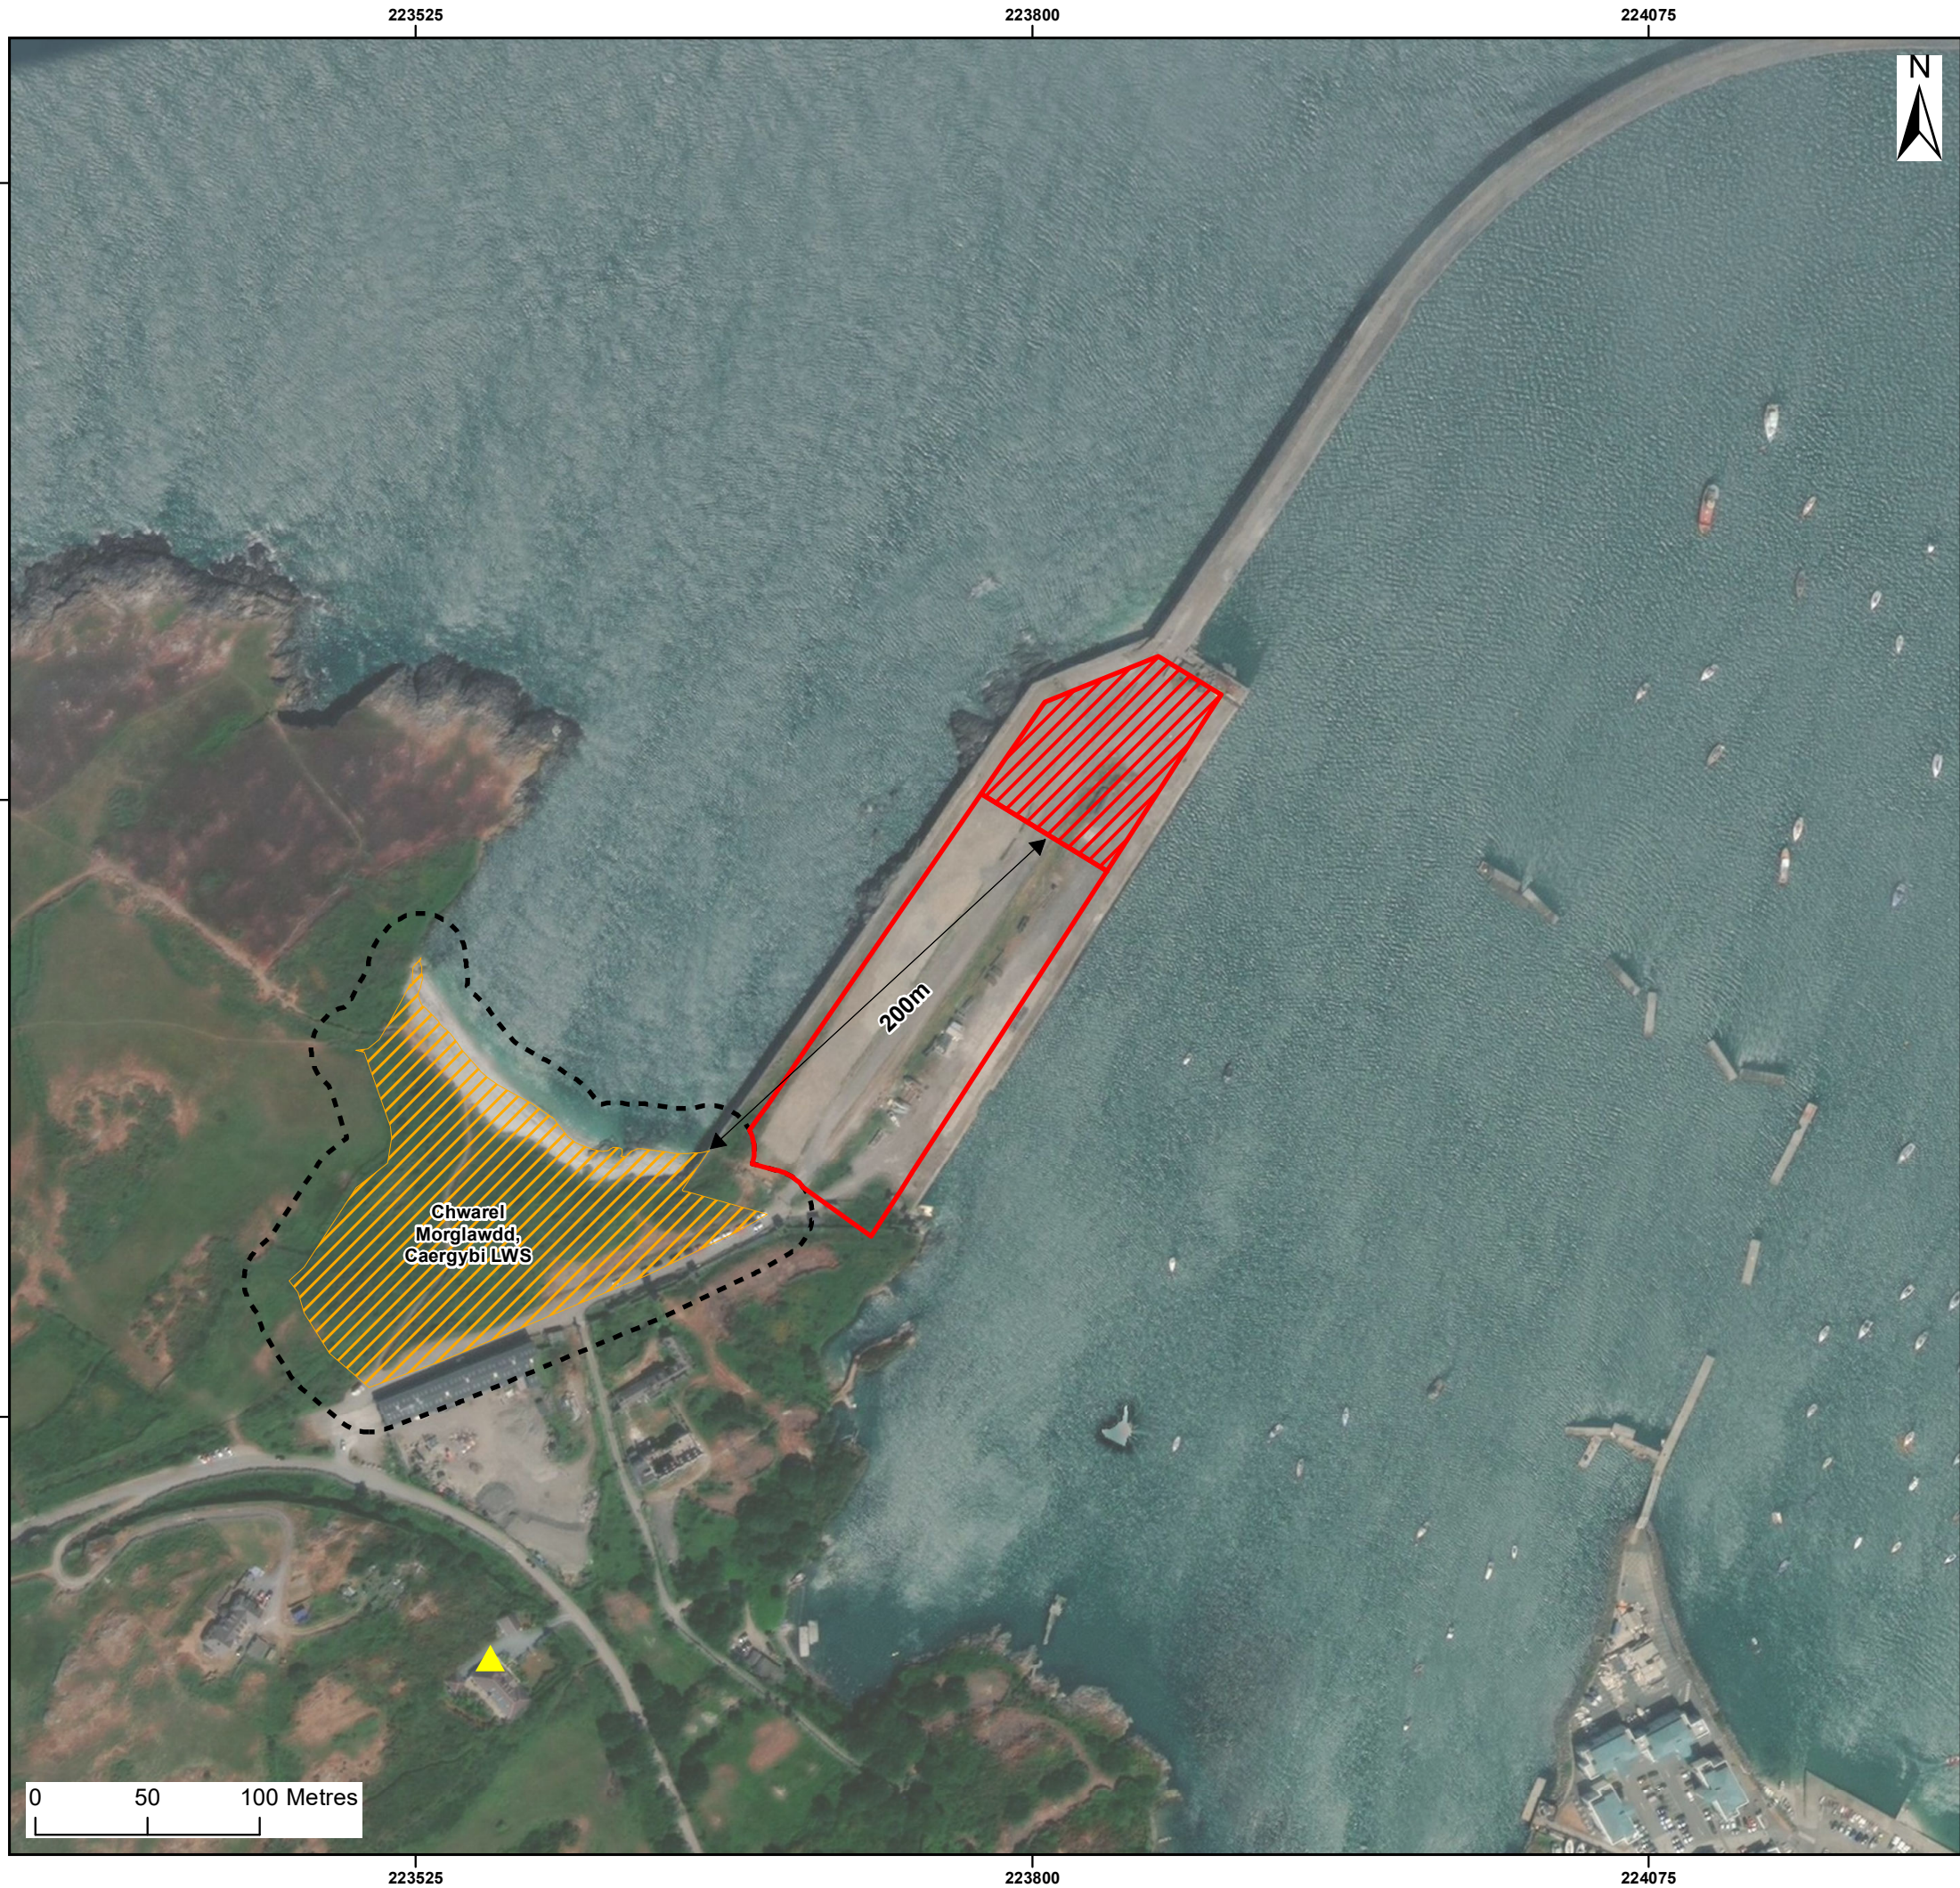
Figure: 2.4 Drawing No: PB9014-001-002

- Soldiers Point Working Area
- Potential Location of Batching Plant
- ▲ Human Receptor
- Local Wildlife Site
- Local Wildlife Site 20m Buffer

Should the concrete batching plant be located on Soldiers Point, it would be located at the northern most end, closest to the Breakwater (**Figure 2.4**). As such the nearest human receptor would be located over 350m away and as such potential impacts arising from air quality and noise would not be significant. However, the mitigation measures set out above will be put in place regardless to comply with best practice and standard industry practices.

A small outlier area of the LWS Chwarel Morglawdd Caergybi is located directly at the landward end of Soldiers Point (see **Figure 2.4**). This area is an important feeding and nesting area for birds. Species recorded include shelduck, oystercatcher, red-breasted merganser and ringed plover.

In order to prevent any direct damage to the LWS a buffer of 20m will be established around the boundary of the LWS to prevent any direct damage to the site during the construction phase.

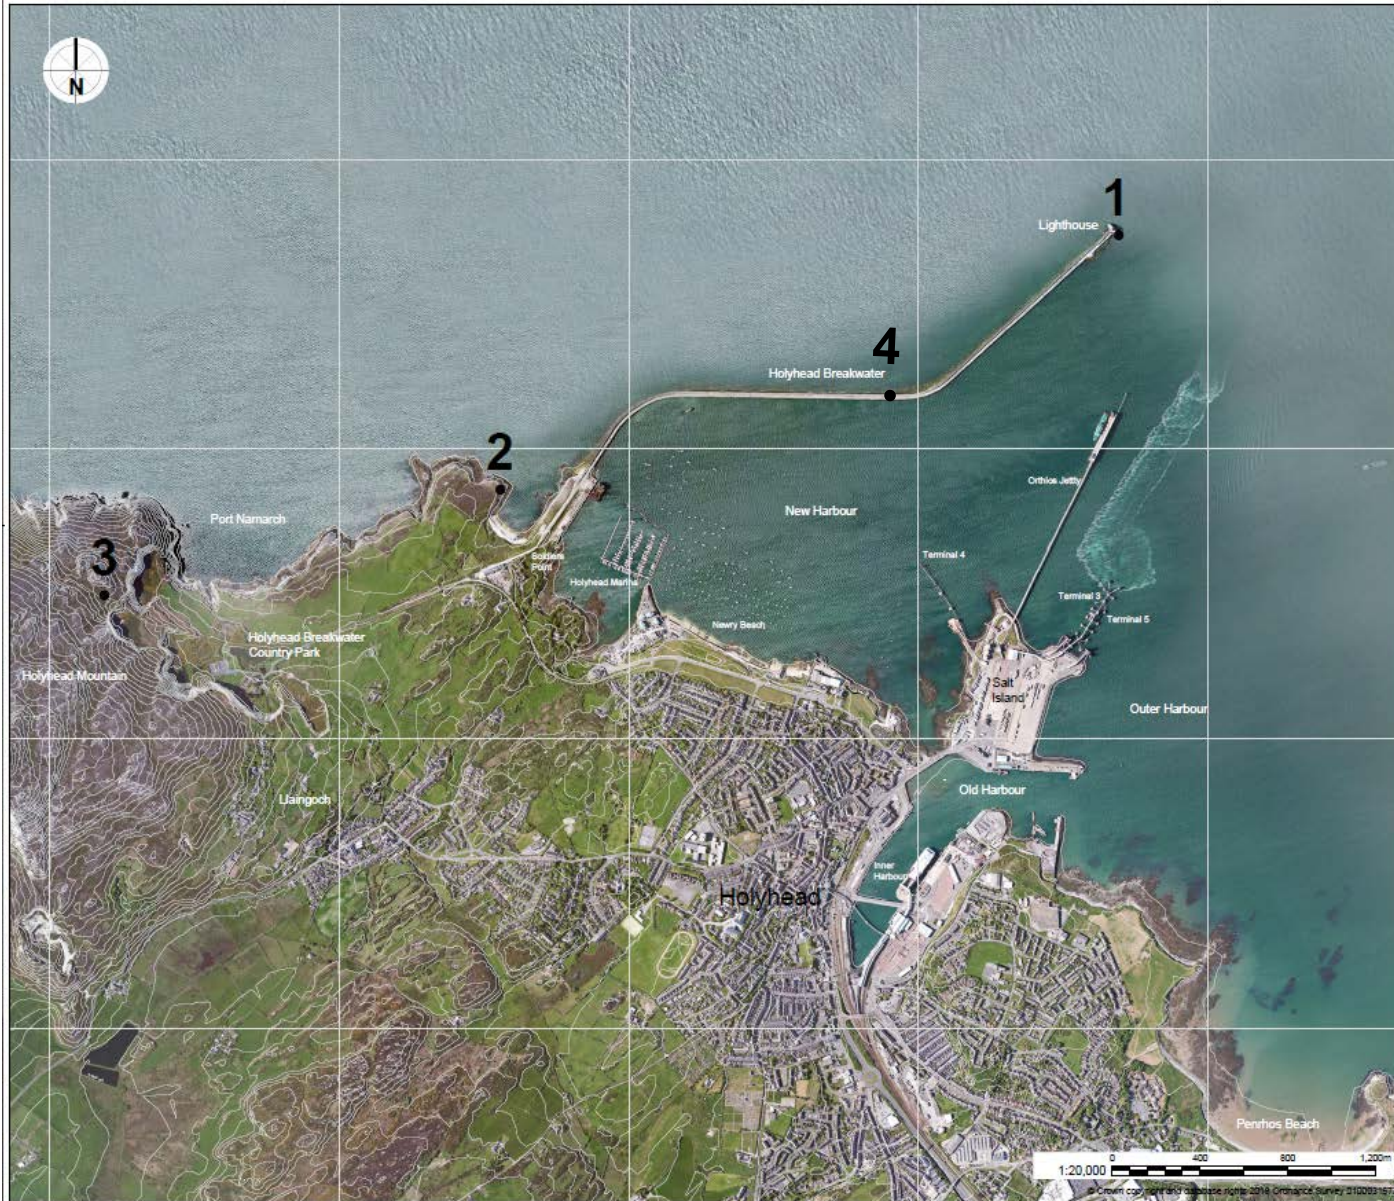
Figure 1 Proposed viewpoints

Three viewpoints are proposed from which photomontage images of the proposed refurbishment works would be produced (see **Figure 1** at the end of this note), as follows:

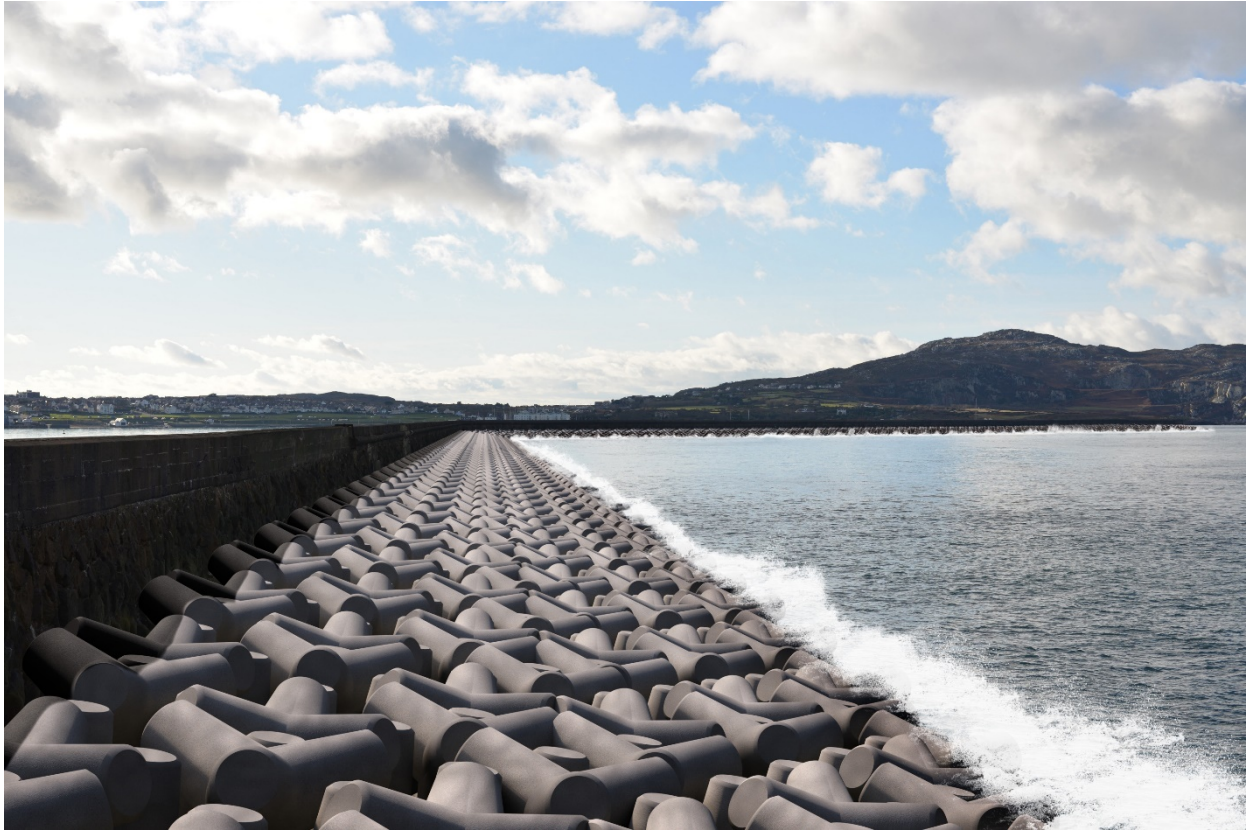
Figure 5: Draft view of tetrapod solution (DRaW (UK) Ltd)

A draft indicative view of the tetrapod solution is shown in Figure 5.

This image demonstrates that there will be a noticeable visual impact on the breakwater and, consequently, a change to the setting of these heritage assets which is anticipated to have an adverse effect upon their significance. However, from the breakwater itself, the tetrapods along the seaward side would only be visible from the upper promenade.

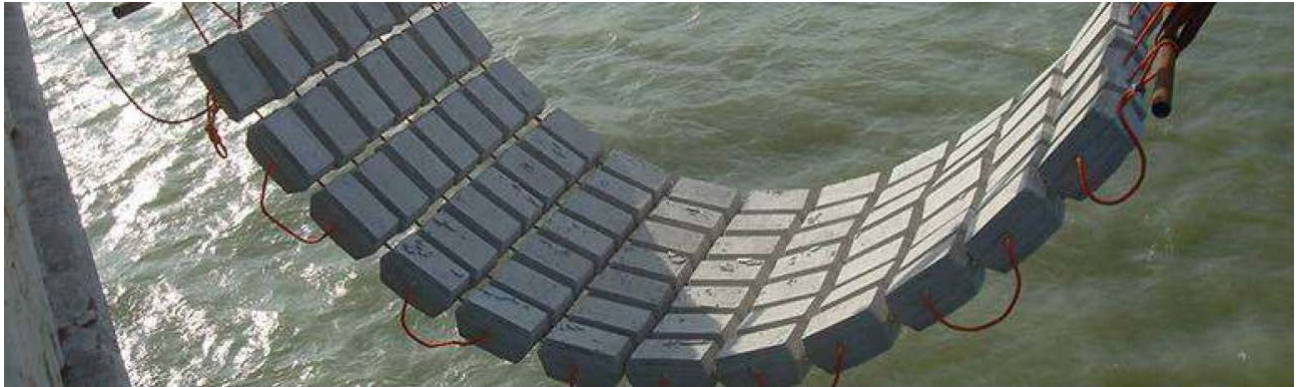
Figure 6: Example of an articulated concrete block mattress (ACBM), (Credit: Maccaferri)

On the leeward side the preferred solution is to place an articulated concrete block mattress (ACBM) on to the existing rubble mound profile, see Figure 6.

This ACBM would be located below the water surface and consequently, is not anticipated to result in any settings impacts. As this is a relatively easy solution, which can be undertaken as and when required without the need for specialised marine construction equipment, and could also be undertaken from the breakwater itself, it is possible that this might be progressed by Stena as part of their ongoing maintenance activity, rather than forming part of the final proposed refurbishment project.

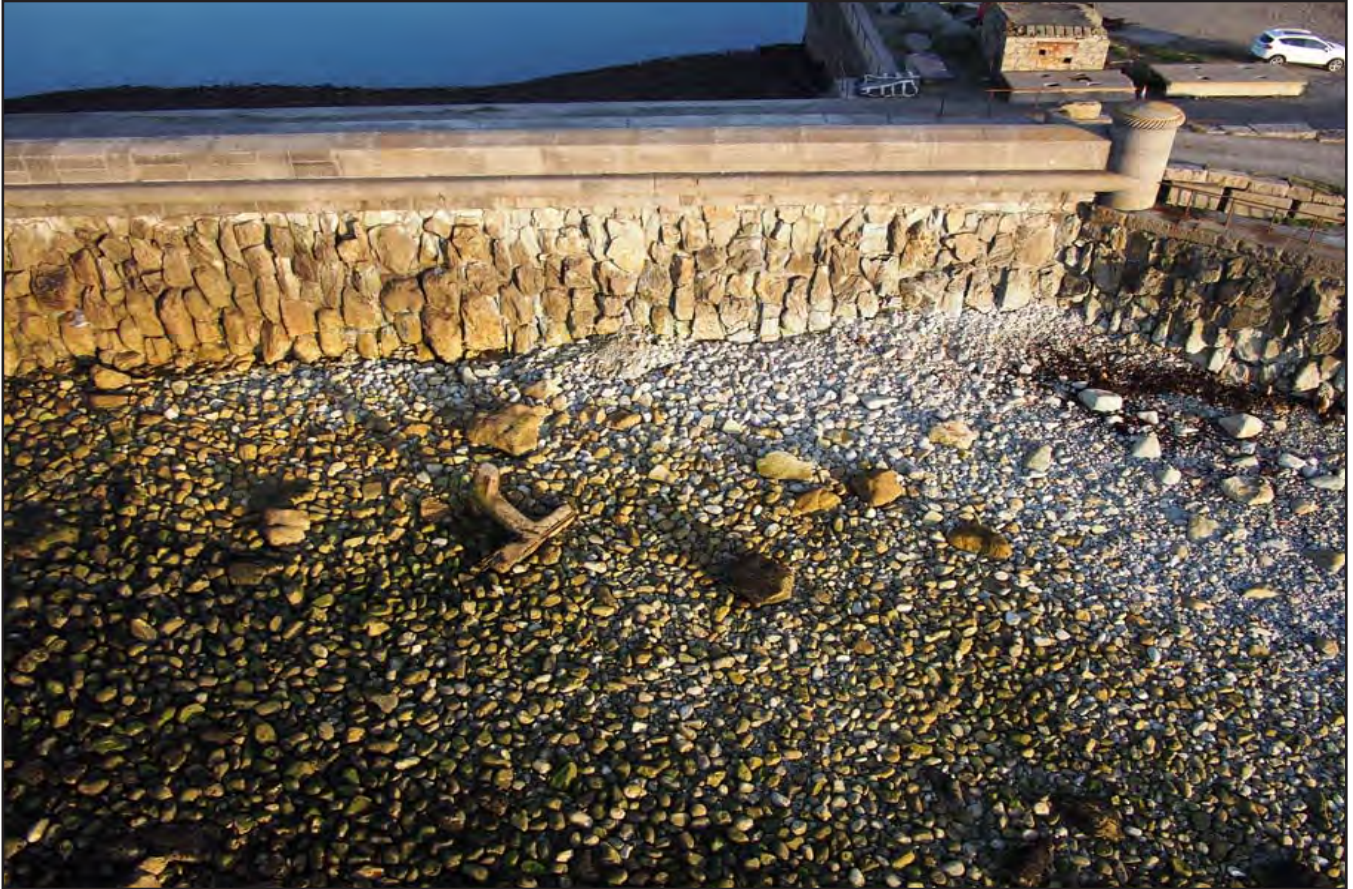
Plate 03: Seward view of the parapet at landsend, showing large rubble foundation blocks supporting the parapet (sourced from Civil Engineering Solutions: 20150928 Holyhead Breakwater 1086.jpg).

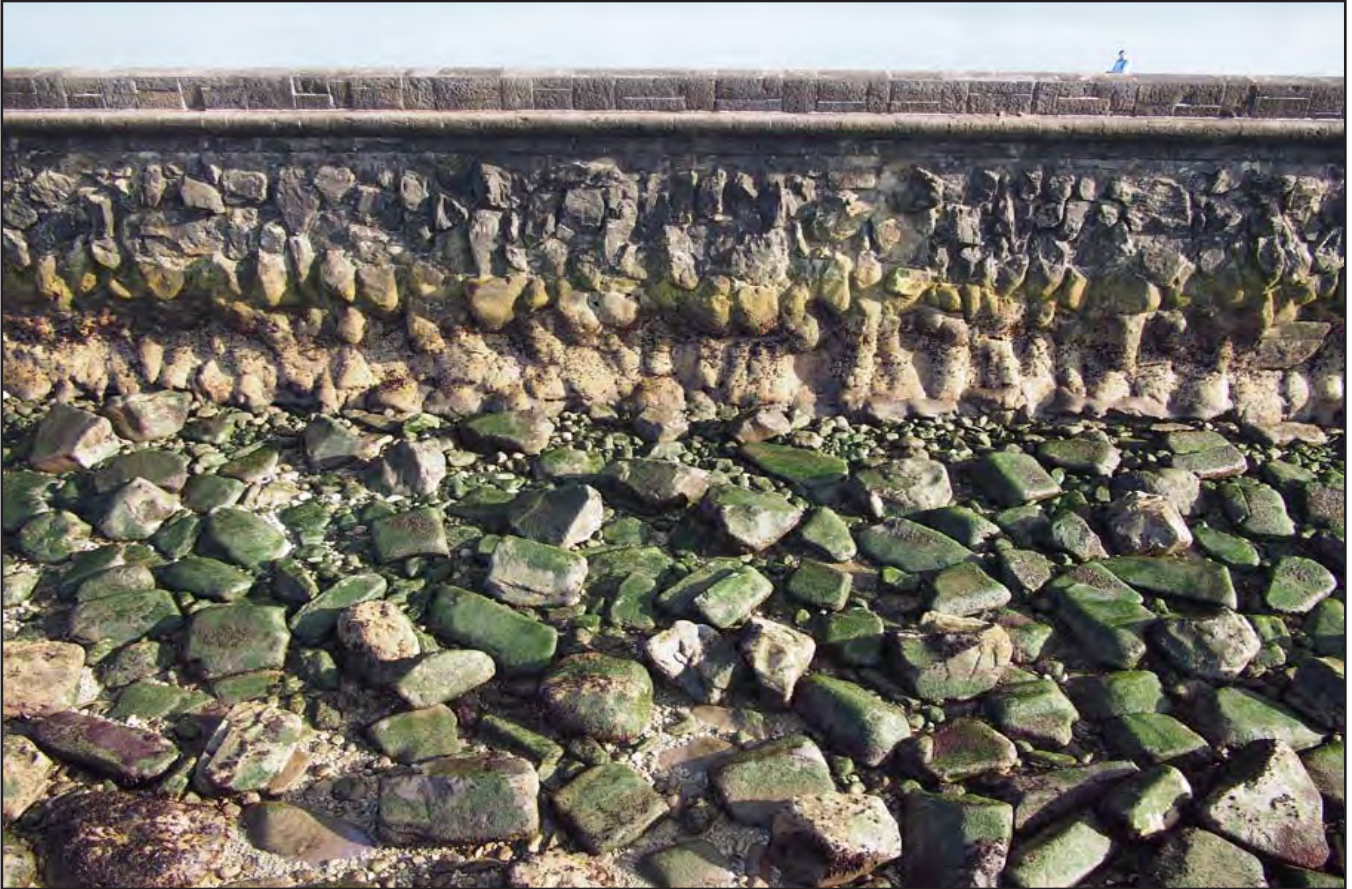
Plate 05: Seaward side view of rubble sourced from Holyhead Mountain used as supporting foundations of the parapet (sourced from Civil Engineering Solutions: 20150928 Holyhead Breakwater 186.jpg).

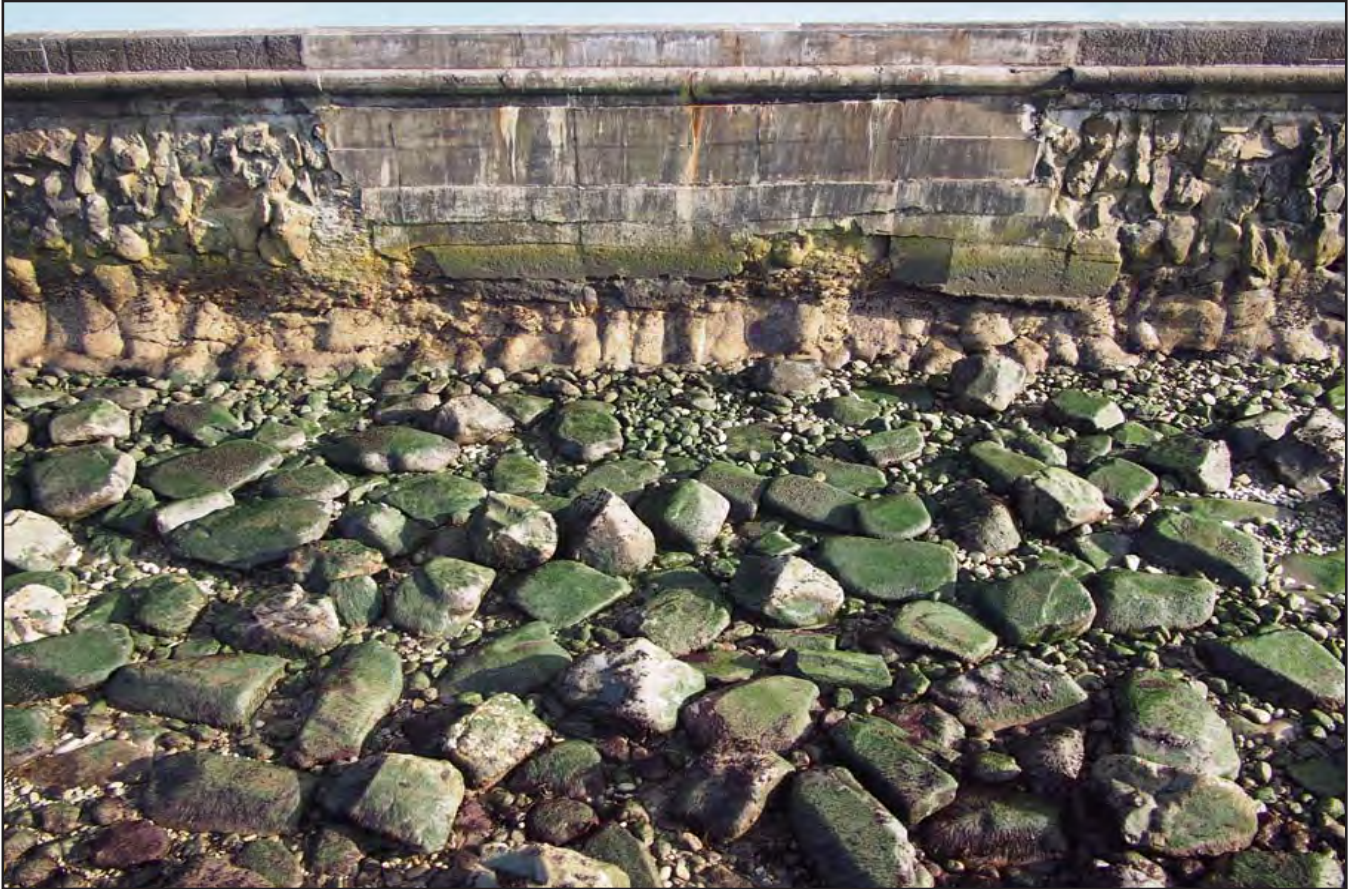
Plate 07: View of mid - 20th century concrete repairs to the seaward side of the breakwater, with the upper slabs molded to resemble original ashlar masonry of the parapet (sourced from Civil Engineering Solutions: 20150928 Holyhead Breakwater 193.jpg).

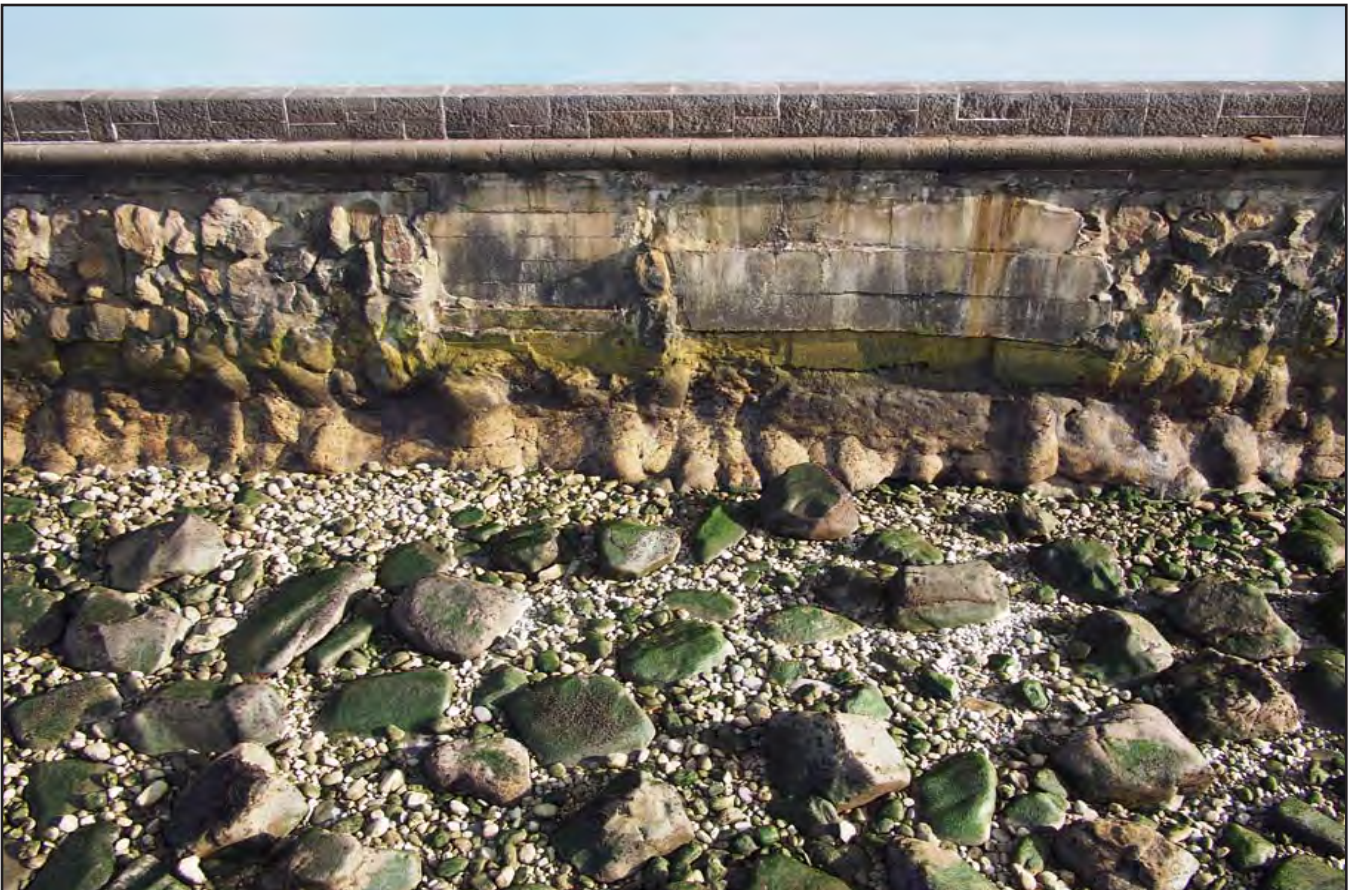
Plate 08: View of further concrete repair work along seawards side of the breakwater (sourced from Civil Engineering Solutions: 20150928 Holyhead Breakwater 203.jpg).

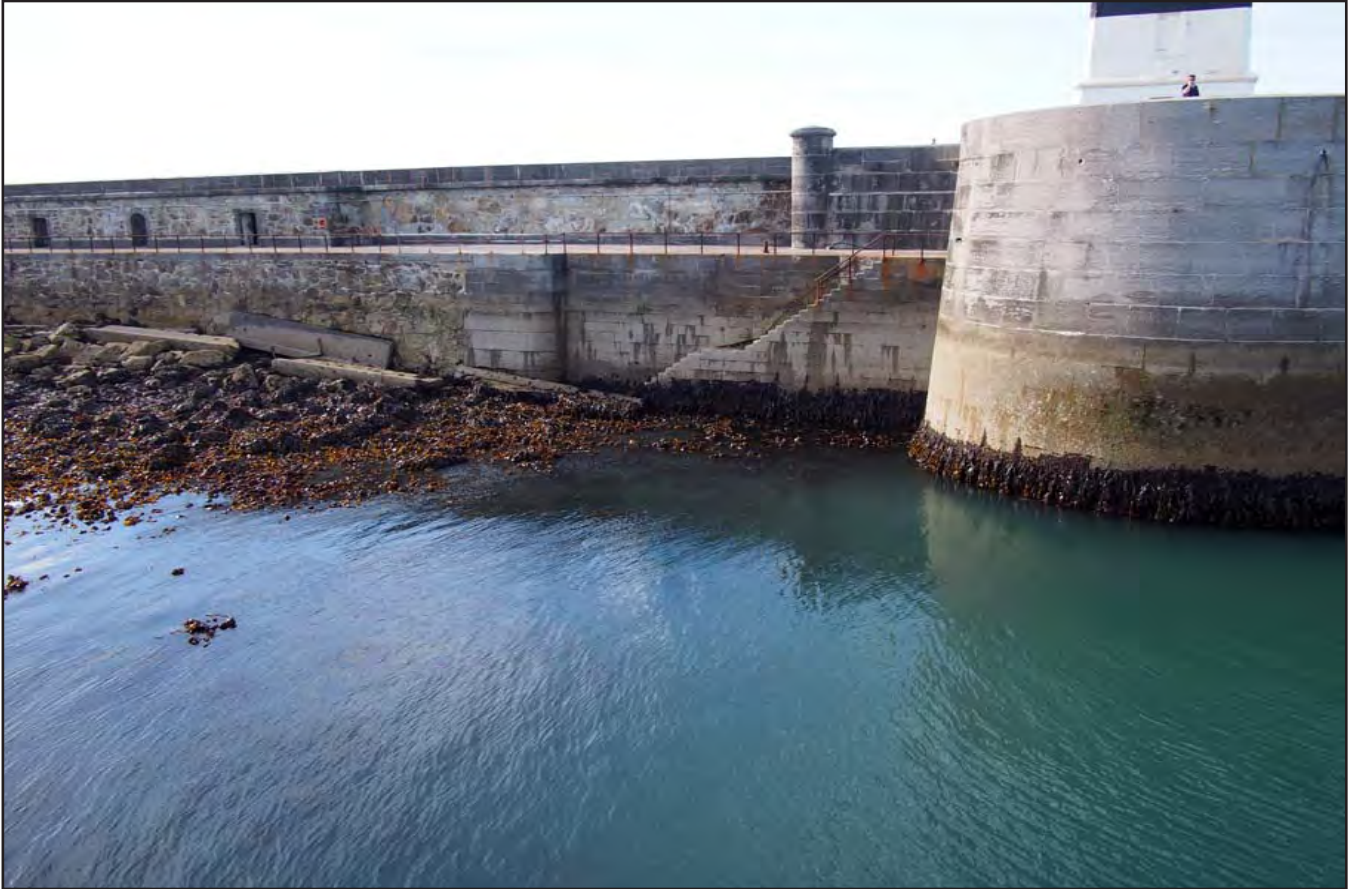
Plate 11: Portside view of the tail end of breakwater showing relationship with the ashlar masonry with view former storage and convenience area (sourced from Civil Engineering Solutions: 20150928 Holyhead Breakwater 151.jpg).

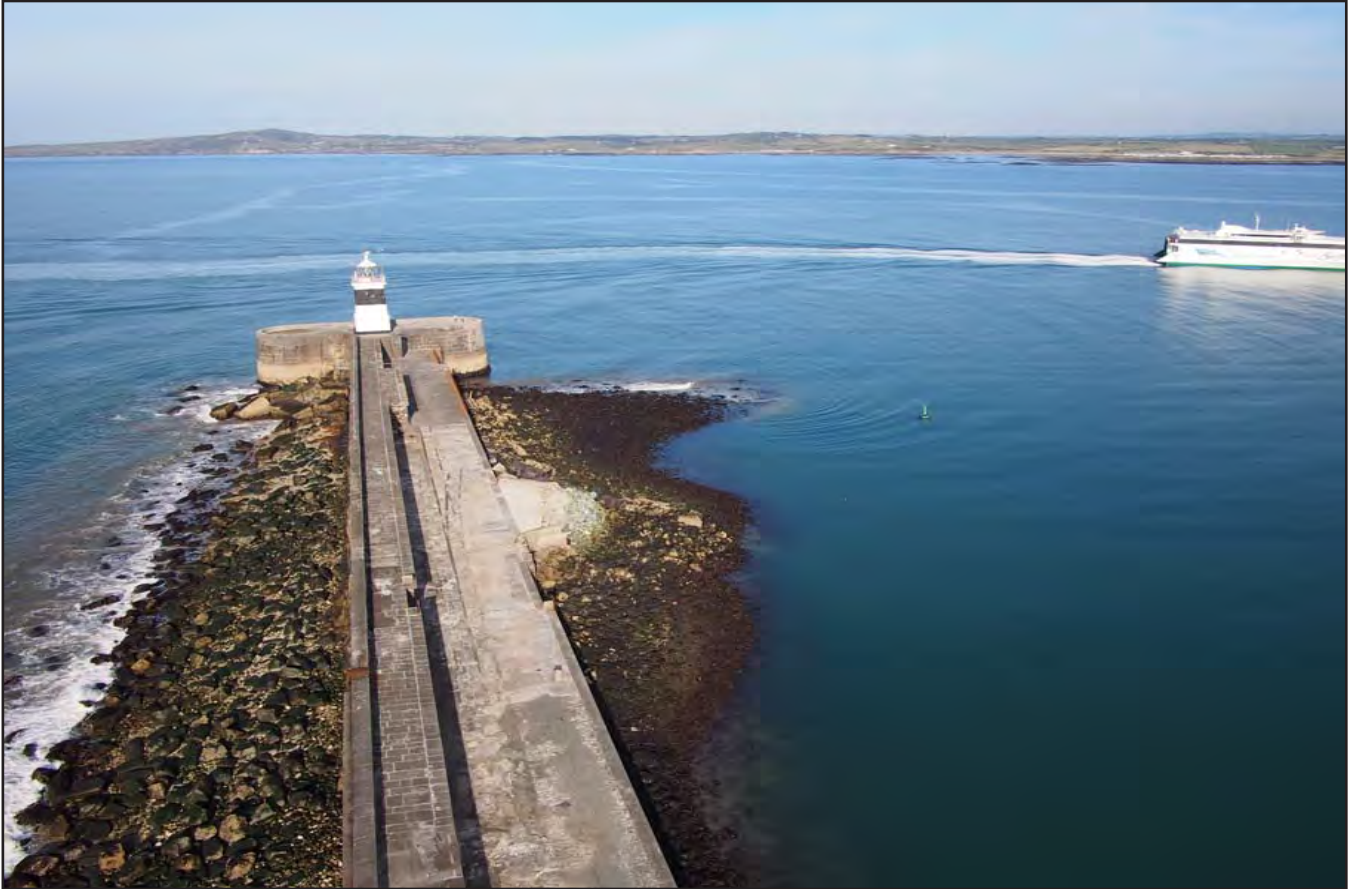
Plate 13: Aerial view of the tail end of the breakwater with the light house
(sourced from Civil Engineering Solutions: 20150928 Holyhead Breakwater 225.jpg).

The lighthouse was built to a design by John Hawkshaw to mark the end of the Breakwater (Plates 14, 25). It was built in 1873 and was square in plan, with chamfered angles, and a stepped plinth. It has horizontal roll moulding at first floor level. There is a walkway around circular lantern, on moulded cornice supports and with iron railings. Inside there are three floors and a basement entered through the lower stage of the breakwater.

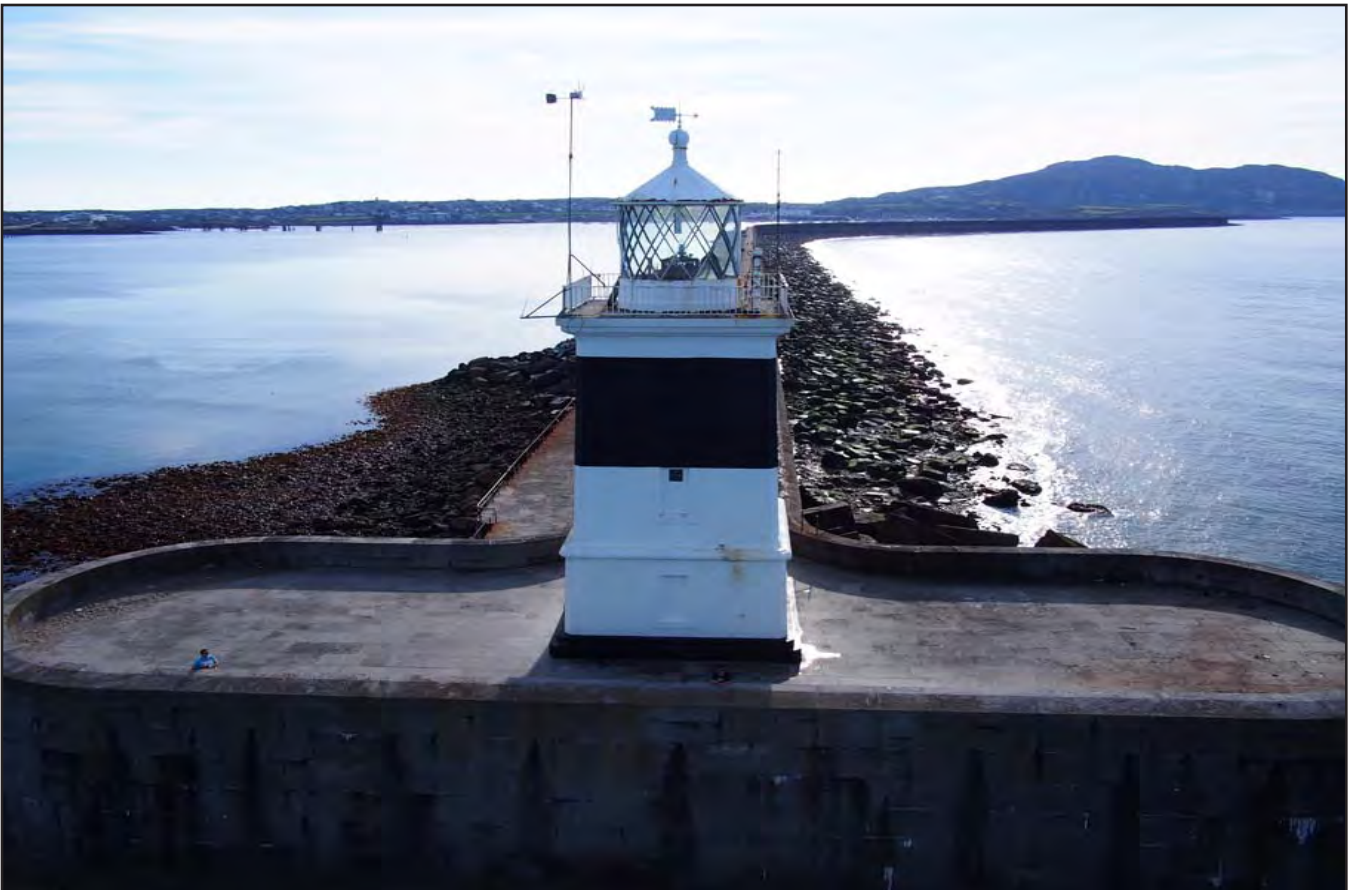
Plate 14: View of full length of breakwater showing its curve leading towards landsend at Holyhead Mountain
(sourced from Civil Engineering Solutions: 20150928 Holyhead Breakwater 160.jpg).

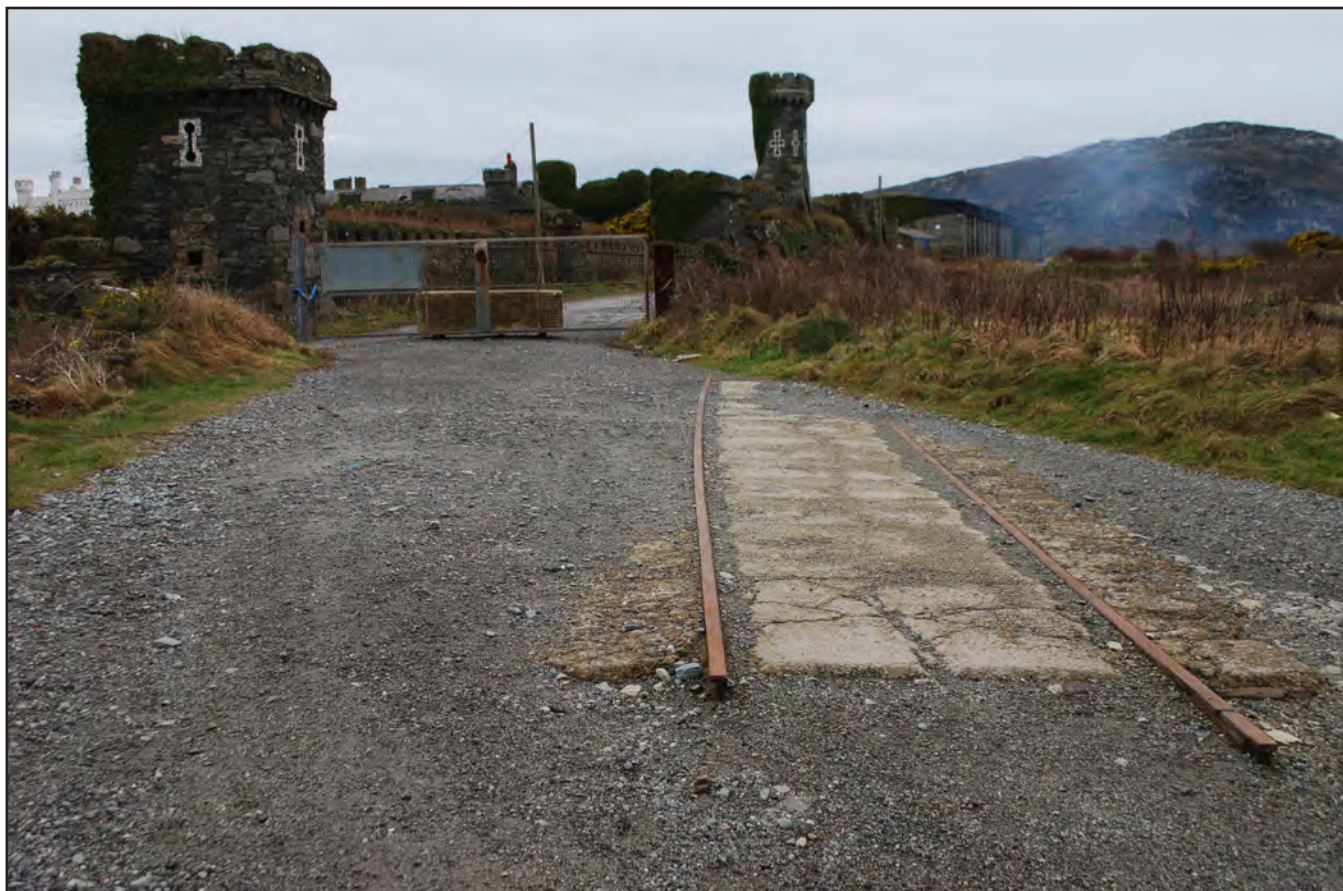
Plate 17: Holyhead Breakwater - view from northeast detailing surviving remnant of rail at landward end of hardstanding/building area (archive image: G2498_001).

A 7ft gauge tramway was built 1848-9 to carry stones from a quarry to the proposed breakwater off Soldier's Point. An extension was also built to Salt Island, though that scheme was later abandoned. Special wagons designed by the resident engineer Dobson were used to tip stones from a timber staging to create a wide mound upon which the breakwater was subsequently built. Written records testify to their being five parallel tracks running along the staging (Davidson, *forthcoming*). The tramway continued to be used for maintenance, though in 1910, when a contract for major repair works was let to S Pearson and Son, a new standard gauge line was laid alongside, and following 1913 only this gauge was used. Rail marks visible at the end of the breakwater are 7ft in width, though sleepers which remain in situ close by (laid longitudinally not across the track) are of standard gauge width. Remains of the standard gauge rails are visible outside the Engine Shed (PRN 18110), and further north, where the track to the breakwater crosses the fence line (Plate 17; Figure 09).

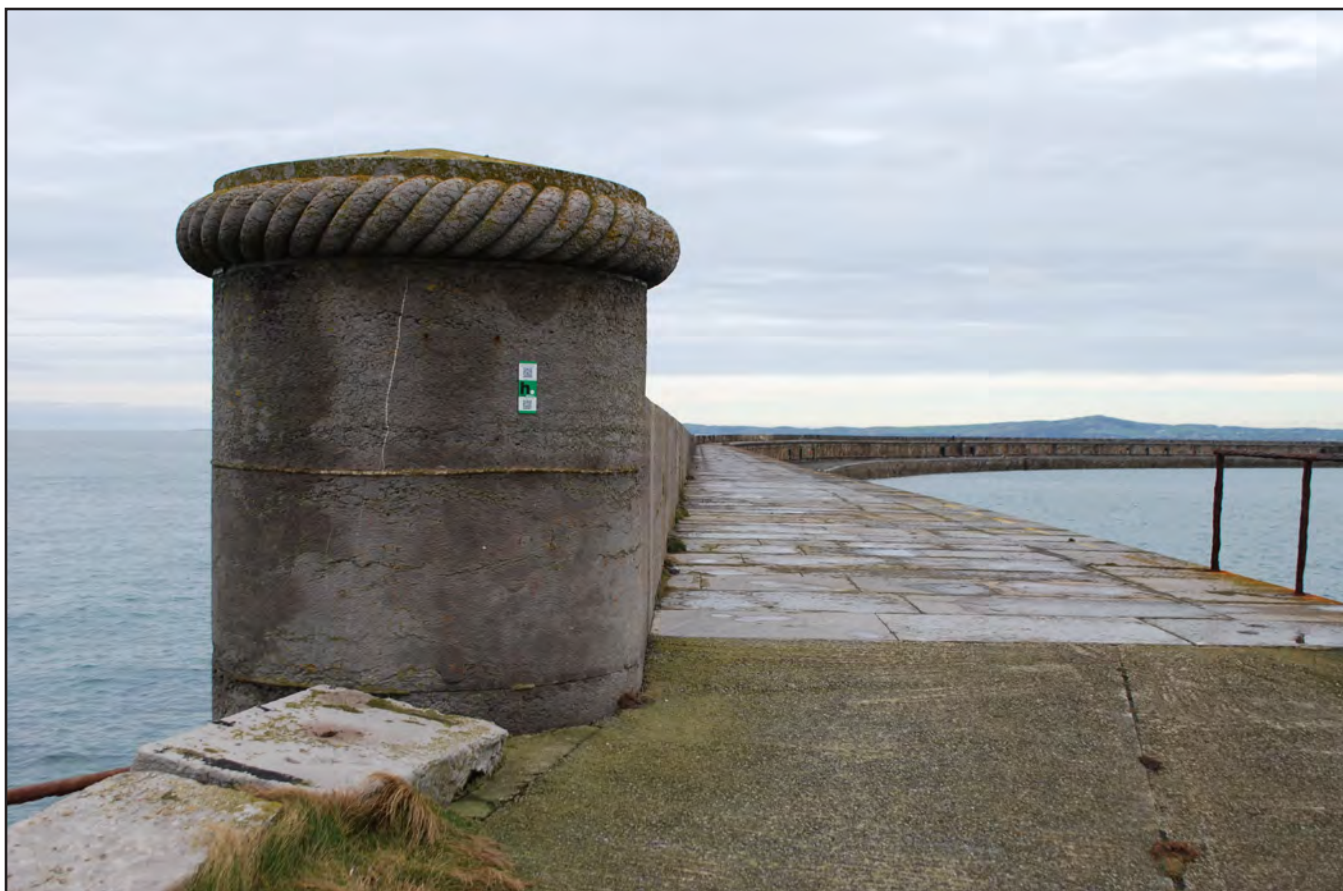
Plate 18: Holyhead Breakwater - view from southeast of large stone drum with roped design at end of the parapet (archive image: G2498_003).

The seaward side rises nearly 40 ft above high tide, ending in a parapet wall which protects a walkway some 3m wide and a lower quay 13m wide. The latter carried a railway along its length for maintenance, and at the end of the breakwater marks are visible of the former rails, some apparently of the 7ft gauge tramway (Plate 23). Every 183 metres (200 yards) pairs of steps go down to the water, with a mooring post alongside (Plate 21). Another set of steps leads to the higher parapet, with an arched opening alongside (Plate 22). Interspersed equally between each set of steps are refuge shelters built into the breakwater wall between the upper and lower stages, consisting of three small chambers, with two outer square headed doors and a central round headed one (Plate 20). Many are now blocked but it would appear that the two outer chambers contained benches at each end, whereas the central chamber may have been for animal shelters (Plate 19). Towards the north-east end of the breakwater, a wider section of parapet housed two store rooms and a former latrine (Plates 24). The breakwater ends in a large oval platform with a square lighthouse. This is reached from the lower quay by large steps, at one side of which is a round drum pillar with rope-moulded decoration around a horizontal band - a similar pillar can be seen at the start of the breakwater (Plate 18).

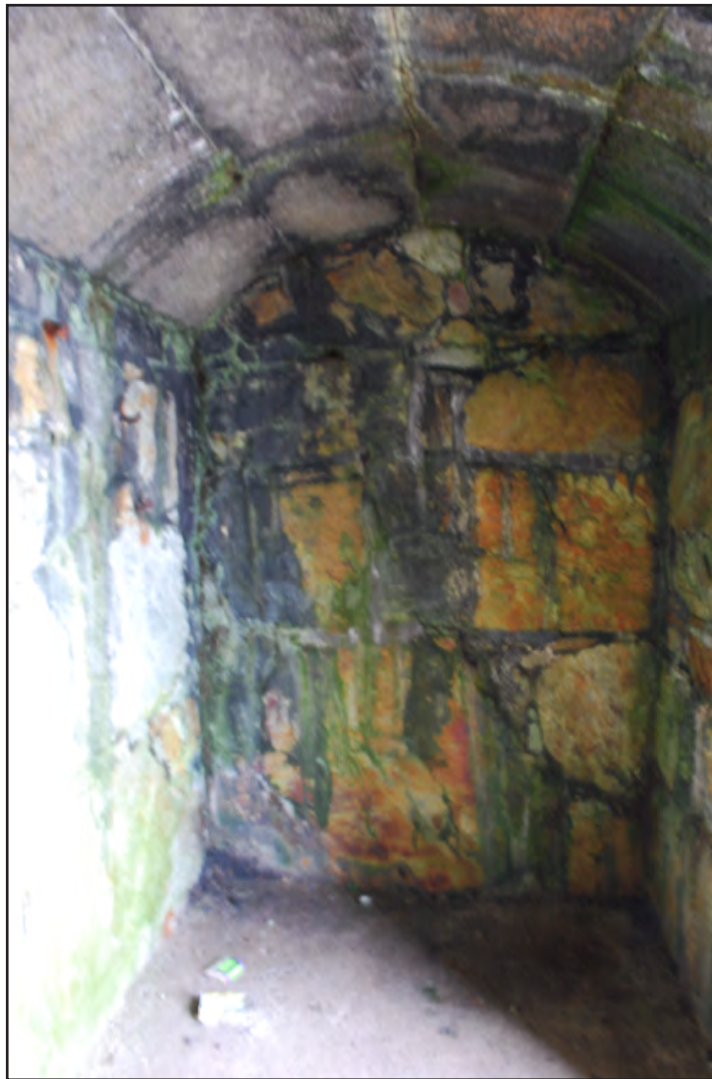
Plate 19: Holyhead Breakwater - interior view of barrel vaulted refuge chamber (archive image: G2498_009).

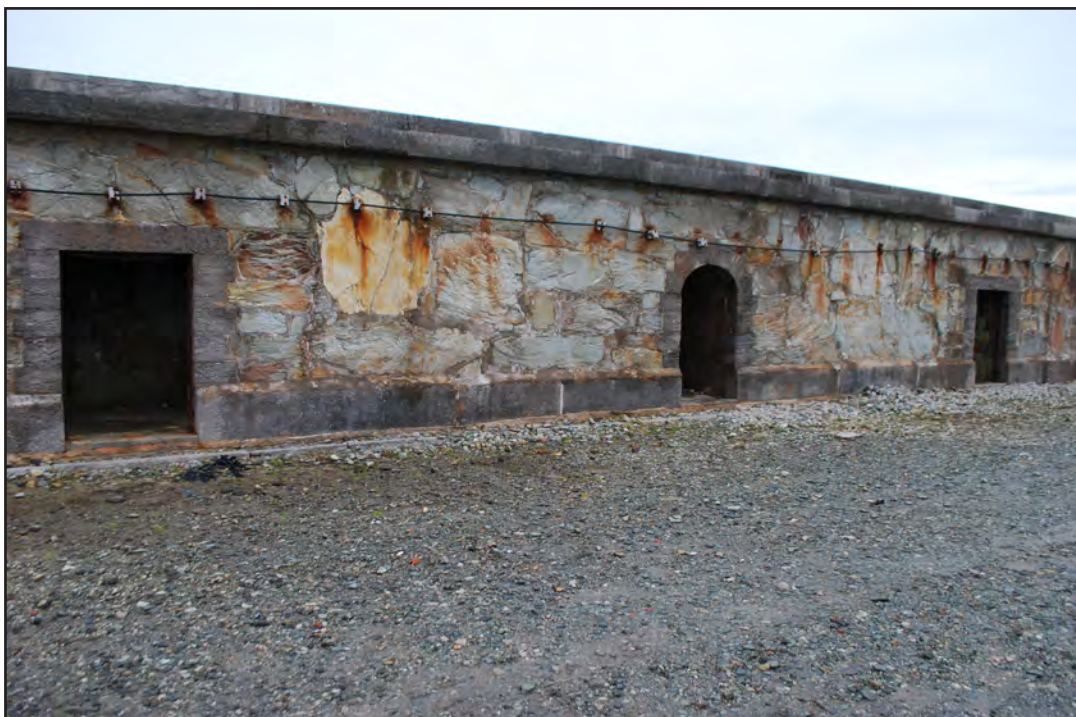
Plate 20: Holyhead Breakwater - view from southwest of three barrel vaulted refuge chambers (archive image: G2498_010).

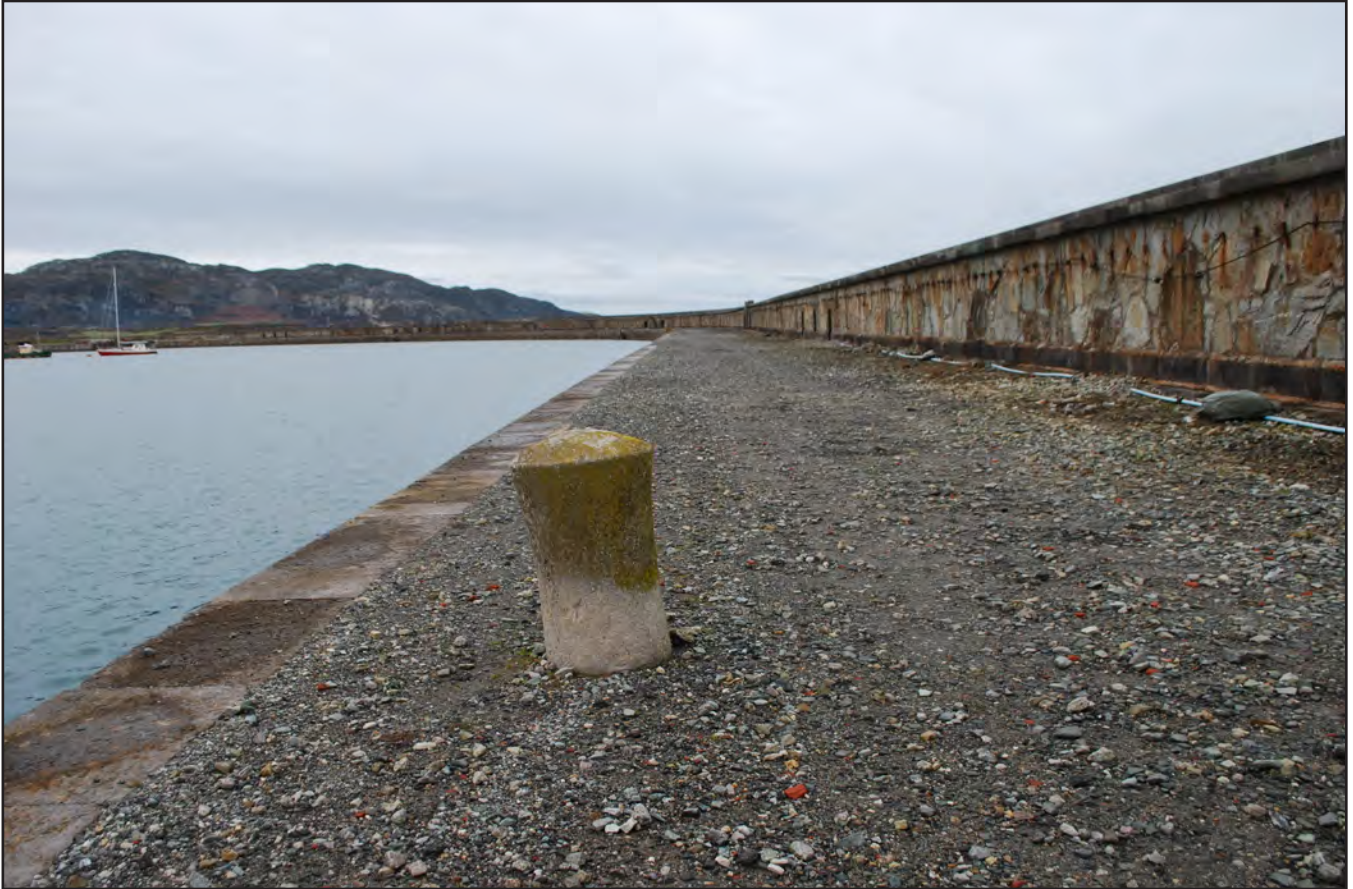
Plate 21: Holyhead Breakwater - view from east of bollard for tying up vessels; located along lower breakwater walkway (archive image: G2498_013).
