Environmental Scoping Report
Holyhead Breakwater Refurbishment Scheme

Client: Isle of Anglesey County Council

Reference: PB9014-RHD-BW-XX-RP-C-0142

Appendix C Level 4 Building Study of Holyhead Breakwater

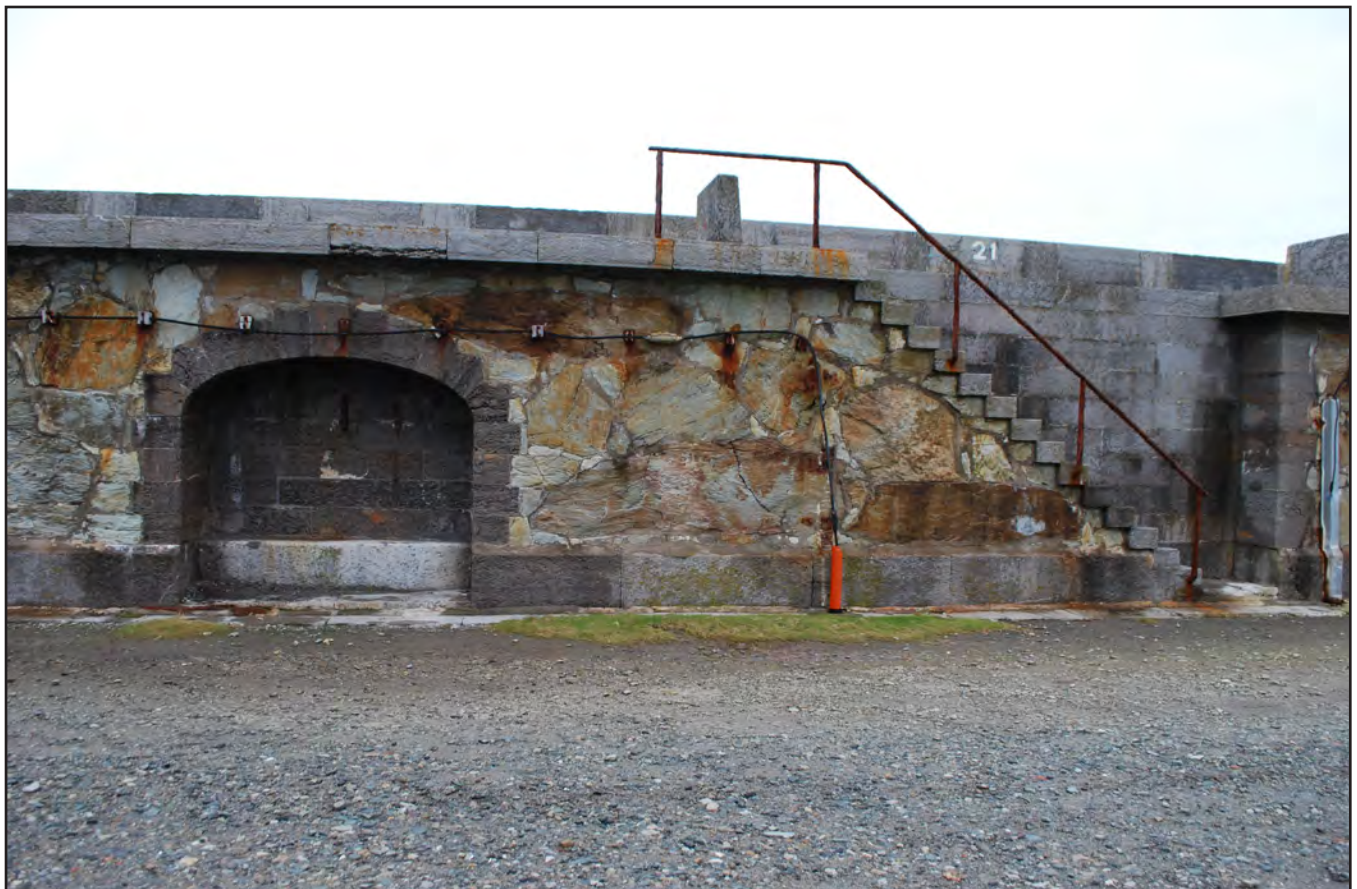
Plate 22: Holyhead Breakwater - view from south of refuge within the breakwater parapet and stairway between upper and lower levels (archive image: G2498_015).

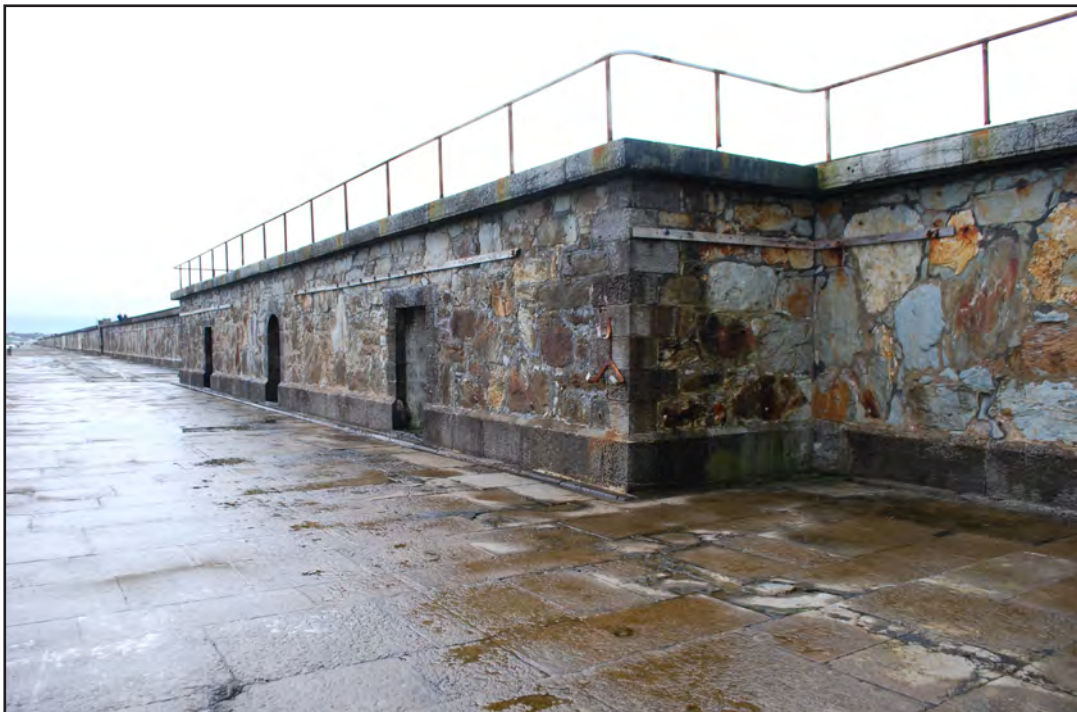
Plate 24: Holyhead Breakwater - view from southeast of upper parapet storage area and central latrines (archive image: G2498_015).

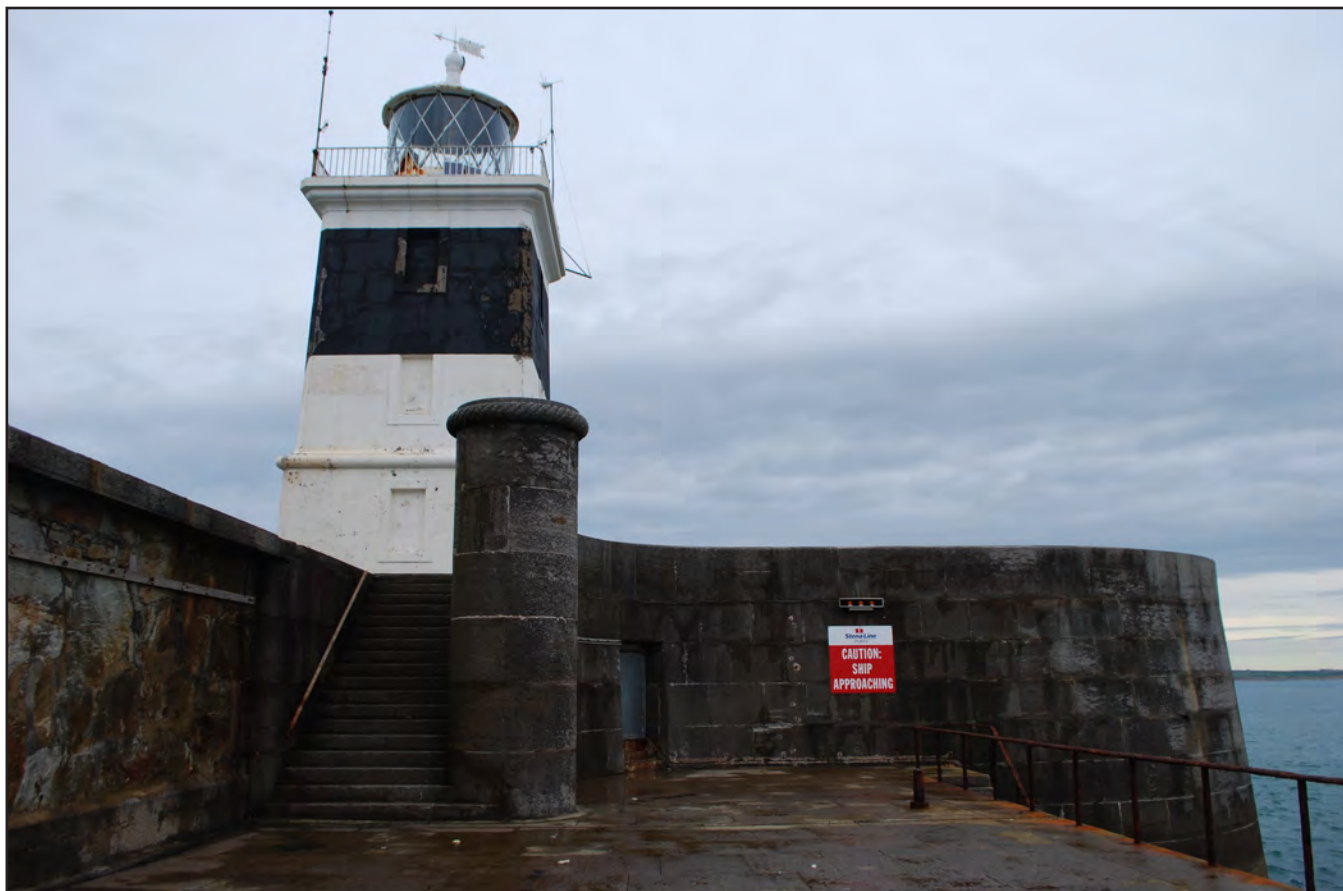
Plate 25: Holyhead Breakwater - view from west of the lighthouse (archive image: G2498_025)

The lighthouse was built to a design by John Hawkshaw to mark the end of the Breakwater (Plates 14, 25). It was built in 1873 and was square in plan, with chamfered angles, and a stepped plinth. It has horizontal roll moulding at first floor level. There is a walkway around circular lantern, on moulded cornice supports and with iron railings. Inside there are three floors and a basement entered through the lower stage of the breakwater.

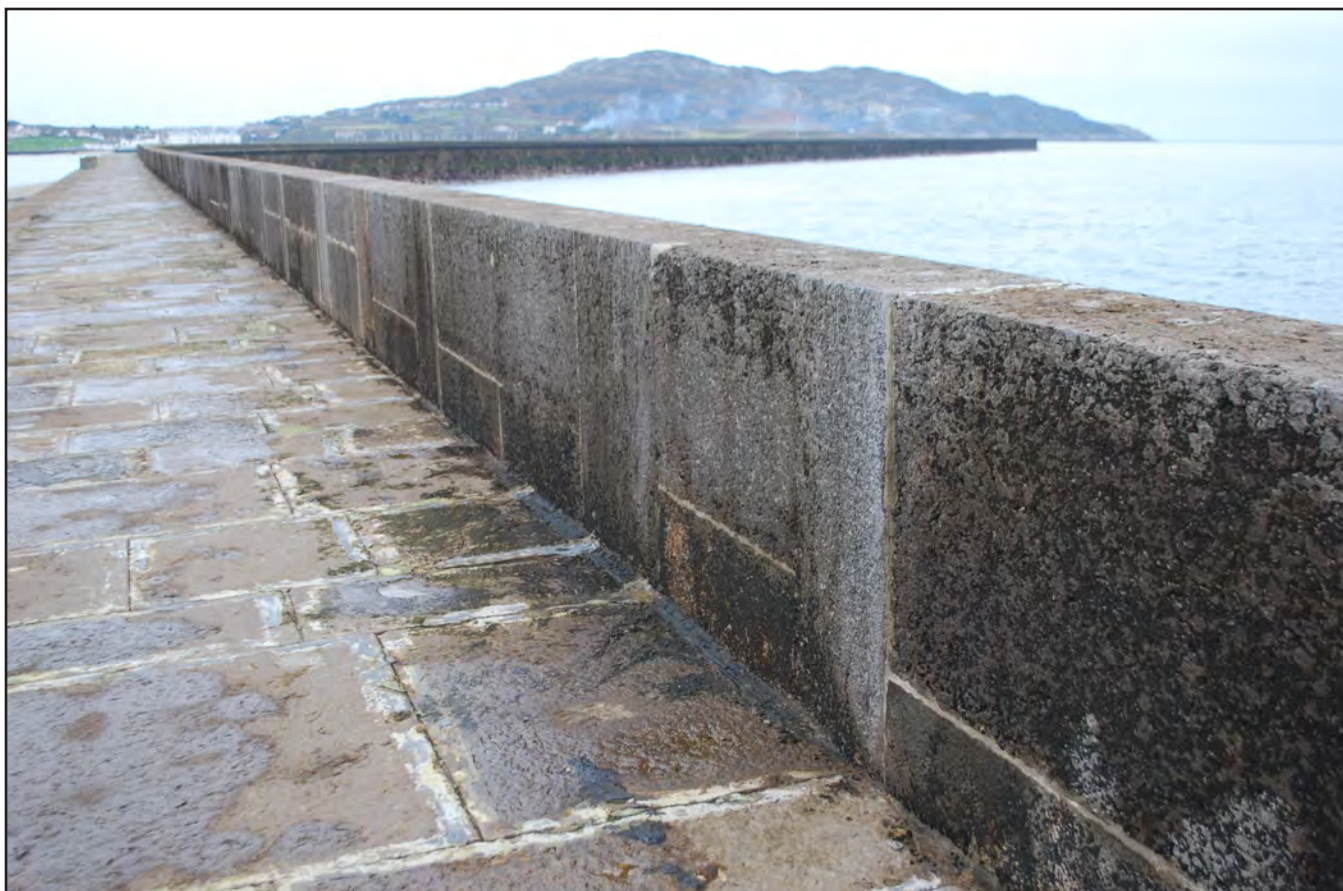
Plate 26: Holyhead Breakwater - view from southeast of parapet ashlar showing cyclopean blocks (archive image: G2498_037)

The Great Breakwater is 2.4 miles long and is z-shaped in plan, and was constructed between 1848 and 1873. It was designed by J.M. Rendel, who was replaced by John Hawkshaw after the former's death on 21st November 1856. The resident engineer, who oversaw the day to day work on the breakwater, was John Dobson, and the contractors were J and C Rigby. The breakwater was, in engineering terms, a very significant development, and several new techniques were pioneered during its construction. The breakwater was built by dumping stone from Holyhead mountain to form a rubble mound, upon which was erected a massive wall faced with limestone blocks (Plate 26).

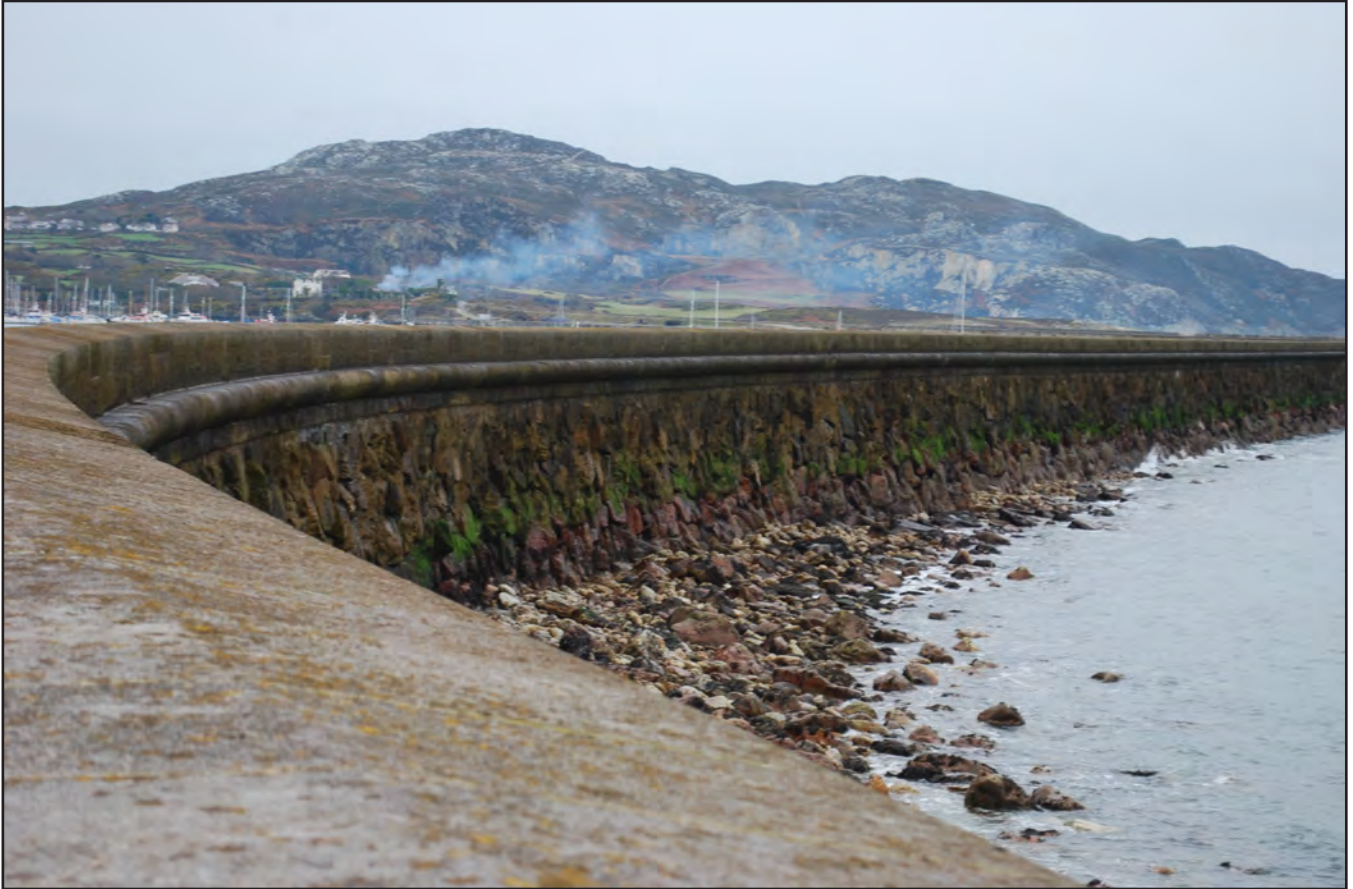
Plate 27: Holyhead Breakwater - view from east-southeast of breakwater dog leg showing seaward side (archive image: G2498_040).

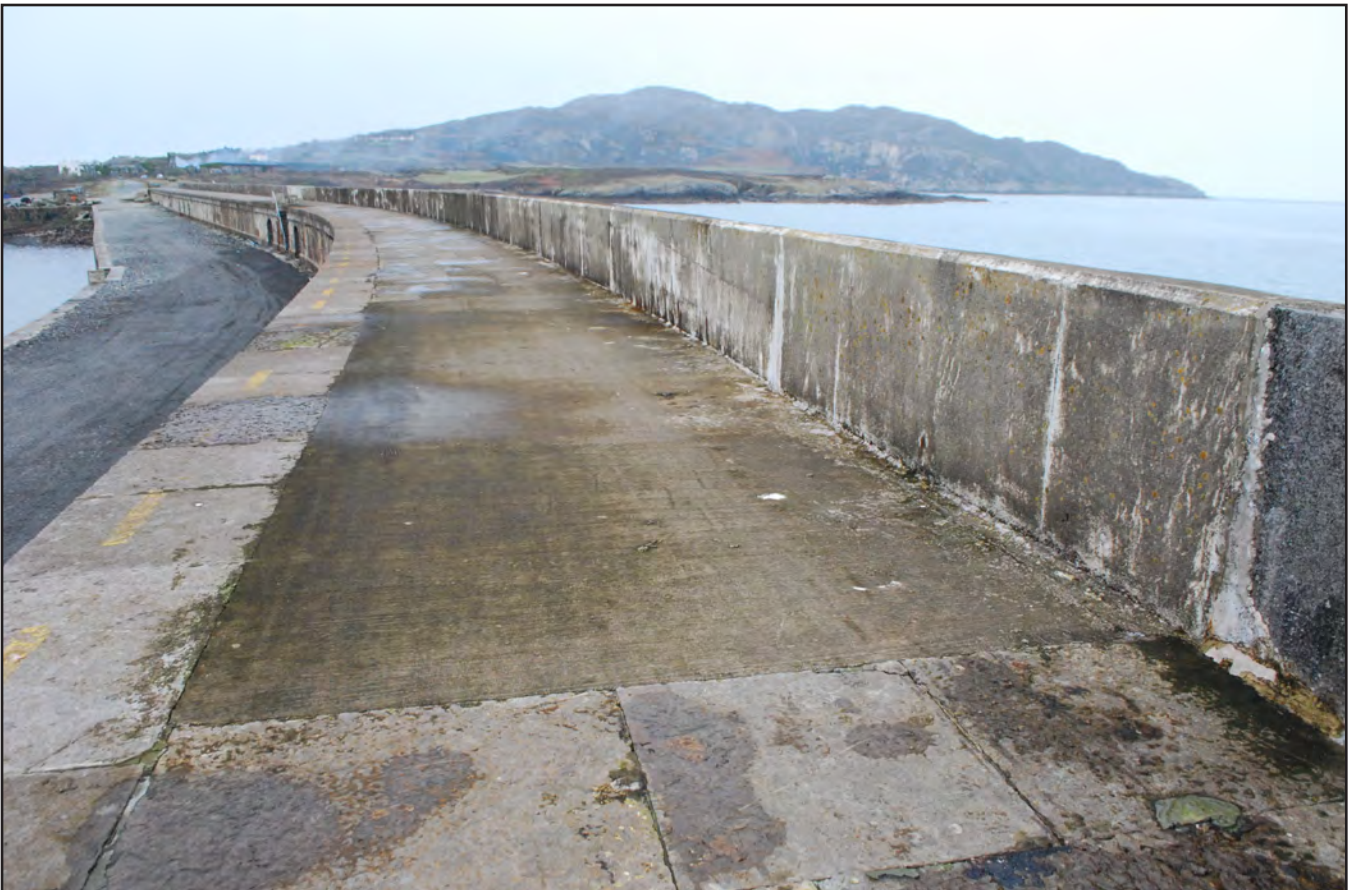
Plate 28: Holyhead Breakwater - view from east of storm damage repair to the parapet and carriageway (archive image: G2498_046).

Holyhead Breakwater - view from east of storm damage repair to the parapet and carriageway (archive image: G2498_046).

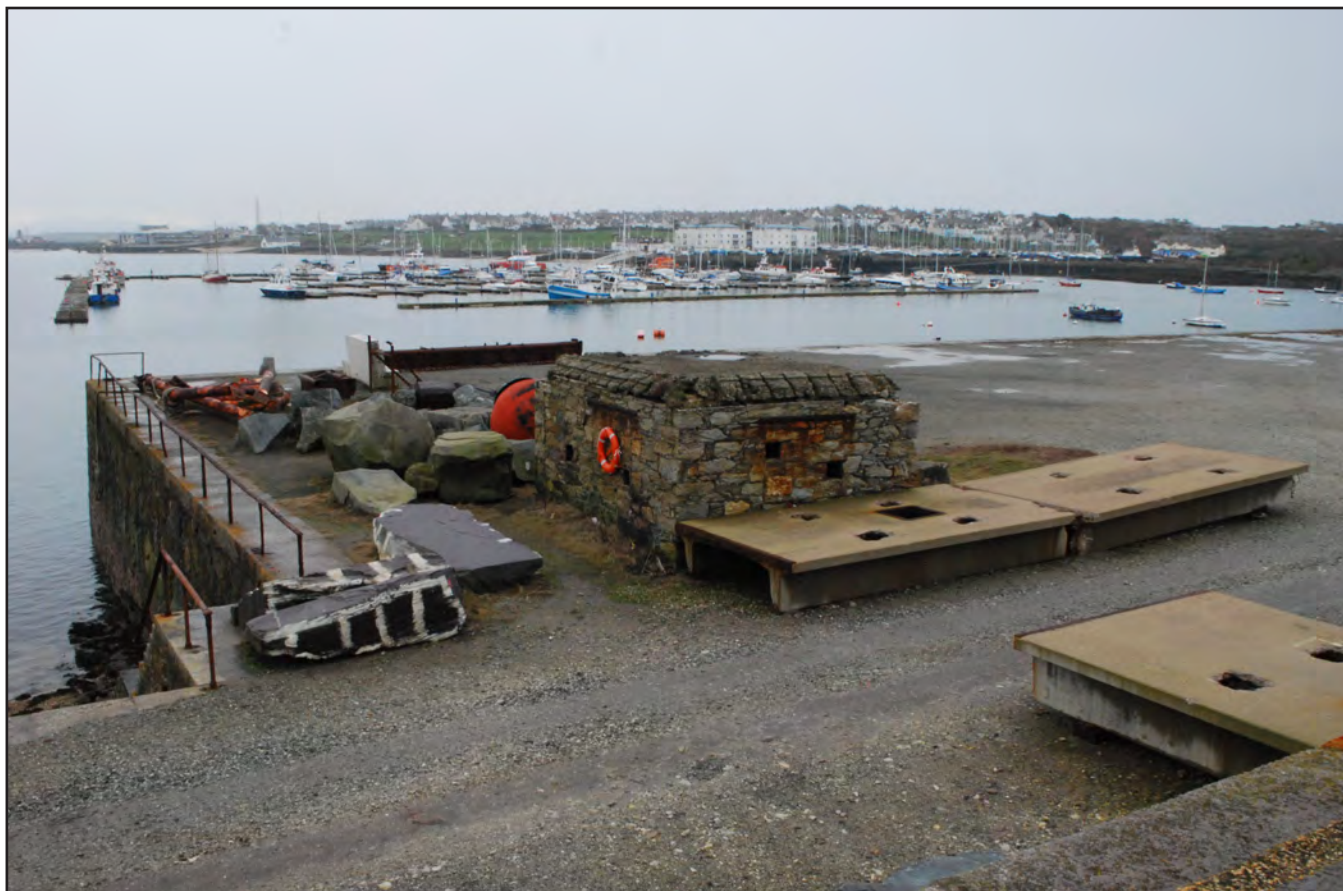
Plate 29: Holyhead Breakwater - view from north of former wharf at southwestern end of the breakwater (archive image: G2498_050).
