NAVIGATION RISK ASSESSMENT ADDENDUM– MORLAIS DEMONSTRATION ZONE

Report Number: 20UK1647
Issue: Issue 02
Date: 18-09-2020

Prepared for: Menter Môn

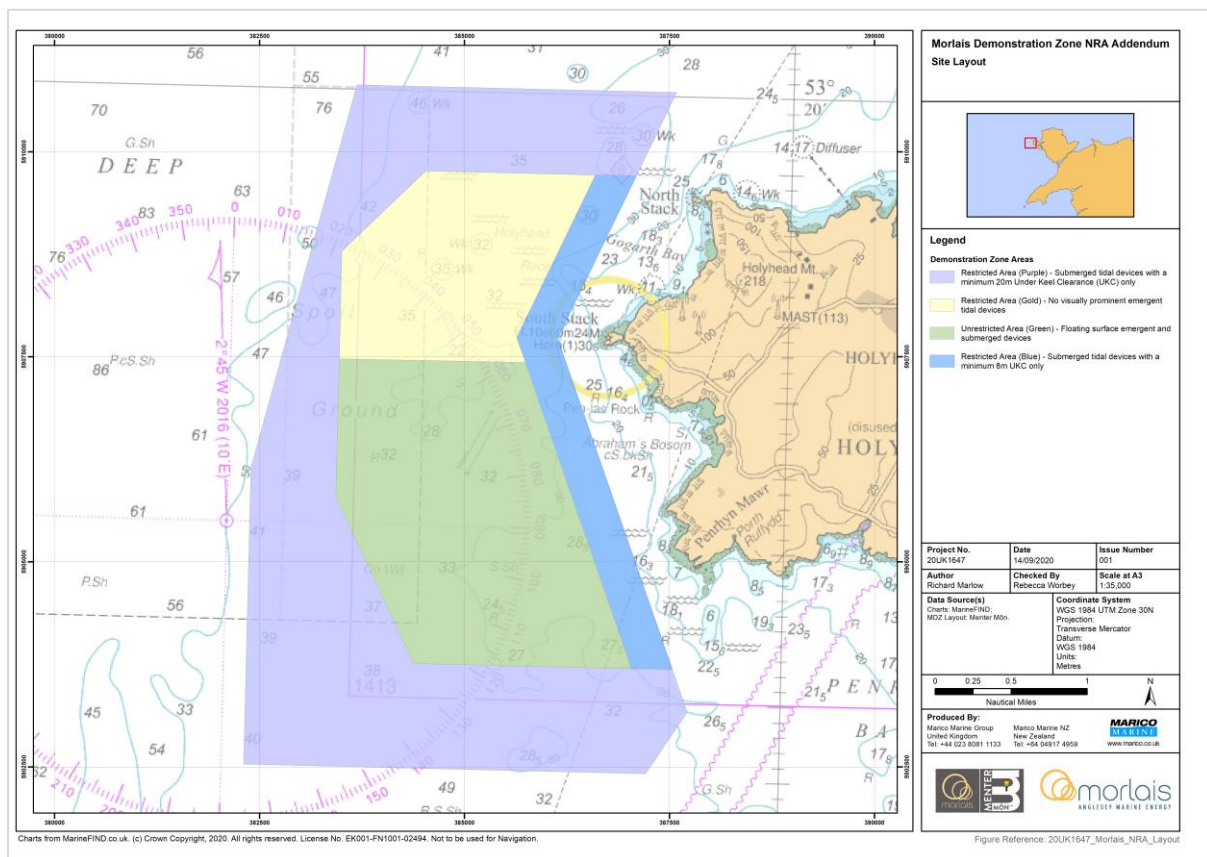
The location and layout of the proposed MDZ is shown within **Figure 1**. The MDZ is located to the west of Holy Island, Anglesey, 500m off South Stack. The MDZ occupies a total area of 35 sq.km and has been sub-divided in to four separate areas; two areas defined based on visual characteristics of which one is for surface emergent devices (green) and one for sub-surface devices (gold) and two further areas based on minimum Under Keel Clearance (UKC) (blue and purple) which will support the installation and commercial demonstration of multiple arrays of tidal energy devices, to a maximum installed capacity of 240 Megawatts (MW). Also shown are indicative electrical hub locations.

- The introduction of a zone of 8m minimum UKC to the east of the MDZ adjacent to the inshore route (**Figure 1**);
- The introduction of a zone of minimum 20m UKC along the northern, west and southern MDZ boundaries (**Figure 1**).

The project seeks consent for a broad Project Design Envelope (PDE) to ensure flexibility in deployment of devices as the technology evolves over time. Subsequently, the location and routing of inter-array and export cables (up to nine assumed), which are to make landfall at Abraham's Bosom, and associated electrical hubs which may extend up to 18 m above the sea surface at LAT (up to nine assumed), and the specific types of turbines to be deployed have not yet been determined. The NRA therefore assumes the potential for utilisation of one of, or a combination of; sea-bed mounted, mid-water or surface devices (see **Table 2-1**) in accordance with the zones outlined in **Figure 1**.

Presuming that the Eastern Inshore Route is between the MDZ and the coast, then the worst-case differences in maximum flow speeds are a reduction of up to 0.3m/s and an increase up to 0.3m/s across the length and width of the Route (**Figure 1**). The largest area of change south of South Stack is a decrease and north of South Stack is an increase. With respect to average speeds, the changes are much smaller both in magnitude and spatially. Most of the Route is affected by changes to currents of +/- 0.1m/s with small areas where the speeds reduce or increase by up to 0.2m/s.

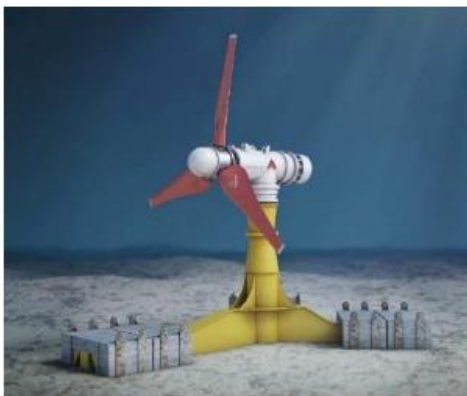
| Sub-Category | Exemplars (Developer or Device Names) | |
|---|---|---|
| Large rotor(s) (>10 m diameter) | <ul style="list-style-type: none"> • SIMEC Atlantis Energy • Andritz Hydro Hammerfest | <p>Developer: SIMEC Atlantis Energy Source: (https://twitter.com/simecatlantis/status/534996023178178560)</p> |

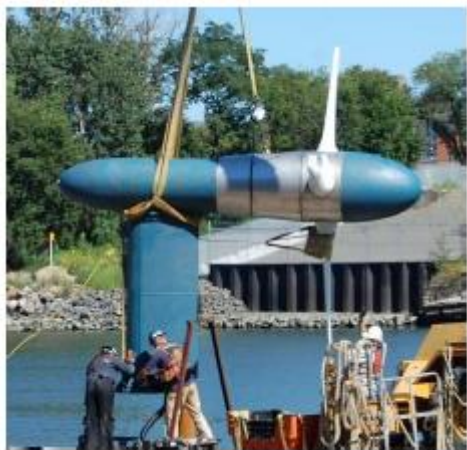
| Sub-Category | Exemplars (Developer or Device Names) | |
|---|---|---|
| Small (<10 m diameter) rotors | <ul style="list-style-type: none"> • Verdant Power • QED Naval SubHub • Nova Innovation • Sabella | <p>Device/Developer: Gen5Tidal/Verdant Power Source: Verdant Power</p> |

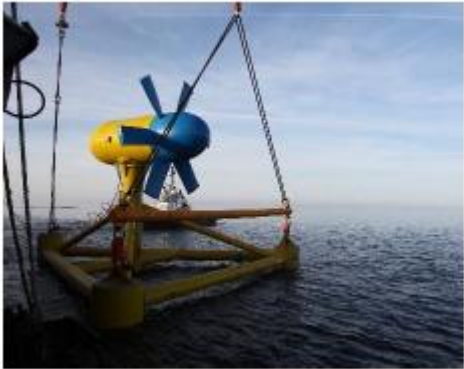
| Sub-Category | Exemplars (Developer or Device Names) |
|---|---|
| | <p>Device/Developer: D10-1000/Sabella Source: Sabella</p> |

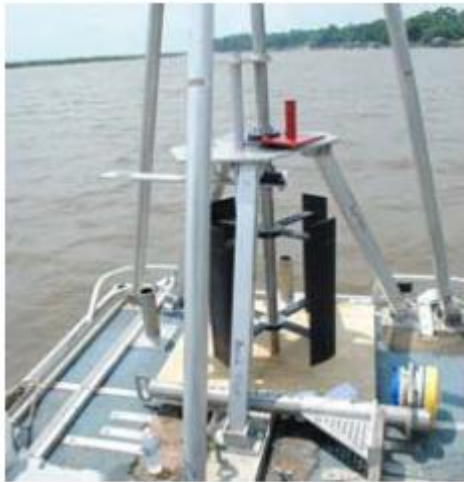
| Sub-Category | Exemplars (Developer or Device Names) |
|---|---|
| <p>Vertical Axis Turbine</p> | <ul style="list-style-type: none"> • Repetitive Energy <p>Developer: Repetitive Energy Source: http://www.repetitiveenergy.com/ourtechnology</p> |

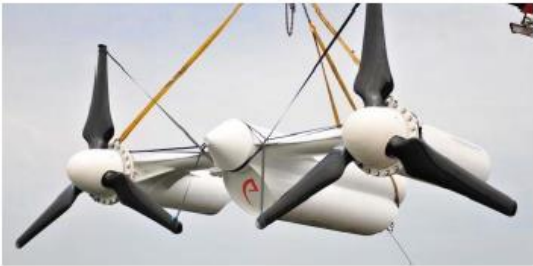
| Sub-Category | Exemplars (Developer or Device Names) |
|---|---|
| <p>Multiple small (<10 m diameter) rotor upon submerged buoyant platform</p> | <ul style="list-style-type: none"> • SME PLATO platform or similar with Tocardo or Schottel TECs • Renewable Devices • Marine Ltd. <p>Developer: Renewable Devices Marine Ltd.</p> |

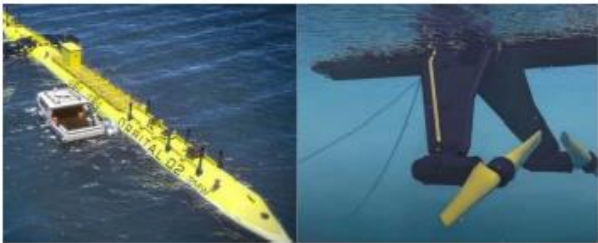
| Sub-Category | Exemplars (Developer or Device Names) | |
|---|--|---|
| Large rotor (>10 m diameter) floating or emergent devices | <ul style="list-style-type: none"> Orbital Marine Power Magallanes | <p>Developer: Orbital Marine Power</p> <p>Source: https://marineenergy.biz/2018/11/16/orbitalmarine-unveils-o2-turbine-blueprints/</p> |

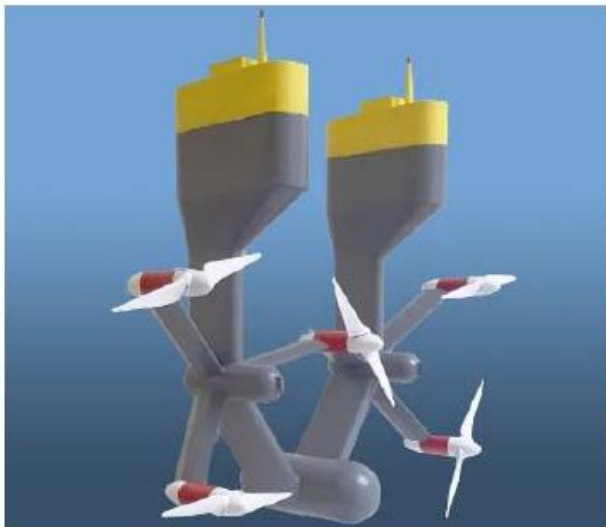
| Sub-Category | Exemplars (Developer or Device Names) | |
|---|--|---|
| Small rotor (<10 m diameter) floating devices | <ul style="list-style-type: none"> Tocado TFS | <p>Developer: Tocardo</p> <p>Source: https://marineenergy.biz/2018/06/06/-tocardo-strengthens-management-with-financeappointments/</p> |

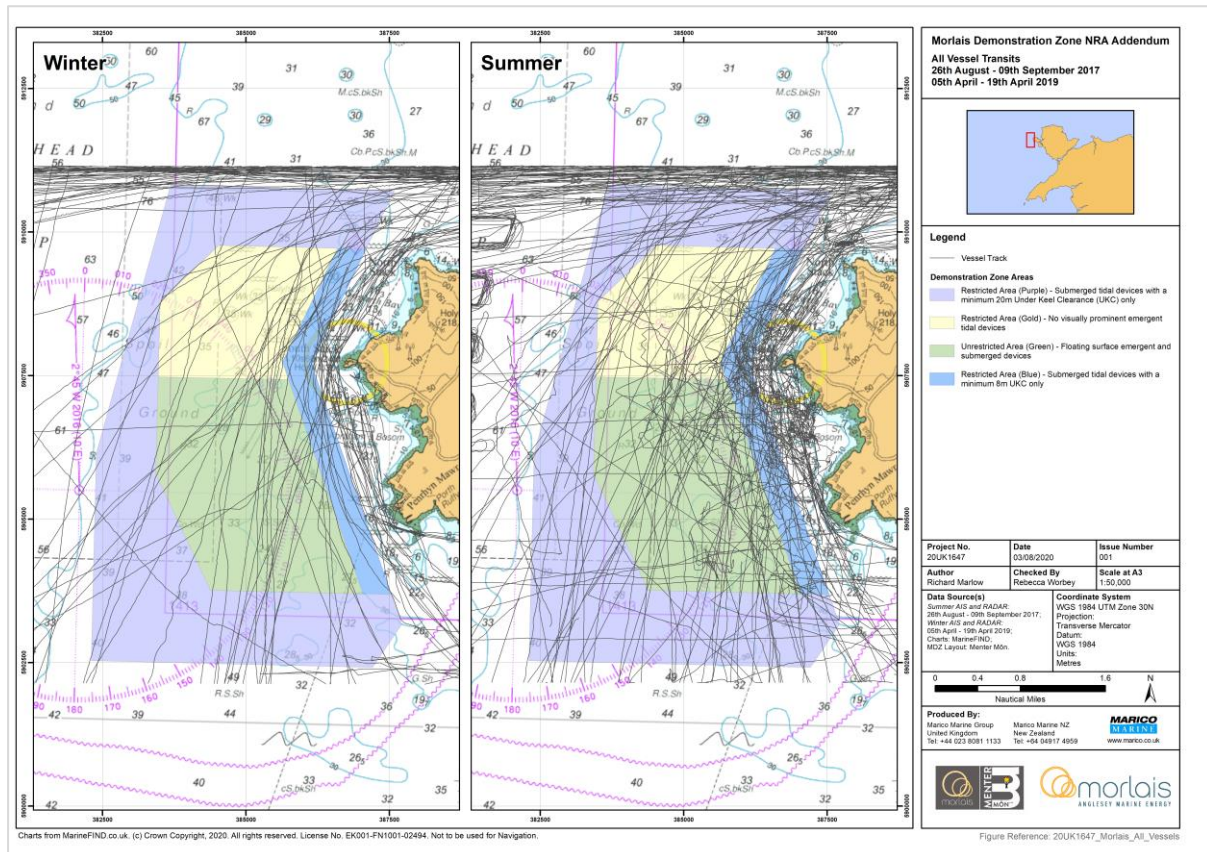
Figure 2: Vessel tracks - summer 2017 and winter 2019.

All vessel tracks recorded by AIS and RADAR between 05th April and 19th April 2019 and 26th August and 19th September 2017 are shown in **Figure 2**. Immediately evident is the inshore passage utilised by smaller low-draught vessels such as; recreational craft, workboats and small fishing vessels and the ferry route to the north of the MDZ utilised by Irish Ferries and Stena Line (see **Figure 6**).

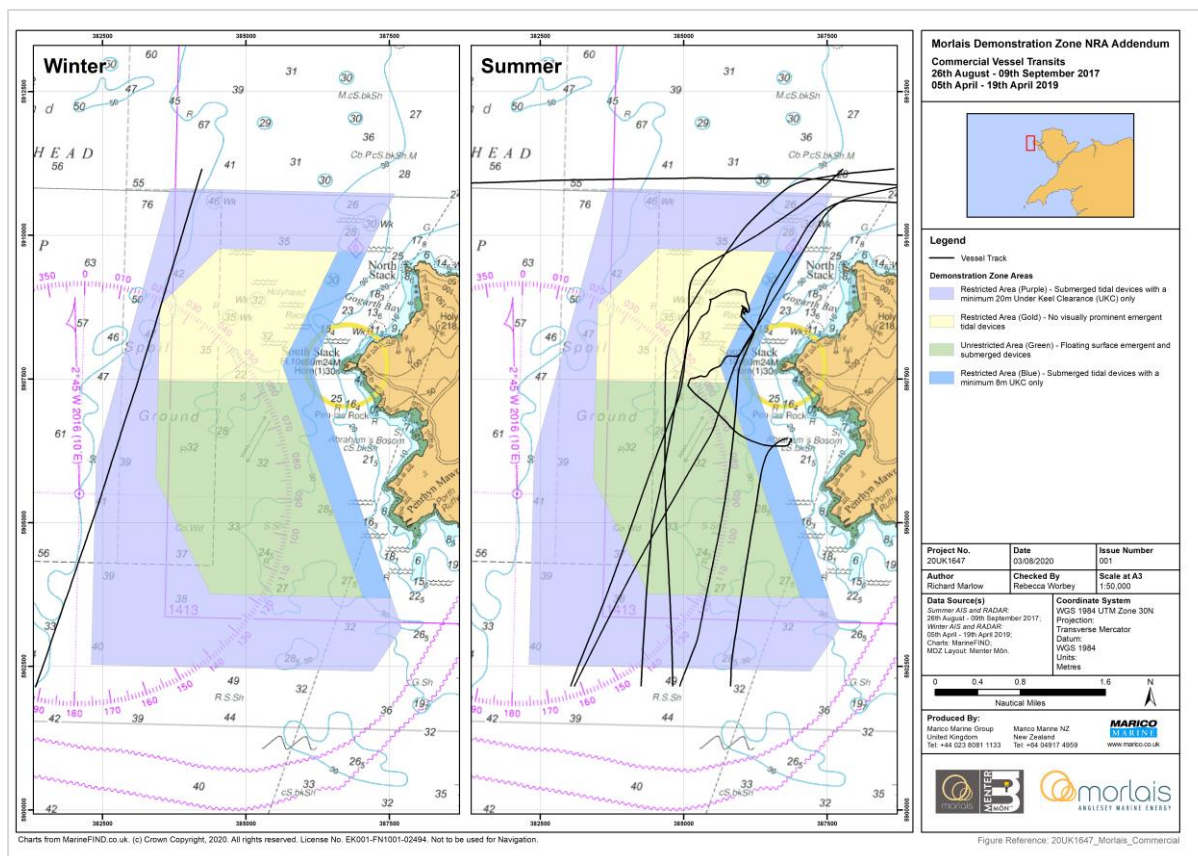
Figure 3: Commercial vessel tracks - summer 2017 and winter 2019

The tracks of commercial vessels >3m draught (including cargo, tankers and dredgers) recorded during two-weeks of winter 2019 and two weeks of summer 2017 are shown in **Figure 3**.

There was one vessel of this category within the winter dataset; the general cargo vessel *Halenic* (unladen draught 3.2m, laden draught 5.5m). This vessel transited 0.2nm from the western boundary of the MDZ. There were two vessels of this category within the summer dataset; the Trinity House vessel *Patricia* (draught 4.5m) and the dredger *DEO Gloria* (draught 3.3m). No tankers were recorded within either dataset.

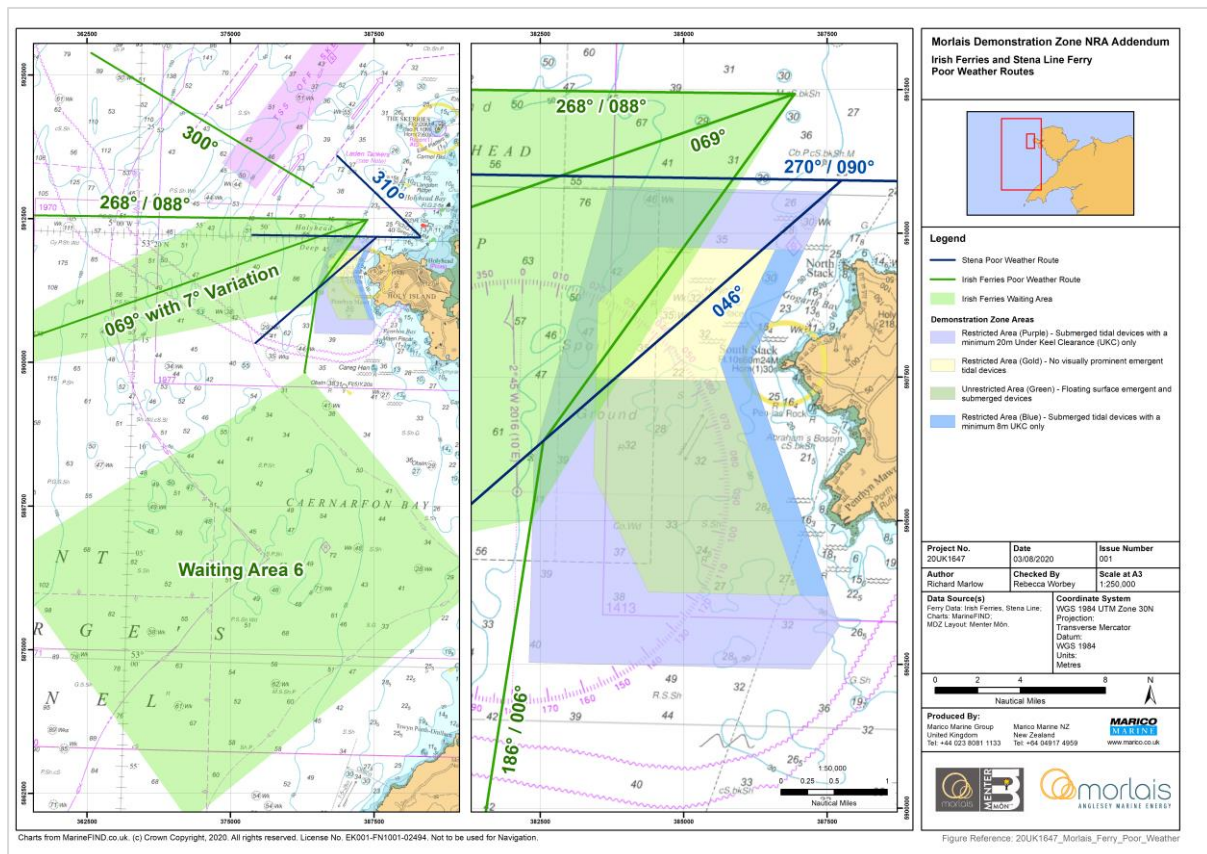
Figure 4: Irish Ferries and Stena Line –Indicative Poor Weather Routes from 2019 NRA Consultation

Irish Ferries and Stena Line ferries operate to the north of the proposed MDZ as shown in **Figure 5** and **Figure 6**. Typically, the ferries generally transit clear of the northern zone boundary, however, occasionally pass within the northern two sub-zones and the western sub-zone during poor weather conditions. A summary of poor weather routing from consultation is given within **Table 7-3** and **Figure 4**.

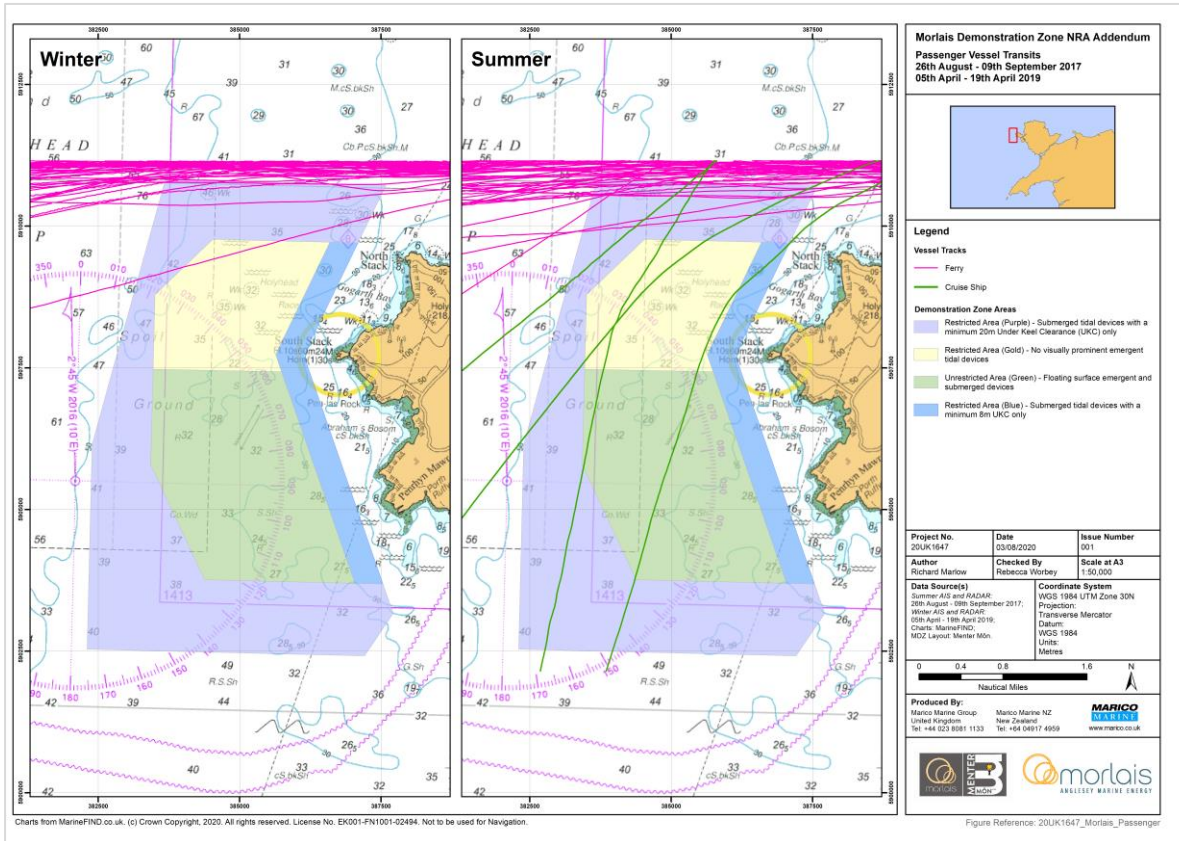
Figure 5: Passenger vessel transits –summer 2017 and winter 2019

In addition to ferries, five transits were made by four unique cruise ship vessels; *Hebridean Sky* (draught 4.2m), *Corinthian* (draught 4m), *Variety Voyager* (draught 3.4m) and *Balmoral* (draught 2.1m) within the two-week summer 2017 dataset. The cruise ships, while infrequent, are noted occupying a larger portion of the proposed MDZ and are present within all nine sub-zones. Cruise ships undertake thorough passage planning and, in contrast to ferries and therefore, may more easily alter passage plans to accommodate offshore infrastructure.

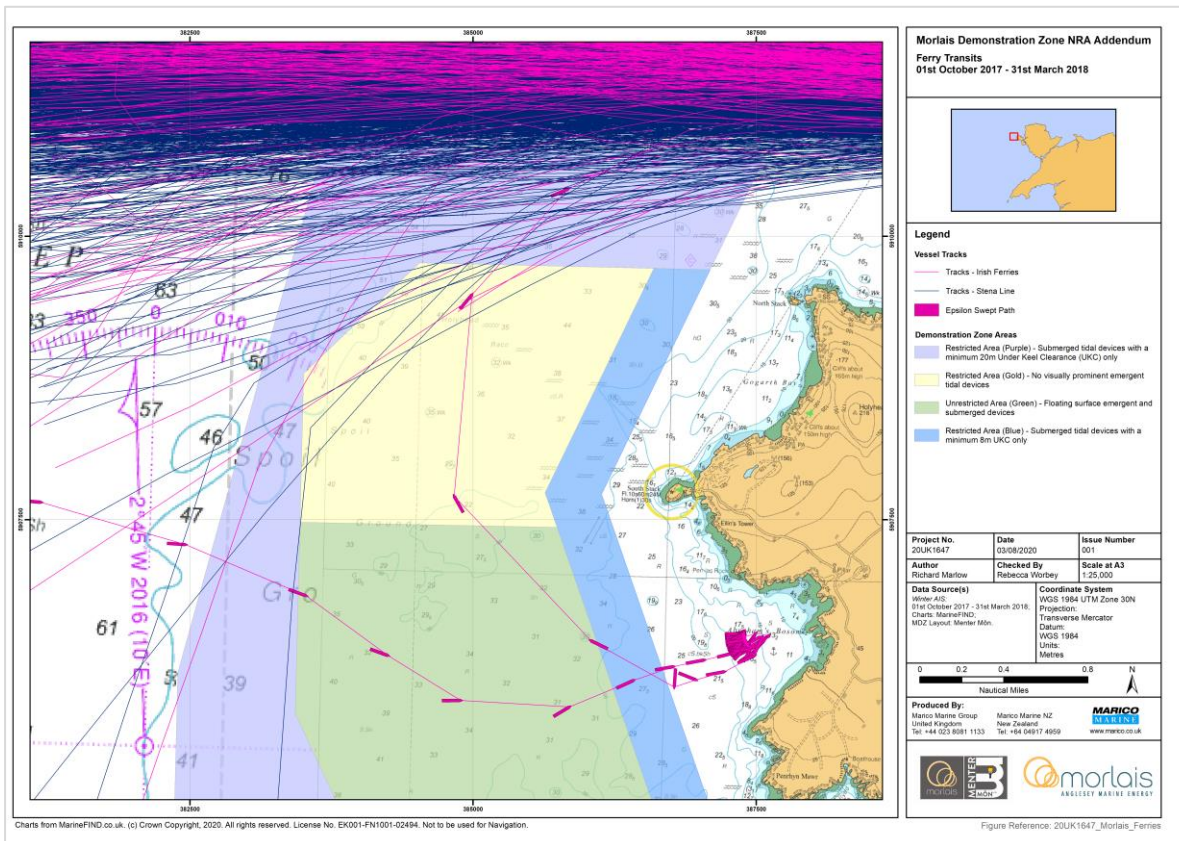
Figure 6: Ferry transits - 01st October 2017 to 31st March 2018

Six months of AIS data from between October 2017 and March 2018 was sourced to account for any seasonal variances in ferry activity and usage of the poor weather routes. The data includes Class A and Class B vessels.

Epsilon is noted in **Figure 6** transiting through the proposed MDZ to anchor at Abrahams Bosom on 03rd March 2018 during the ‘beast from the east’ storm. Although this is considered a rare event (see **Table 7-3**), alternative poor weather/ emergency anchor routes would likely need to be established, should devices with an UKC of <20m be deployed within the MDZ.

Vessel transits by LOA from AIS between 01st October 2017 and 31st March 2018 are shown in **Figure 14**. The majority of vessels transiting through the MDZ are <21m LOA corresponding to; recreational, fishing and other vessel categories. All vessels transiting through the MDZ with a LOA >167m transited within the north and the western of the MDZ with the exception of *Epsilon* (see **Figure 6**) which transited through the MDZ to anchor at Abrahams Bosom on 03rd March 2018.

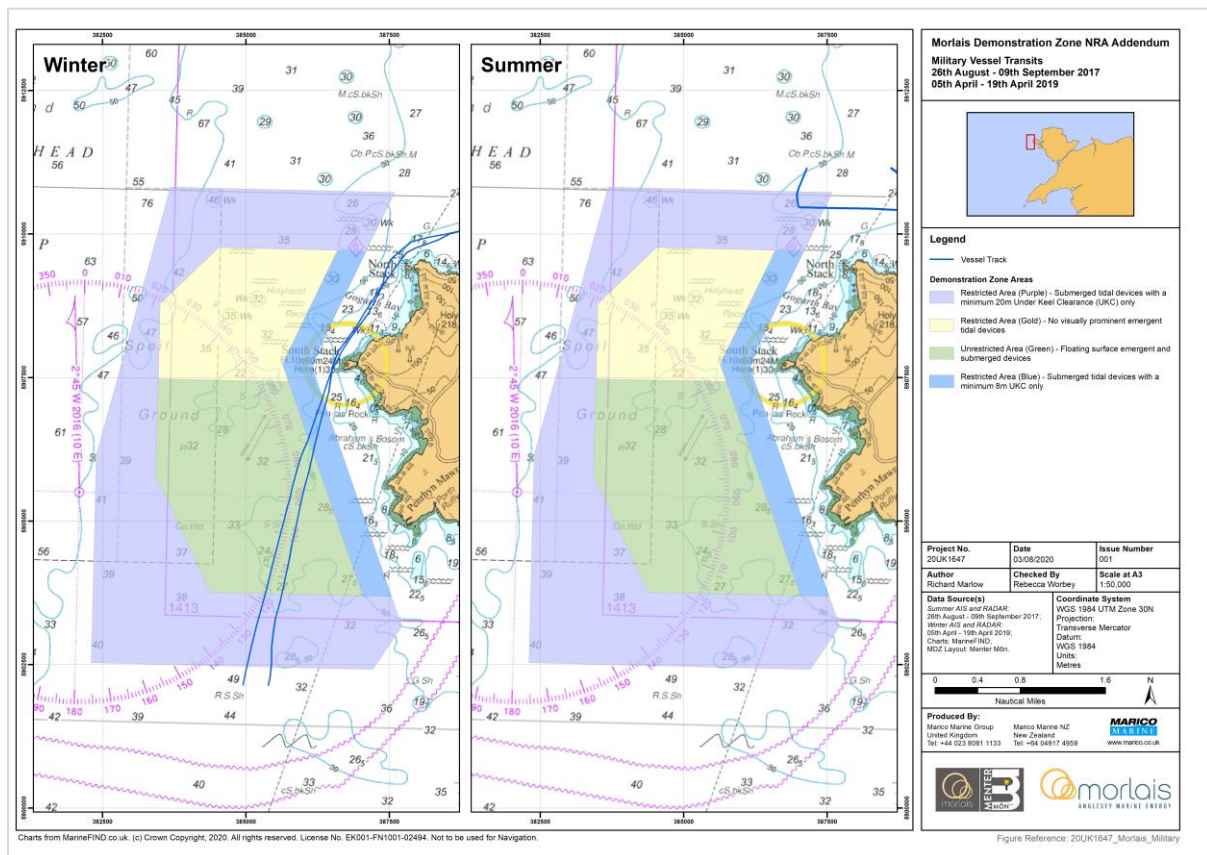
Figure 7: Naval vessel tracks - summer 2017 and winter 2019

Naval vessels may not broadcast AIS given the sensitive nature of their operations and, as such, may be under-represented within the datasets. **Figure 7** shows the tracks naval vessels recorded within the summer and winter 2017 surveys.

Two transits by one unique vessel, the military training vessel *Smit Don*, was recorded within the proposed MDZ within the winter dataset. One transit by *Smit Don* was recorded within the northern most sub-zone of the proposed MDZ within summer. *Smit Don* has a recorded draught of <3m.

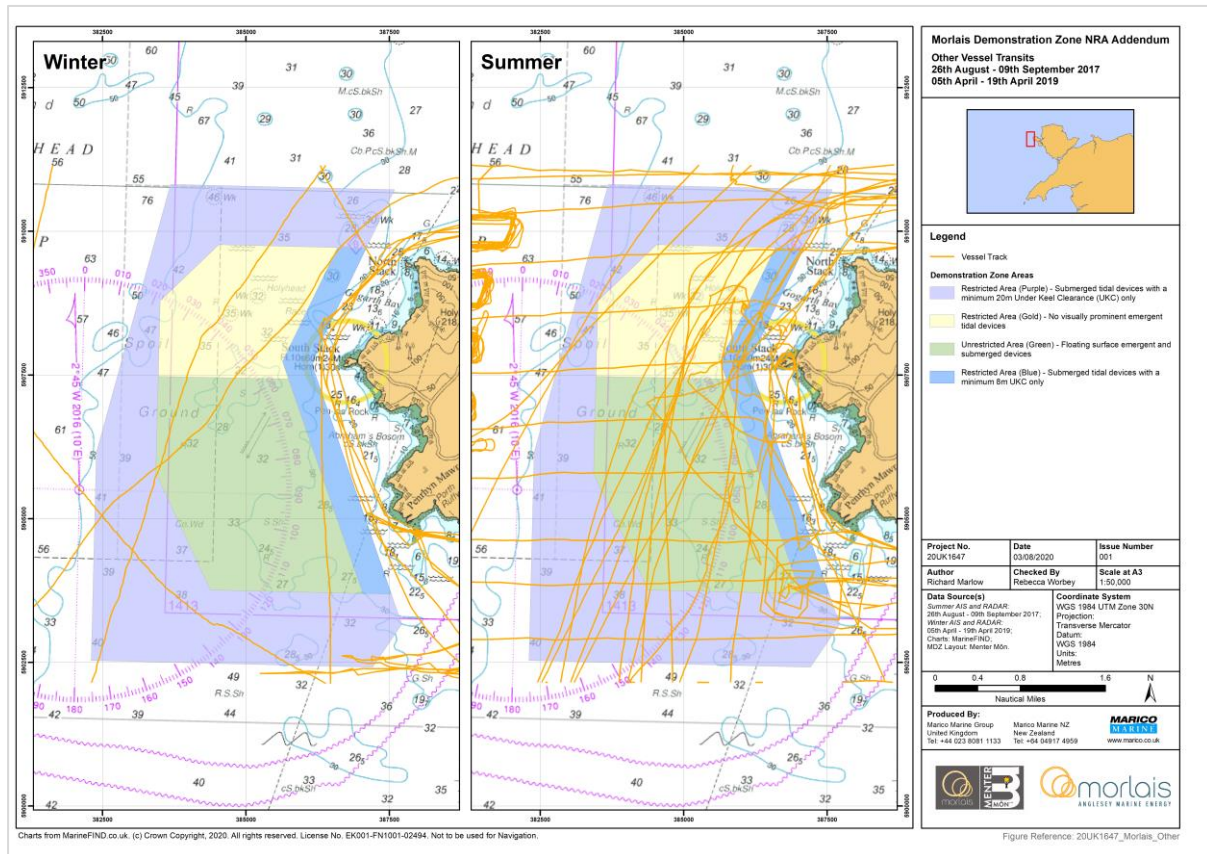
Figure 8: Other vessel tracks - summer 2017 and winter 2019

Figure 8 shows an assortment of other vessel types which are active near the project, including; tugs and tows, survey vessels, RNLI vessels, construction and maintenance vessels and cable laying vessels. This vessel category is active across the entirety of the proposed MDZ and is primarily comprised of vessels with draught <3m. *MV Seekat C* is noted undertaking Morlais project related surveys within the summer dataset. Unsurprisingly, the number of 'other' category vessels is much higher in summer than in winter.

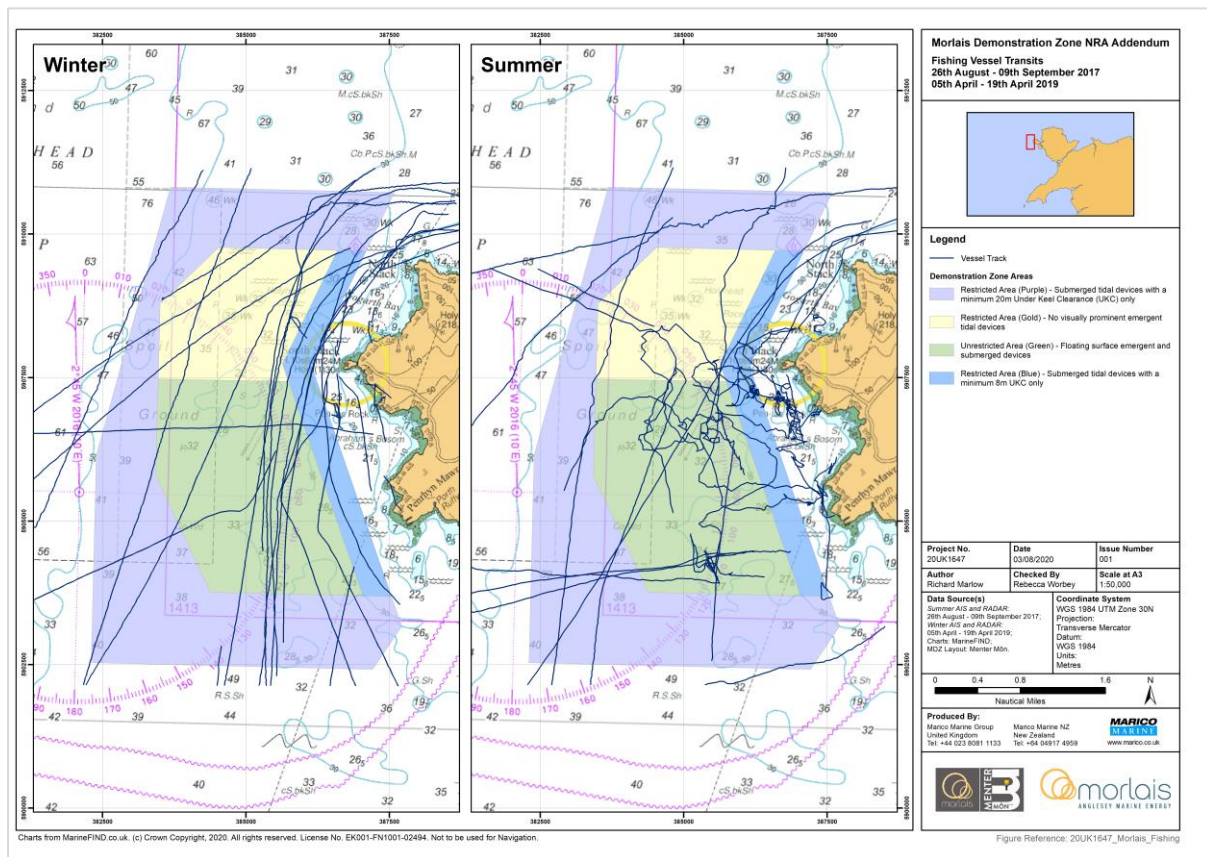
Figure 9: Fishing vessel tracks - summer 2017 and winter 2019

The tracks of fishing vessels during summer and winter from radar and AIS are given in **Figure 9**. The ASD⁹ details that within this region, inshore trawlers 'may be encountered at any time in depths of 25m to 35m' and that pots may be found up to 10 miles offshore'. The tracks within the inshore passage and those actively fishing within the eastern portion of the proposed MDZ are comprised of smaller fishing vessels that do not carry AIS while the majority of fishing vessels on transit are larger

AIS carrying vessels. It is noted that vessels engaged in fishing are more prevalent within summer than winter where the majority of vessels are on transit through the MDZ.

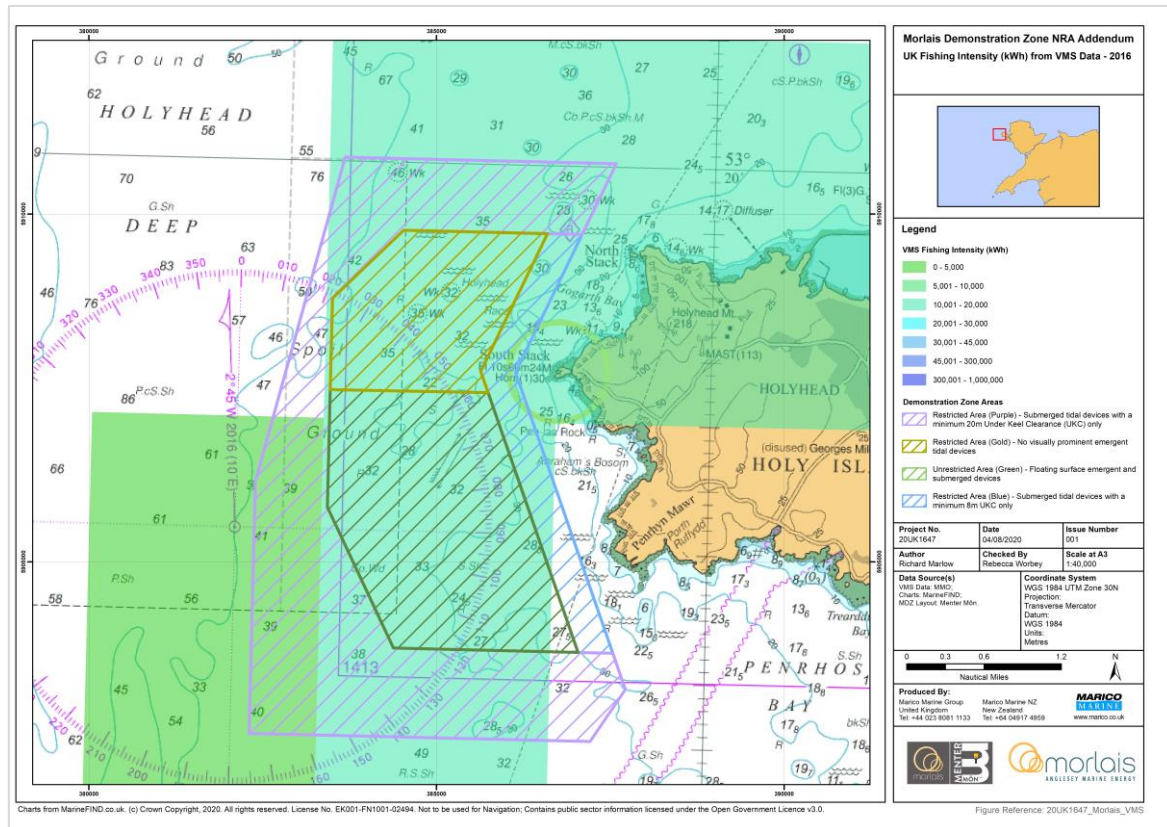
Figure 10: Fishing intensity (kWh) from VMS data - 2016

Fishing data from AIS and RADAR has been supplemented by fishing intensity data as recorded by the MMO using the Vessel Monitoring System (VMS). VMS is required on vessels greater than 15m Length Over-All (LOA) and effort is presented in kW hours (kWh) (calculated by multiplying the time associated with each VMS report in hours by the engine power of the vessel concerned at the time of the activity).

Fishing intensity from VMS in the vicinity of the MDZ is shown within **Figure 10**. Intensity is determined to be low at less than 20,000 kWh per year, particularly to the west of the zone where the intensity falls to <5,000 kWh per year.

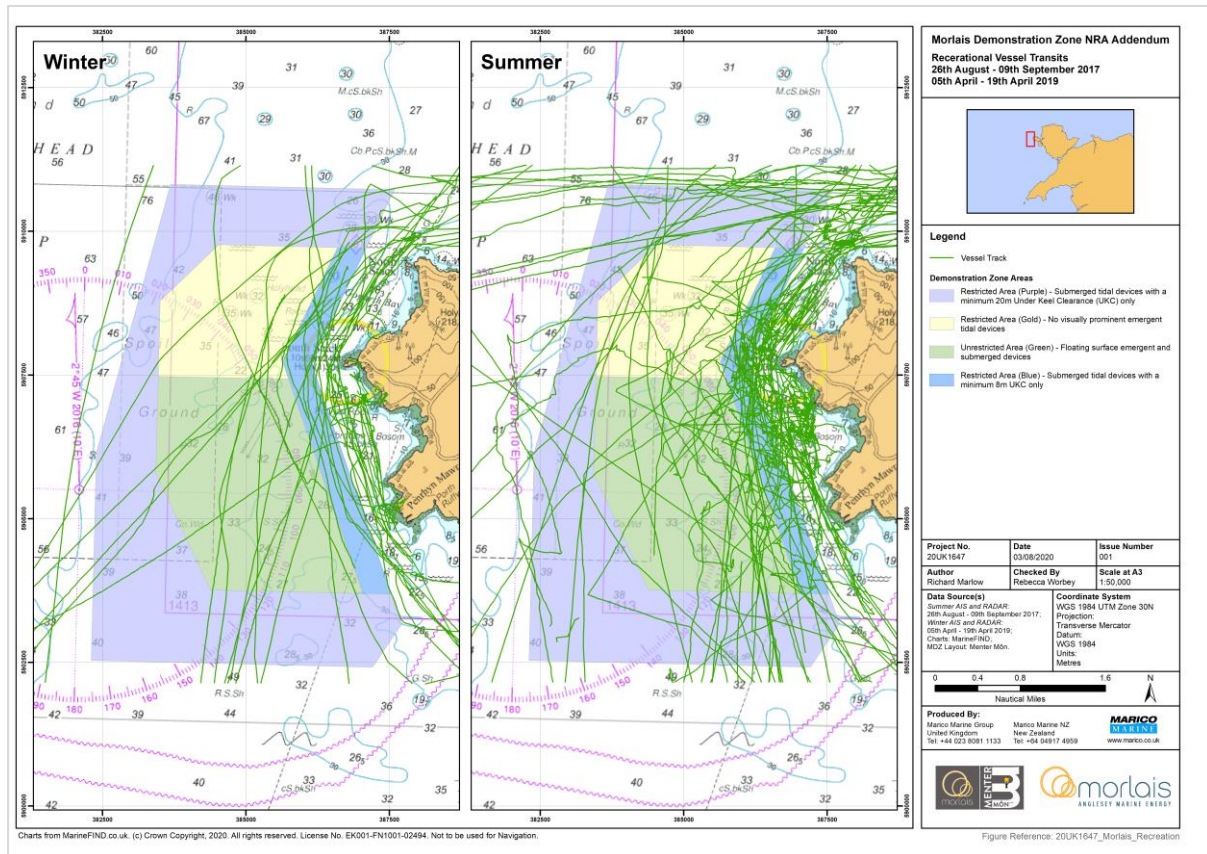
Figure 11: Recreational vessel tracks - summer 2017 and winter 2019

The tracks of recreational vessels are given within **Figure 11**. Most tracks are concentrated close to shore with small recreational craft, including yachts, primarily utilising the inshore passage to the east of the MDZ. The density of recreational vessels increases substantially in summer, as demonstrated by

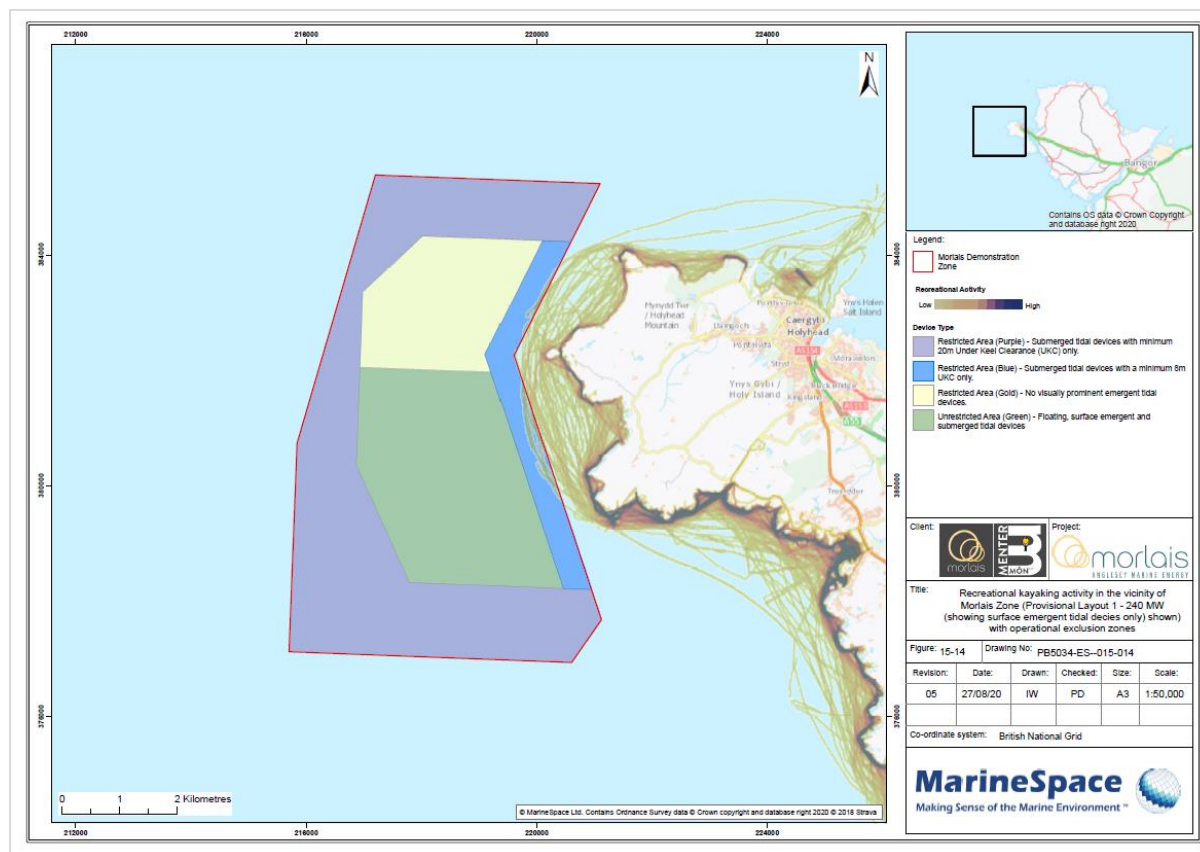
Figure 12: Sea Kayaking in vicinity of MDZ – Source: Marine Space

Activities of small un-powered recreational craft such as kayaks, canoes and small dinghies, similarly to sailing vessels, were reported in consultation to operate primarily close inshore within the inshore passage; *'the zonation of the MDZ as indicated in **Figure 1** should not itself impede passage around the Stacks by kayak' (Annex D)*. This is further corroborated by **Figure 12** which demonstrates kayak transits within the inshore route and close to shore.

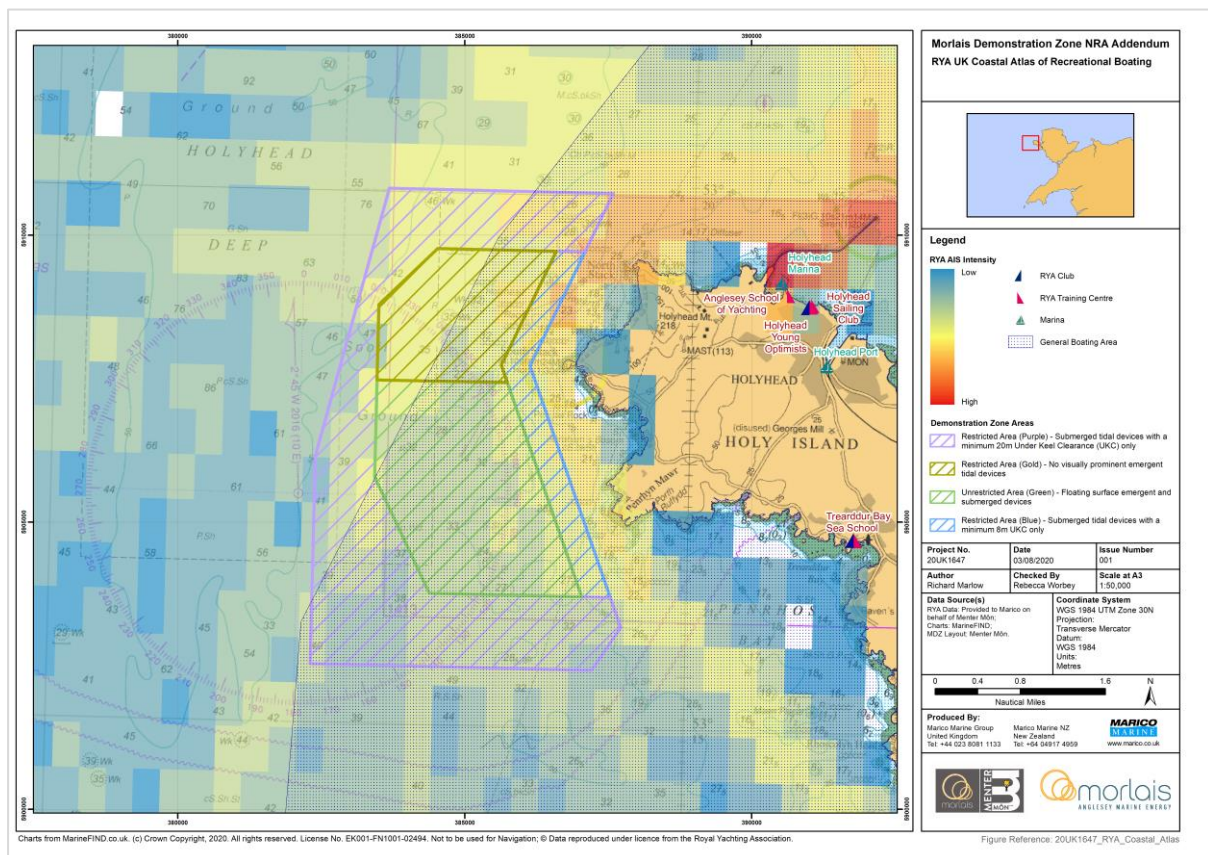
Figure 13: RYA Coastal Atlas of Recreational Boating – AIS mean of summer 2014 and summer 2017.

close inshore and in many estuaries are frequented by vessels that are small¹². General boating polygon areas are provided to compliment the AIS data. These polygons were generated utilising racing information from the RYA's previous dataset and information acquired from clubs and other sources in 2015 (see **Annex F**) replacing the 2012 dataset that 'cover large expanses of the coastline, and give less information than the AIS data as they indicate no intensity of use¹³ (**Figure 13**).

By comparison to the general boating areas indicated in **Figure 13**, those shown in **Annex F** coincide with the views expressed during stakeholder consultation and corroborates the determination from AIS, RADAR and local stakeholder consultation and the CA AIS data that utilisation of the western route is limited in comparison to that of the inshore areas.

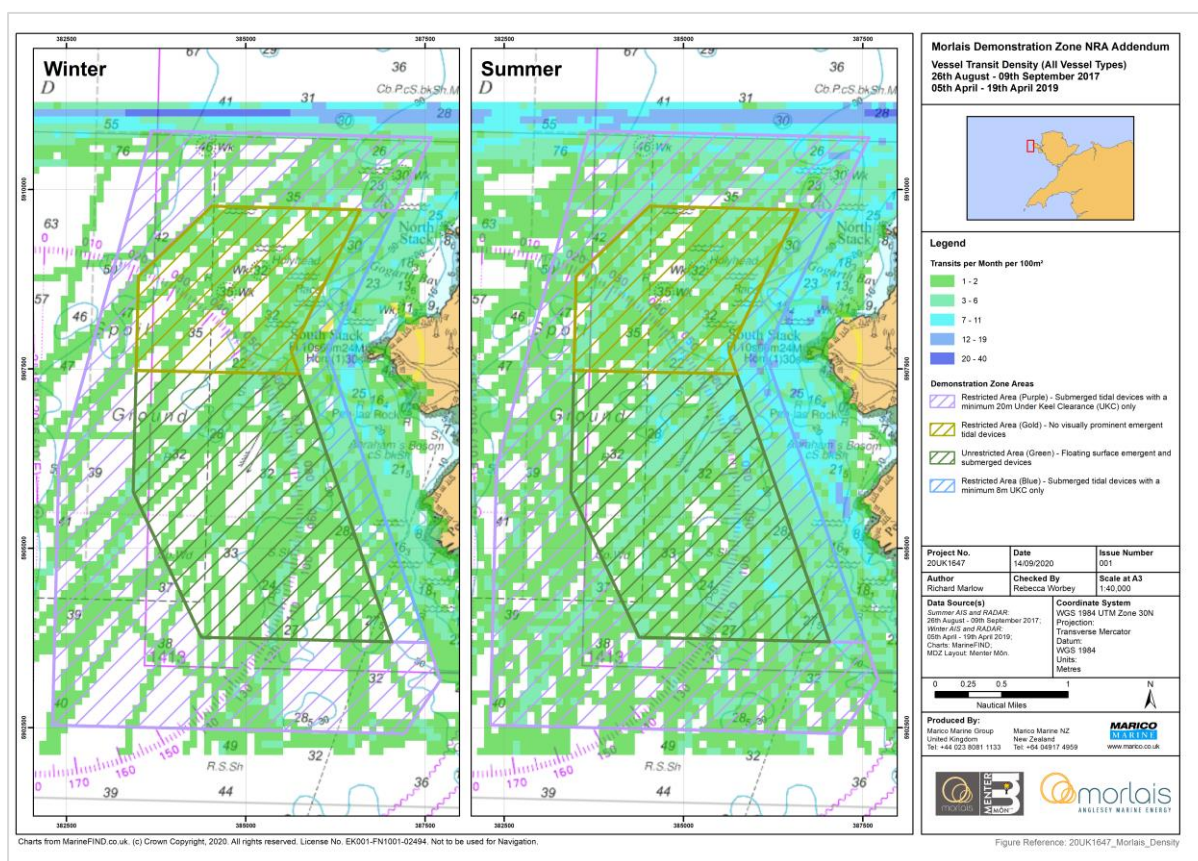
Figure 15: Density – All Vessels (Summer 2017 and Winter 2019) AIS & RADAR

Vessel transit density from the summer 2017 and winter 2019 RADAR and AIS surveys is represented within **Figure 15**. The inshore passage and ferry route to the north of the MDZ are clearly evident, demonstrating the highest traffic densities.

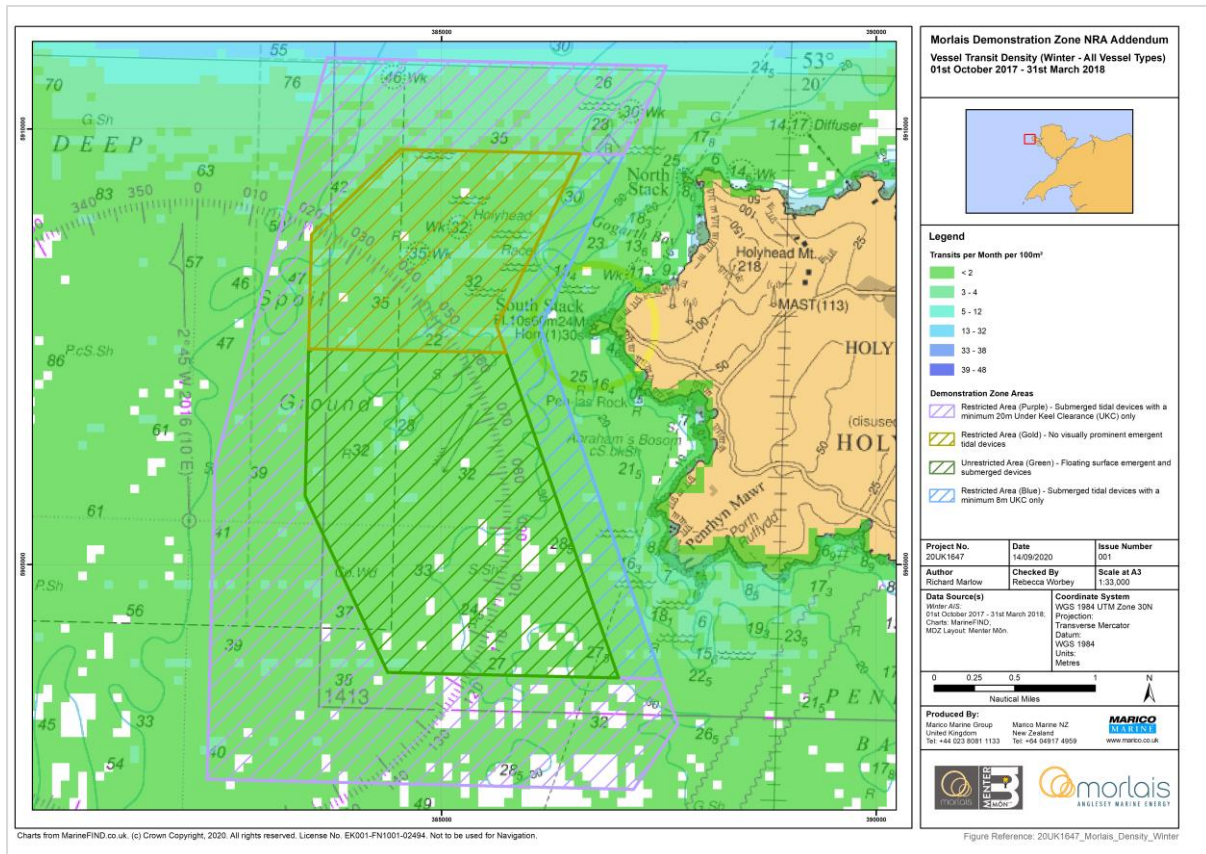
Figure 16: Density – All Vessels (01st October 2017 – 31st March 2018) AIS only.

Vessel transit density per month across the MDZ for the winter 2017 / 2018 period (from AIS only) is depicted in **Figure 16**. It is evident that traffic density of larger vessels carrying AIS is low within the MDZ during winter at <4 transits per month, with up to 12 transits per month occurring in the northern most 200m of the MDZ as a result of the ferry route.

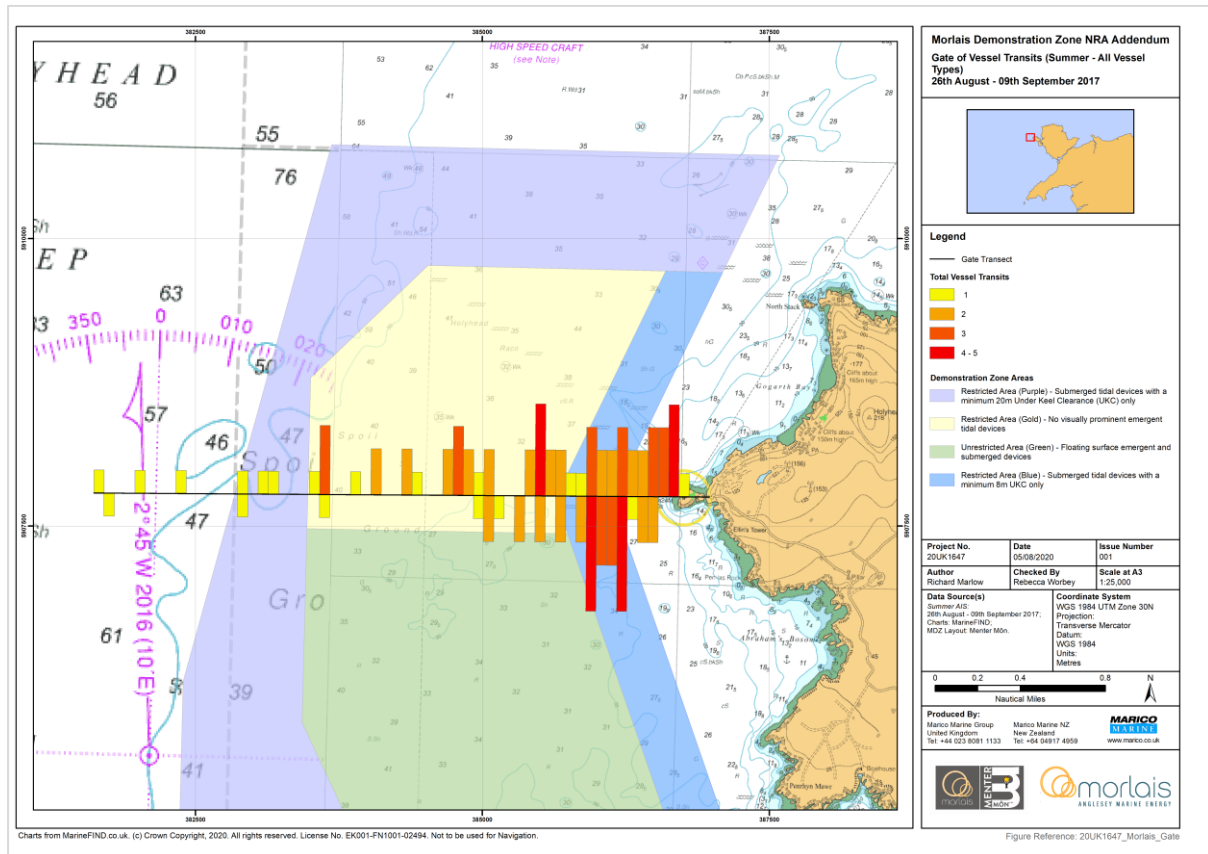
Figure 17: Transits through EW gate (July 2017)

For the purposes of gate analysis, the two-weeks summer 2017 radar and AIS data was utilised to represent the worst case. Gate analysis was conducted across an east- west trending gate through the centre of the proposed MDZ from South Stack as depicted within **Figure 17**.

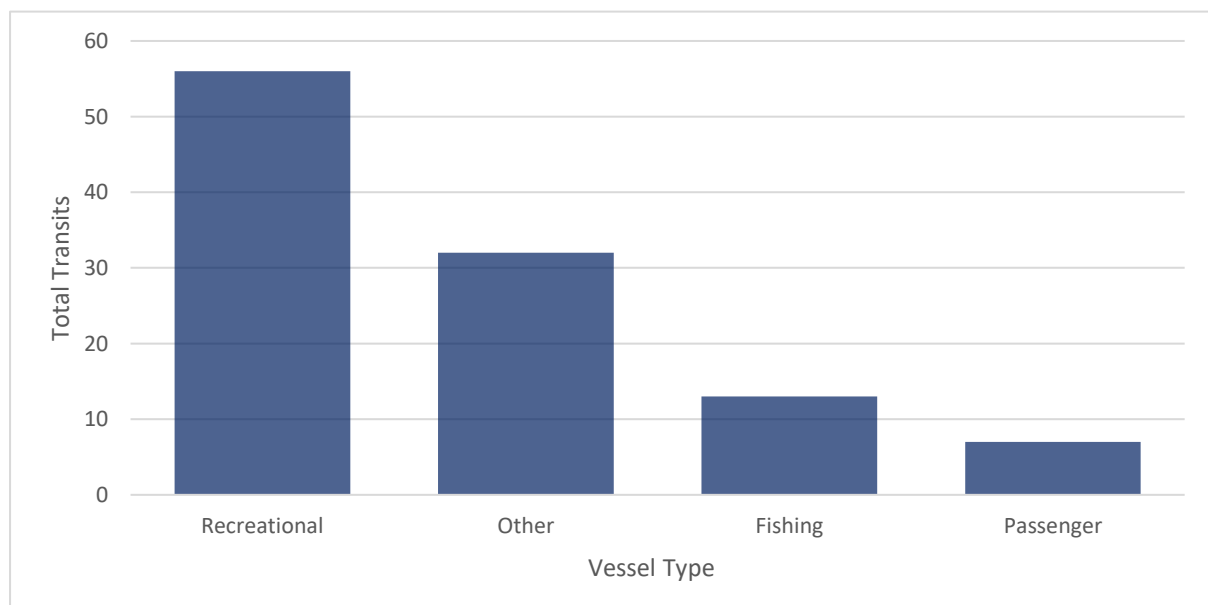
Figure 18: Frequency of transits by vessel type

In total 108 transits occurred through the gate. These transits have been analysed according to type in **Figure 18**. The most common vessel type to transit the gate was recreational, accounting for 52% of all transits, with other category vessels, fishing and passenger vessels accounting for 30%, 12% and 6% respectively. No cargo vessels or tankers transited through the gate during the two- week survey period.
