NAVIGATION RISK ASSESSMENT ADDENDUM– MORLAIS DEMONSTRATION ZONE

Report Number: 20UK1647
Issue: Issue 02
Date: 18-09-2020

Prepared for: Menter Môn

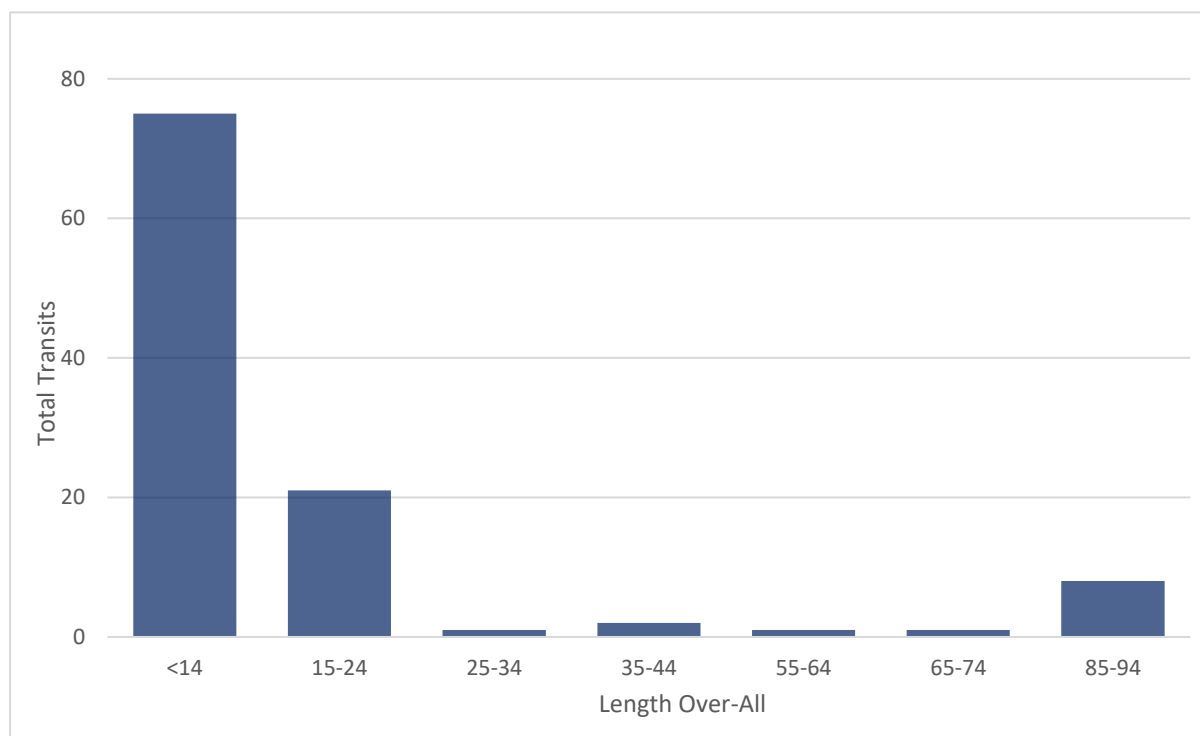
Figure 19: Vessel transits by LOA

Figure 19 demonstrates transits by LOA. The majority (69%) of vessels are less than 14m LOA reflecting the predominance of recreational vessels and other small craft such as; workboats, tugs and survey

vessels as represented by the 'other' classification. The increase in number of transits with a LOA >85m is a result of the presence of cruise ships *Hebridean Sky* (LOA 90m) and *Corinthian* (LOA 88m).

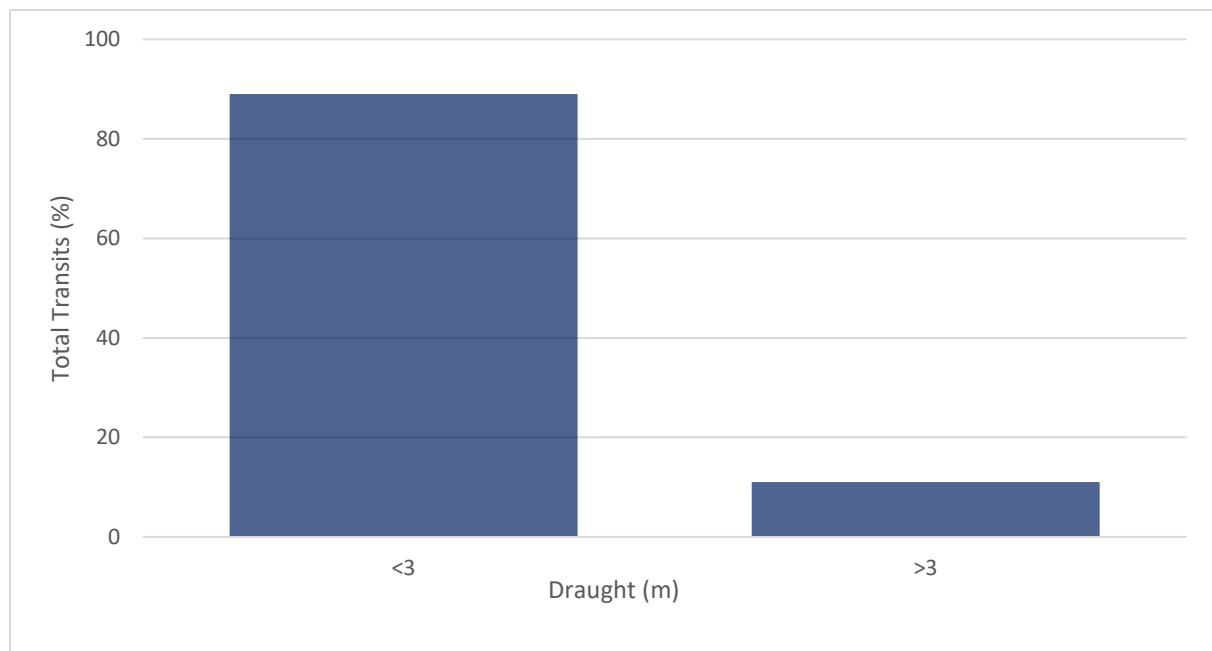
Figure 20: Vessel transits by Draught

Transits through the gates were analysed by draught within **Figure 20**. 89% of vessels that transited the gate have a draught of less than 3m. Twelve transits by 6 unique vessels with a draught >3m transited the gate during the two- week data period; of which; one was a buoy laying vessel (draught 4.6m), three were passenger vessels (draught 3.4 to 4.2m), one a survey vessel (3.6m), and one a fishing vessel (draught 3.5m).

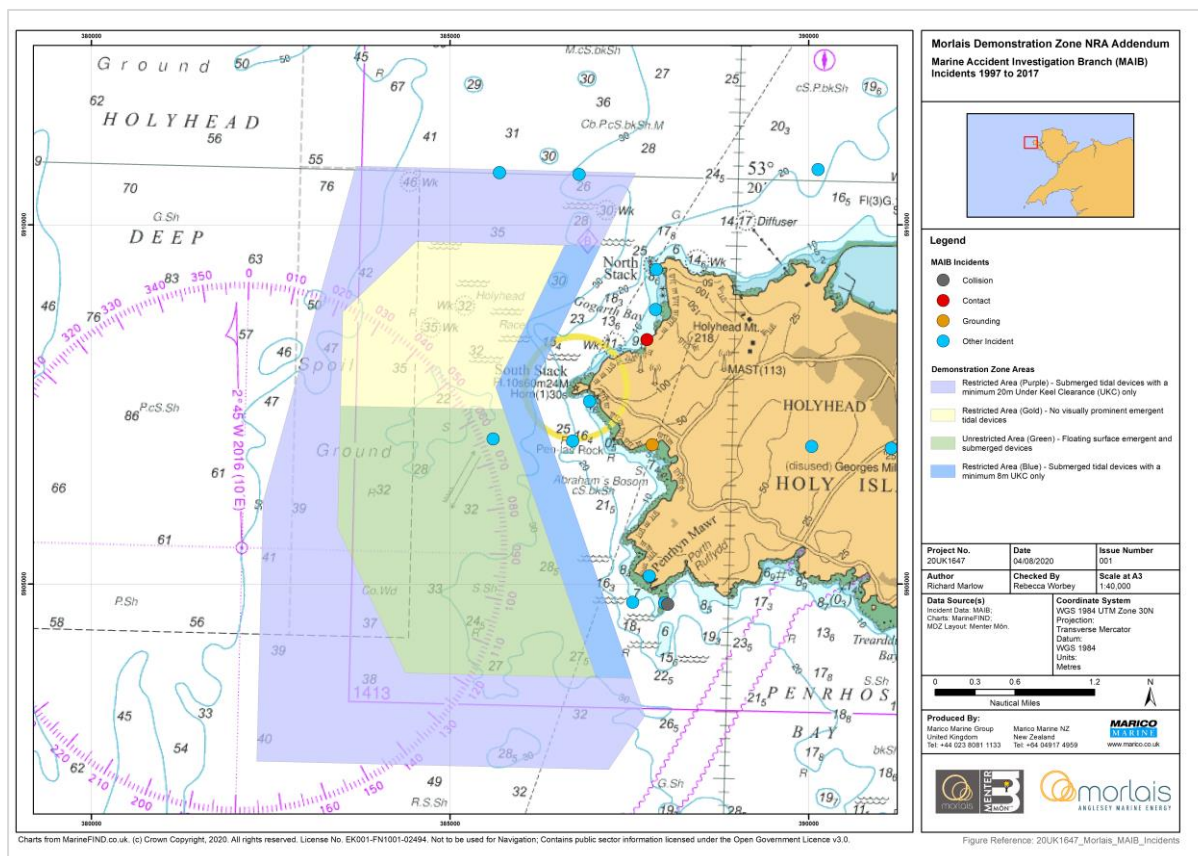
Figure 21: MAIB incidents 1997 – 2017

Figure 21 shows marine accidents investigated by the MAIB in proximity to the MDZ between 1997 and 2017. There were a total of 14 separate MAIB incidents recorded within 1nm, of which, one is considered navigationally significant; a collision between a recreational dive RHIB and a fishing vessel on 31st August 2015. The incident was described by the MAIB as follows:

To support the hazard identification and analysis of the frequency of incidents, a review of the Marine Accident Investigation Bureau (MAIB) incident database was conducted. Historic trends and accident rates within the vicinity of the MDZ and geographic areas of high-risk were analysed and are represented within **Figure 21**.

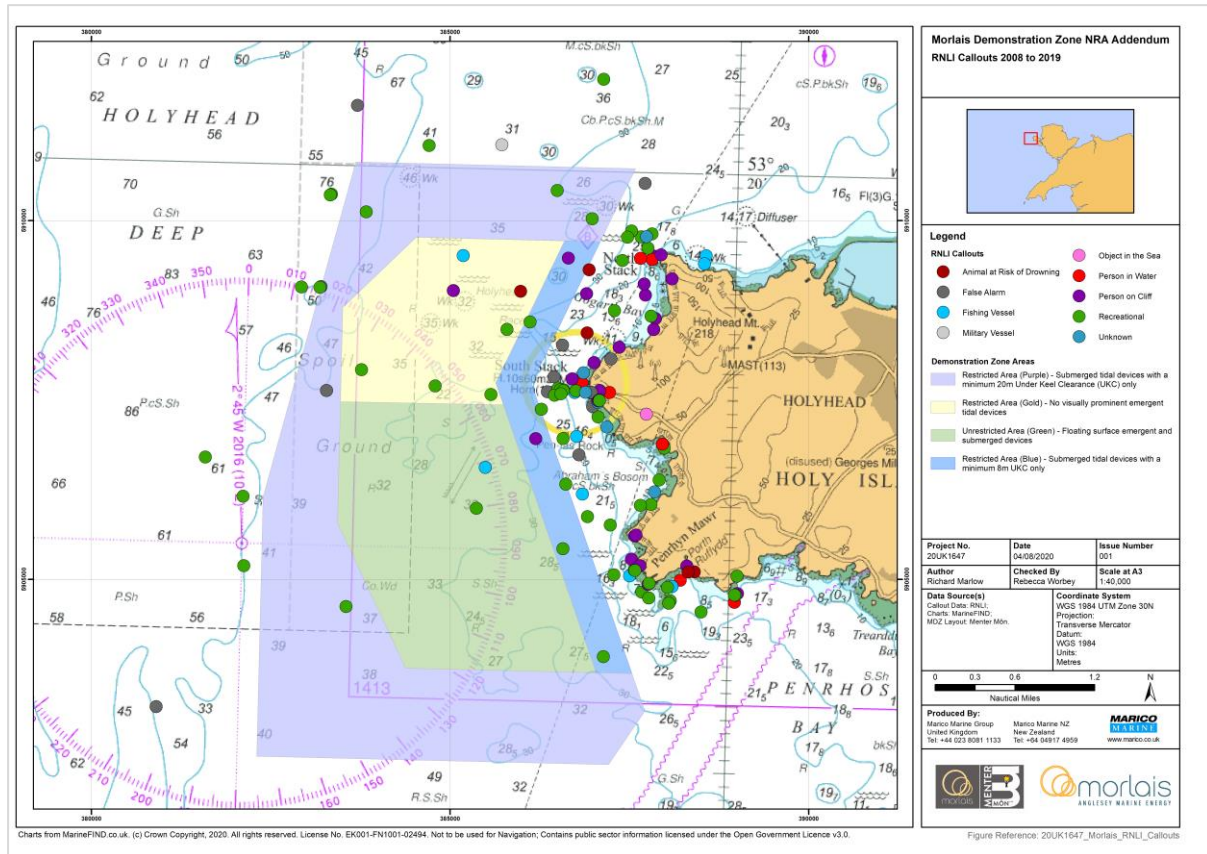
Figure 22: RNLI Callouts within 1nm – 2008 to 2016.

RNLI callouts are shown within **Figure 22**. A total of 125 callouts occurred within 1nm of the MDZ, or approximately 16 per year. Of these, 56 callouts (45%) involved recreational vessels, and 10 or 8% involved fishing vessels. 9% of callouts were in response to a person in the water and 25% were in response to persons stranded on the adjacent beach cliffs. One callout was in response to a military vessel that experienced a machinery failure. 23% of callouts reported machinery failure as the cause for assistance. 50% of callouts were answered by Holyhead Lifeboat station and 50% by Trearddur Bay Lifeboat station.

A total of 21 callouts occurred within the MDZ, of which, 12 or 57% were in response to recreational vessels. 50% of callouts within the MDZ occurred in 2008 and 2012, the busiest years for callouts. There were 2 callouts per year between 2014 and 2016 within the MDZ.

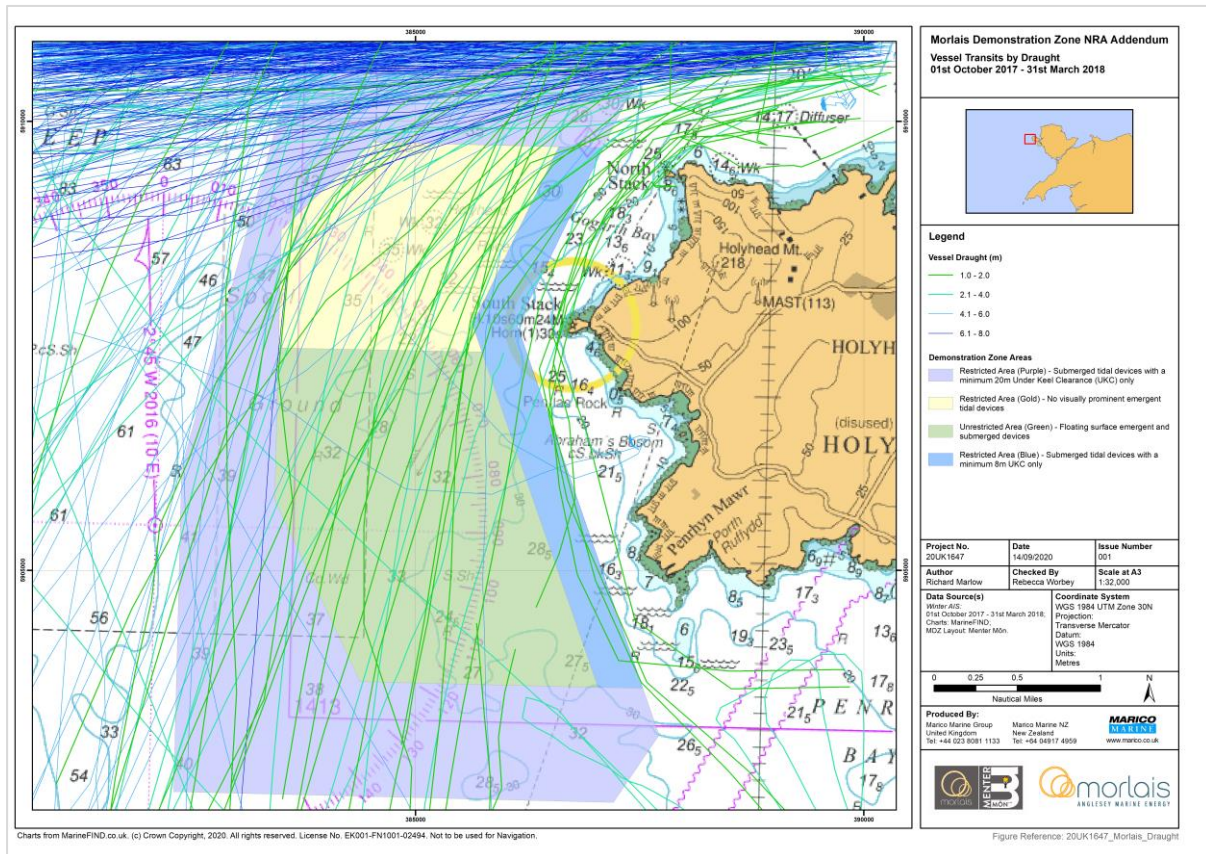
Figure 24: Transits by draught (AIS only) - 1st October 2017 and 31st March 2018

Vessel transits through the MDZ by draught between 1st October 2017 and 31st March 2018 are given in **Figure 24**.

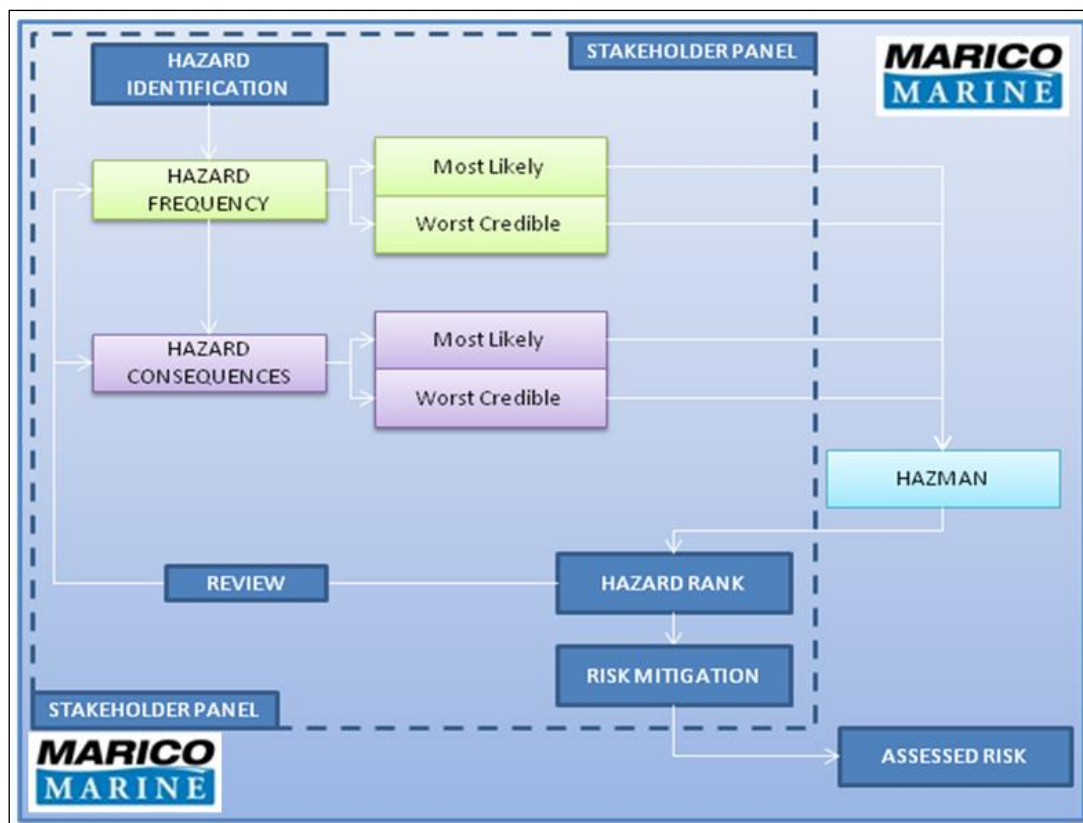
Figure 25: Marico hazard identification and risk assessment process.

The results of the analysis and consultation with stakeholders would be used to identify hazards associated with the project. These hazards were scored for their likelihood and consequence and a ranked hazard list of the greatest hazards was produced using our risk management software Hazman (Figure 25). Additional mitigation has been identified and recommended to ensure the risks are As Low As Reasonably Practicable (ALARP).

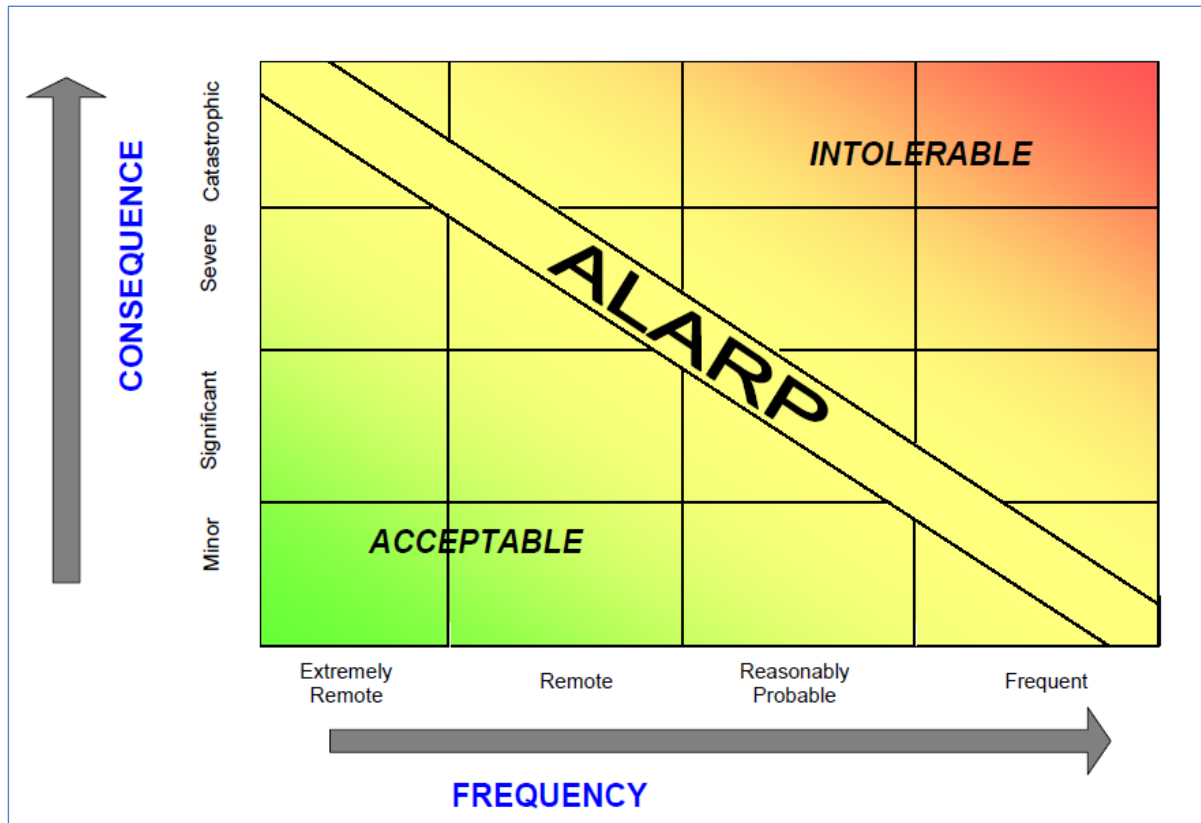
General risk matrix.

The combination of consequence and frequency of occurrence of a hazard is combined using a risk matrix which enables hazards to be ranked and a risk score assigned. The resulting scale can be divided into three general categories:

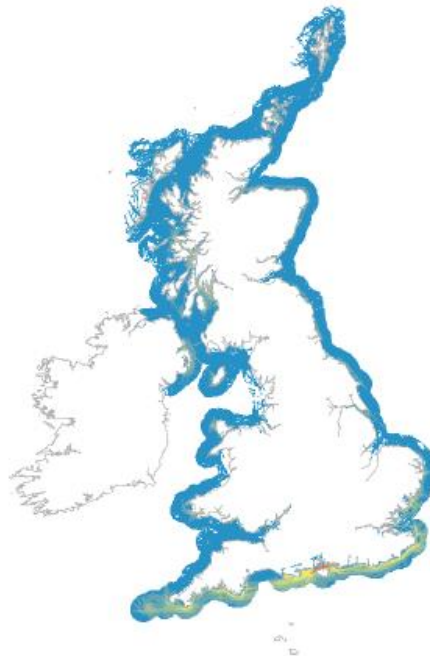
Figure 4 UK AIS with a standard scale

*Coastal Atlas AIS - Standard and Log10 Scaling Source: RYA UK Coastal Atlas of
Recreational Boating 2.1 User Guide*

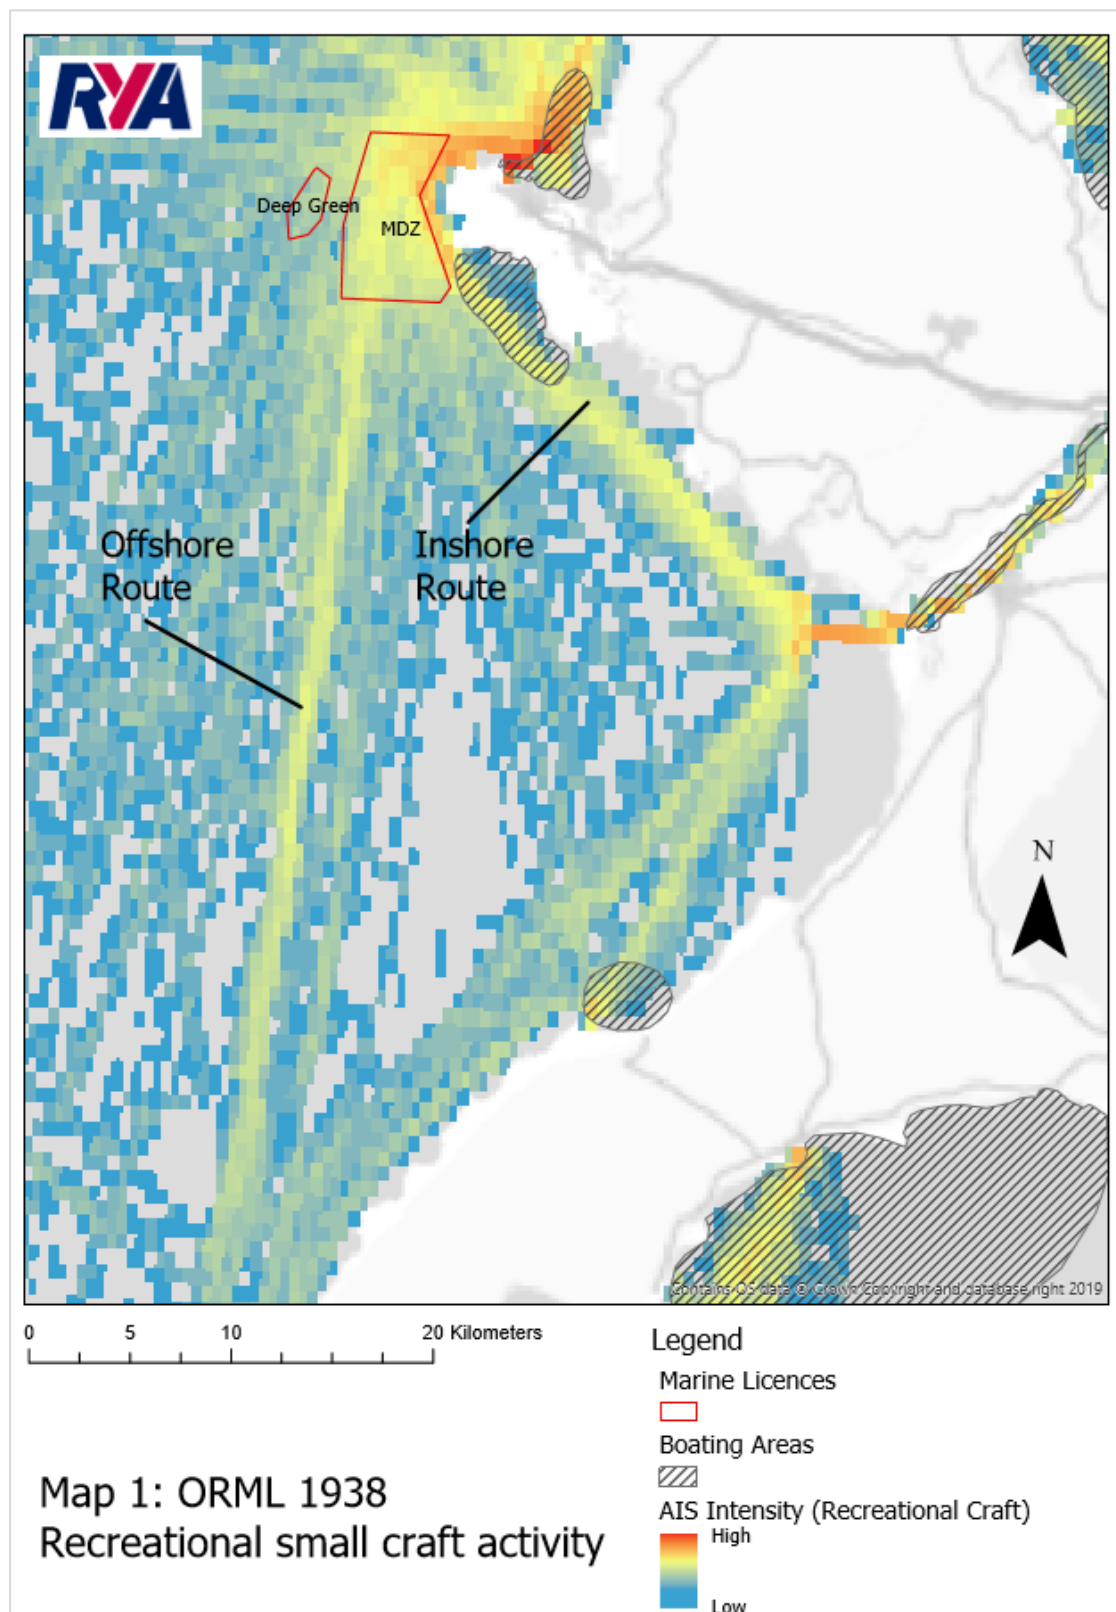
RYA Recreational Small Craft Activity in Vicinity of MDZ –Log10 AIS– Source RYA March 2020
