# **Old Colwyn Coastal Defence and Active Travel**

Flood Consequence Assessment (FCA)

July 2020

**Document reference:** 415437-MMD-00-XX-RP-N-1720

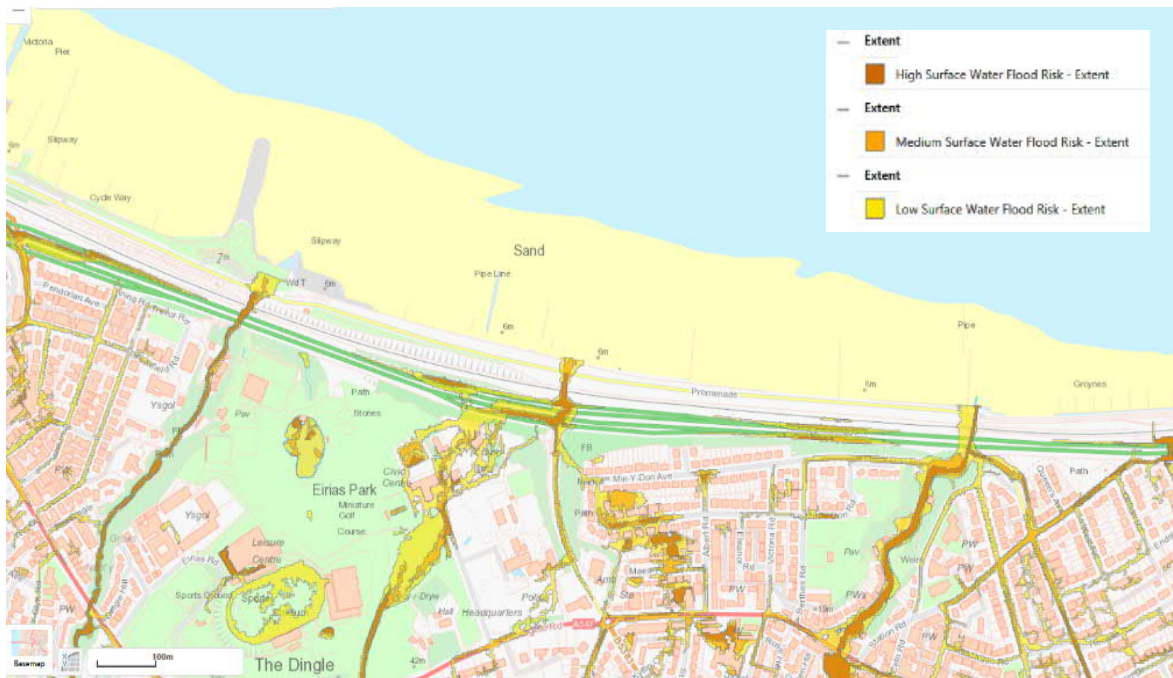
**Figure 2.1: Colwyn Bay Surface Water Flood Risk**

Indicated in the Welsh Government Development Advice Map (Figure 2.1), the site is located within Flood Zone C2. This classification indicates the areas is at flood risk of a 1 in 1000-year return period (RP) within any given year.

The Environment Agency's 'Risk of Flooding from Surface Water' online maps shows that there is some surface water flood risk in the area of interest (Figure 2.1). However, the majority of these surface water sources are culverted under the promenade before discharging to the beach. In general, surface water runoff from the promenade and highway area flows into outfalls and directly to the foreshore and into the sea. Additionally, for the Scheme, the promenade will be at a higher elevation at the retainer wall and will have a decreasing profile of 1:40 towards the top of the rock revetment, so that any surface water on the promenade will drain out towards the sea. Furthermore, kerbside drains, along the highway, will direct surface water flooding through outfalls under the promenade out to sea as well.

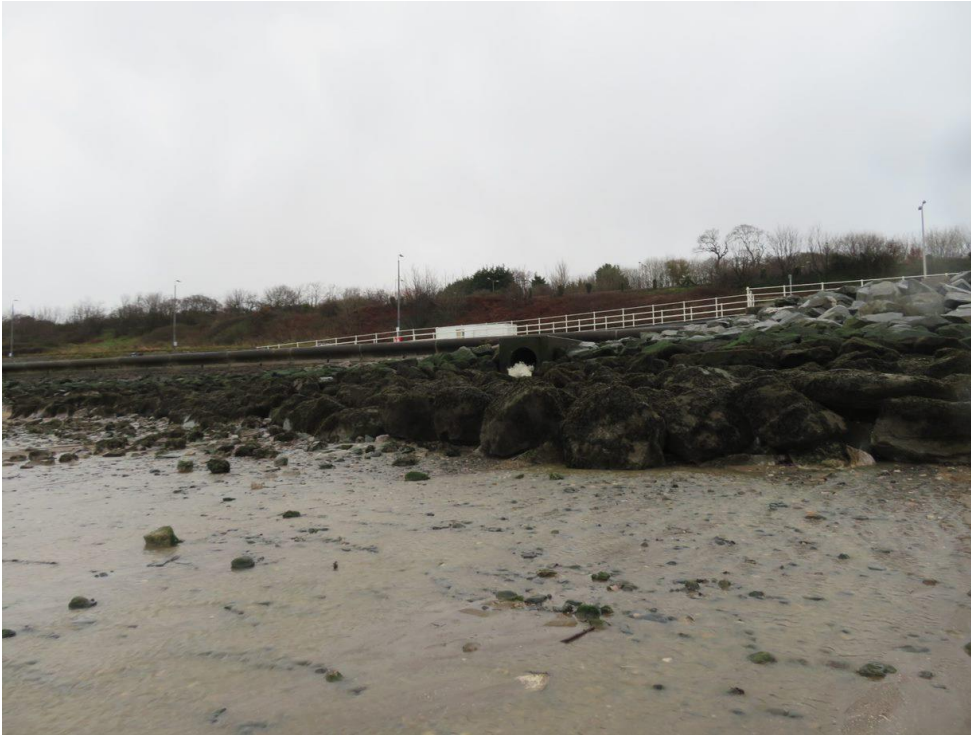
**Photo 2.1: Profile 1**

Photos of the structures and the beach at those profiles are shown in Photo 2.1 to Photo 2.4 below.
