TYPICAL VERTICAL DRILL AND GROUT REPAIR SECTION

TYPICAL HORIZONTAL DRILL AND GROUT REPAIR SECTION

TYPICAL ELEVATION OF PROPOSED HARBOUR WALL

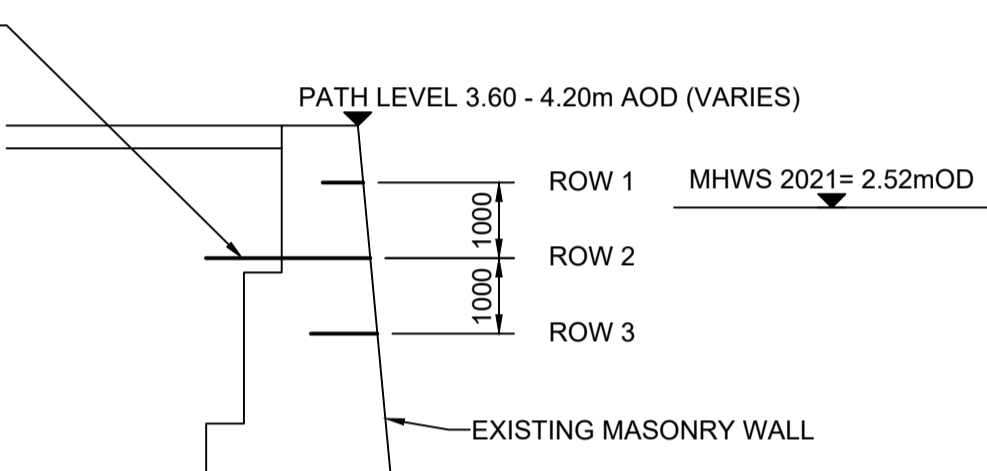
1. 35mm DIA HOLES AT 2m HORIZONTAL CENTRES AND 1m VERTICAL CENTRES, DIAMOND STAGGERED PATTERN OVER ENTIRE WALL FACE. DRILL HOLES TO BE PRESENT BETWEEN EXISTING MASONRY JOINTS AND INTO THE MORTAR. TOP AND BOTTOM ROW TO FILL VOIDS WITHIN WALL AND MIDDLE ROW TO FILL VOIDS BEHIND WALL - SEE DETAIL 'D' BELOW

1:100

2. 17mm PLASTIC TUBES TO BE INSERTED INTO DRILL HOLES AND INJECTED WITH 1:2 LIME / CEMENT GROUT TO STABILISE WALL AND GROUND

35mm DIA HOLES AT 2m HORIZONTAL CENTRES AND 1m VERTICAL CENTRES, DIAMOND STAGGERED PATTERN OVER ENTIRE WALL FACE. DRILL HOLES TO BE PRESENT BETWEEN EXISTING MASONRY JOINTS AND INTO THE MORTAR. TOP AND BOTTOM ROW TO FILL VOIDS WITHIN WALL AND MIDDLE ROW TO FILL VOIDS BEHIND WALL - SEE DETAIL 'C' ABOVE
