**HaskoningDHV UK Ltd.  
Industry & Buildings**

To: Emma Collett (Isle of Anglesey County Council)  
From: Neil Chamberlain and Victoria Cooper (Royal HaskoningDHV)  
Date: 11 March 2020  
Copy: Jamie Gardner (Royal HaskoningDHV), Sarah Marjoram (Royal HaskoningDHV)  
Our reference: PB9014-RHD-BW-XX-FN-C-0136  
Classification: Project related

**Subject: Holyhead Breakwater Refurbishment Options and Impacts to Heritage Significance**

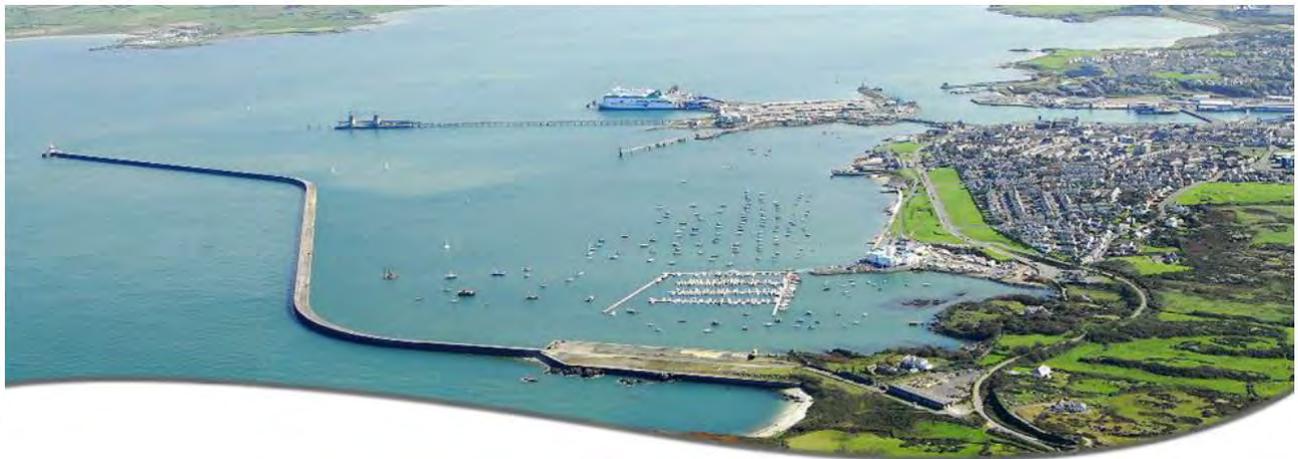
An aerial view of the Holyhead harbour is shown in Figure 1.

*Figure 1: Aerial view of Holyhead harbour (© Holyhead Port Authority)*

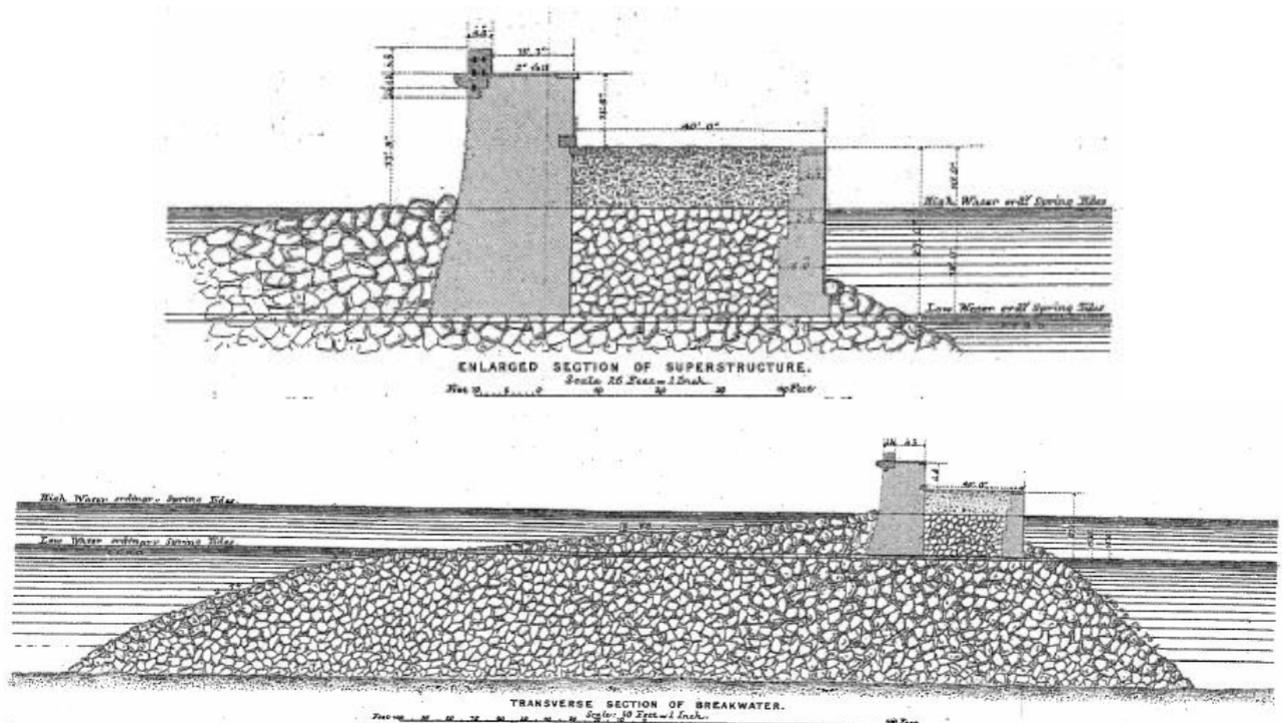
The breakwater is typical of one built during the Victorian period and consists of a mound of rubble stone (hereon known as 'rubble mound'), upon which is erected a substantial stone superstructure (hereon known as the 'superstructure'), the end of the breakwater being terminated by a head, on which sits a Grade II Listed lighthouse. A cross-section of the breakwater, taken from Hayter's Paper, is reproduced in Figure 2.

Figure 2: As built cross-section through Breakwater (Hayter, 1876)

The construction of the rubble mound was formed by dumping a large quantity of rock and using the natural processes of the sea this rock was moved around by the action of waves. The rock was then regularly replenished until the sea shaped the rubble mound to the form required. The completed rubble mound contained some 7 million tonnes of quartzite that was quarried from the nearby Holyhead Mountain.

Once the rubble mound had been formed, and consolidated by the natural processes of the sea, the superstructure was built along the rubble mound crest. The superstructure consisted of a solid sea wall of masonry, built principally of larger quartz rock (individual units weighing up to 15ton), again quarried from the Holyhead Mountain, and set in lias-lime mortar. The foundation of the superstructure approximates to

0.0mCD and was placed following the excavation of loose rock along the crest of the mound. The top of the sea wall is at 12mCD which is further increased to 13.2mCD by the use of a parapet structure. The sea wall supports a 12.2m wide promenade road-way which is also supported by a lee side retaining wall, which is founded at 0.0mCD. The promenade and the top of the lee wall are set at a level of 8.5mCD. The space between the sea wall, lee wall and promenade surface is filled with a layer of stone placed on a loose stone core material. The plinths, cornices, parapets, paving, coping and other ashlar works are constructed from Anglesey limestone.

The head at the seaward end of the breakwater is a structure 45.7m (150ft) long and 15.2m (50ft) wide. It is founded on the rubble mound at -5.8mCD and is mostly built of ashlar masonry using stone that is partly Runcorn sandstone and partly Anglesey limestone set dry below MLWS or Anglesey limestone set in mortar above MLWS.

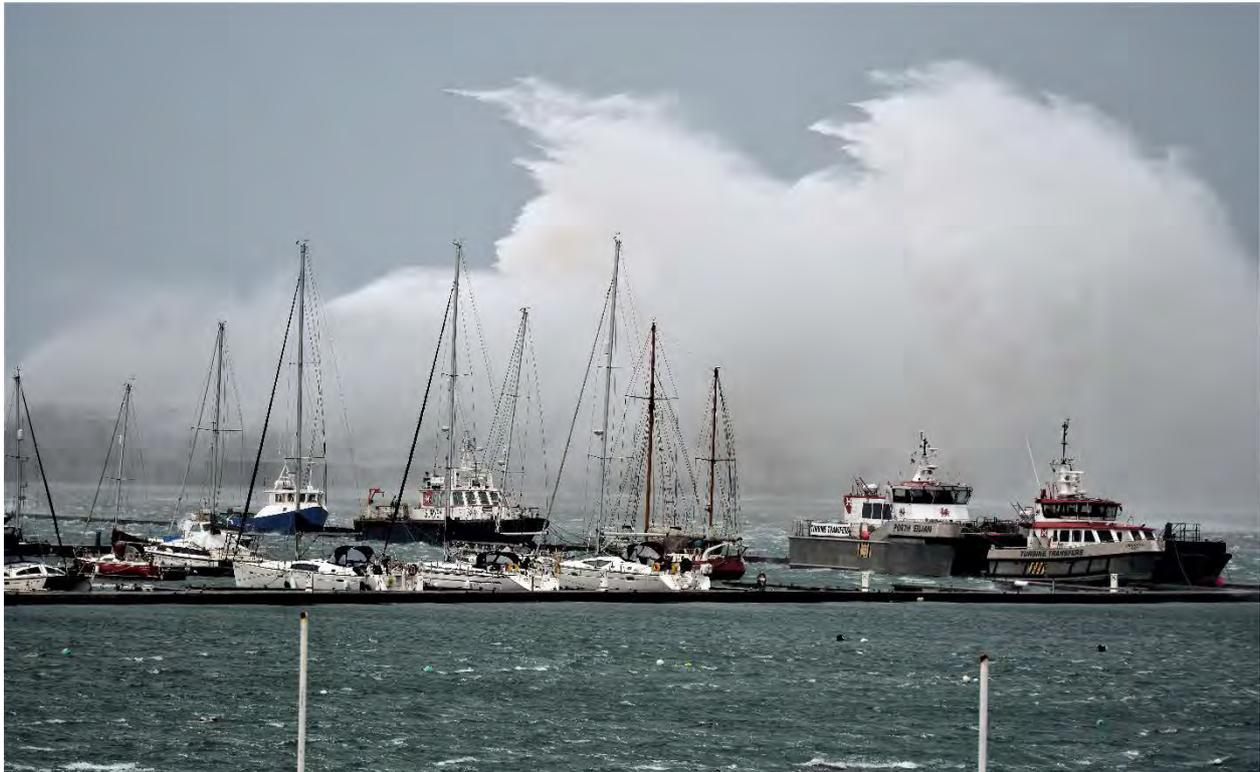
The violent action of the waves on the seaward side of the Holyhead Breakwater can be seen on any windy day when sheets of water are thrown up and over the superstructure and land on the structure behind. Under extreme storm conditions this phenomenon looks very spectacular but is extremely dangerous for anyone on the breakwater and can lead to significant damage to the superstructure. The photograph below shows the water being thrown vertically and then over Holyhead Breakwater during Storm Doris on 23<sup>rd</sup> February 2017.

Figure 3: Storm Doris (23 February 2017) (Copyright DJ Photography)

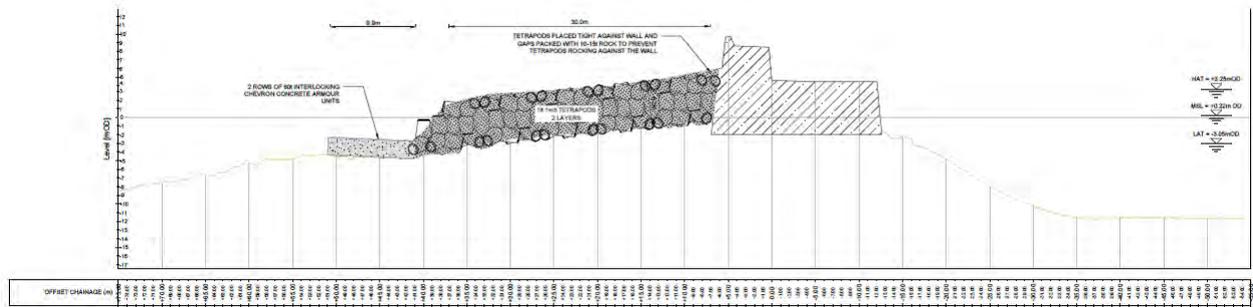
Due to the aggressive nature of the wave climate approaching Holyhead under storm conditions the size ( $18.1\text{m}^3$ ) and weight (42t) of the concrete armour units is significant. Although every effort has been made to minimise the height of the proposed Tetrapod scheme, which has to be formed from 2 layers, it will stand approximately 5.2m high above the existing rubble mound and therefore, it is unfortunate that it will hide some of the existing seaward masonry superstructure from view. A typical cross section of the Tetrapod solution is presented below in Figure 4 which shows that to hold the 2 layers of Tetrapods in place, a double line of 60t chevrons is also required.

Figure 4: Typical cross section through proposed Tetrapod solution for the seaward side.

grounds because the iconic masonry superstructure would be hidden from view. Therefore, a compromise has been developed where large concrete armour units (2 layers of Tetrapods) are placed on the rubble mound to hold the top portion of the rubble mound in place (30m) whilst also trying to minimise the violent action of the waves crashing into the listed masonry superstructure.

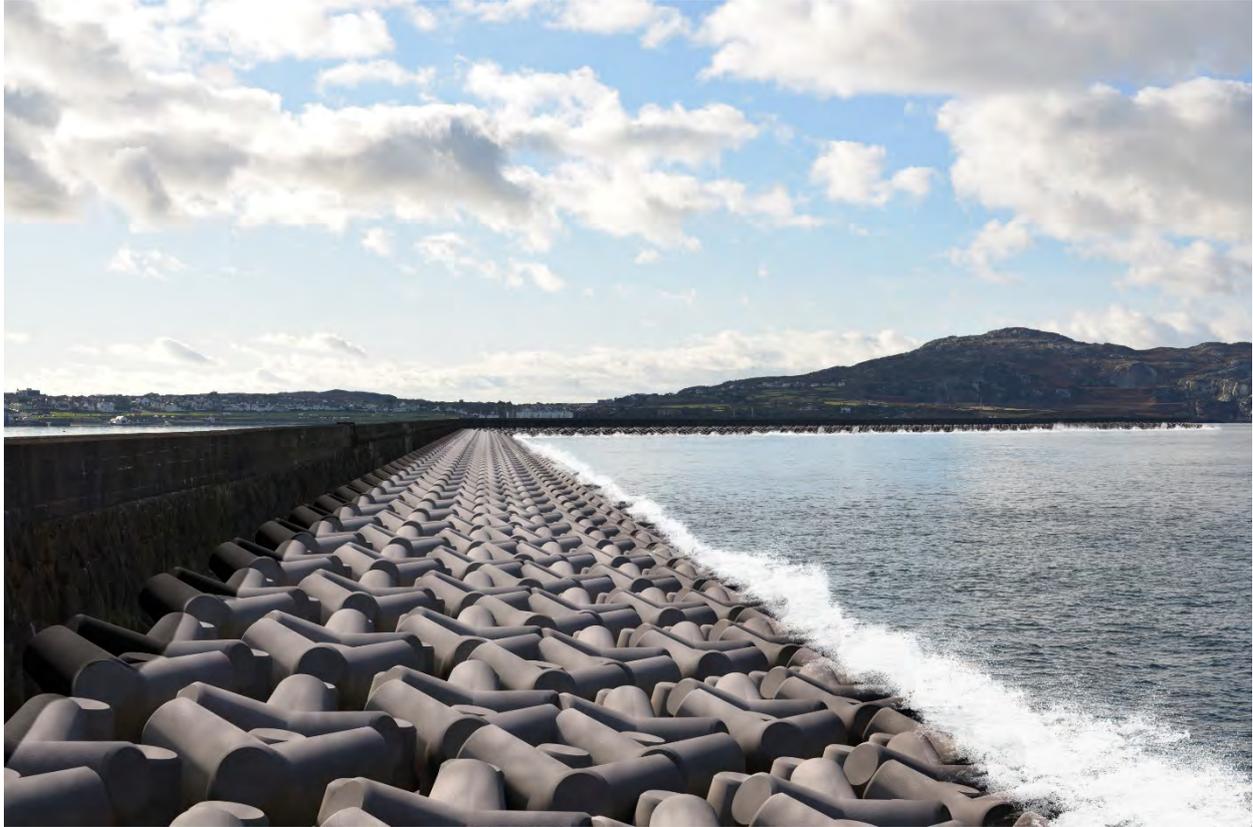
A draft indicative view of the tetrapod solution is shown in Figure 5.

Figure 5: Draft view of tetrapod solution (DRaW (UK) Ltd)

This image demonstrates that there will be a noticeable visual impact on the breakwater and, consequently, a change to the setting of these heritage assets which is anticipated to have an adverse effect upon their significance. However, from the breakwater itself, the tetrapods along the seaward side would only be visible from the upper promenade.

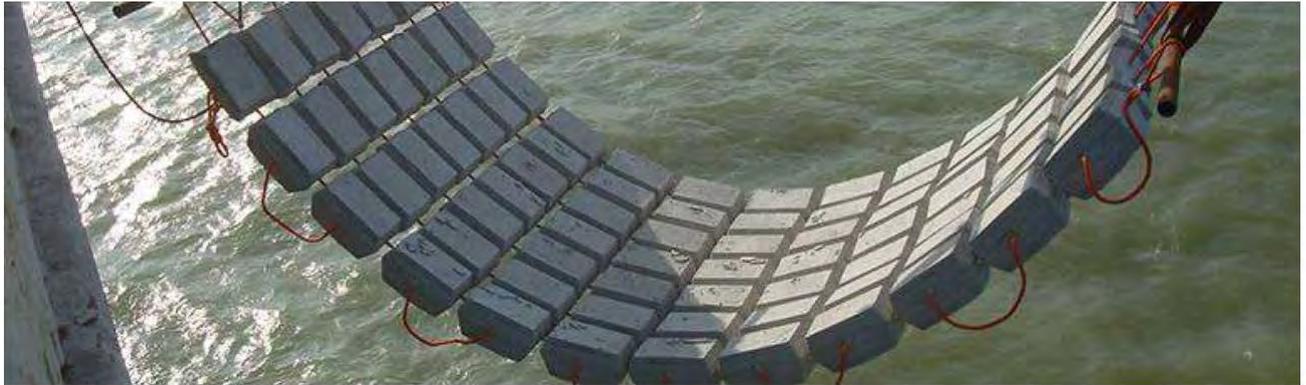
On the leeward side the preferred solution is to place an articulated concrete block mattress (ACBM) on to the existing rubble mound profile, see Figure 6.

Figure 6: Example of an articulated concrete block mattress (ACBM), (Credit: Maccaferri)

This ACBM would be located below the water surface and consequently, is not anticipated to result in any settings impacts. As this is a relatively easy solution, which can be undertaken as and when required without the need for specialised marine construction equipment, and could also be undertaken from the breakwater itself, it is possible that this might be progressed by Stena as part of their ongoing maintenance activity, rather than forming part of the final proposed refurbishment project.
