# St Julian's Viaduct

## Appendix F - Saltmarsh Mitigation, Reinstatement and Monitoring Plan – (SMRMP)

| DOCUMENT INFORMATION | | | |
|---|---|---|---|
| Project | St Julians Viaduct – Scour Protection Works | | |
| Title | Appendix F - Saltmarsh Mitigation, Reinstatement and Monitoring Plan | | |

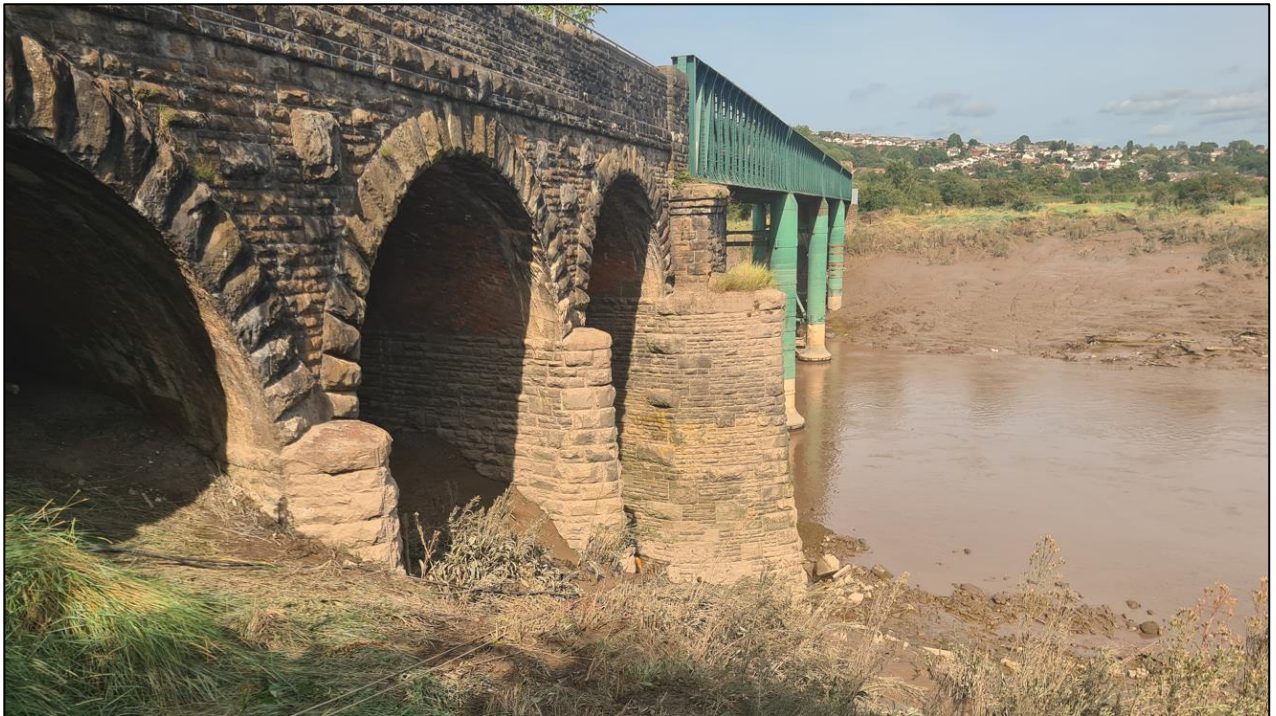
- 1.2.1 The site is located north of the M4 Corridor, spanning the river Usk, North to South, with the town of Caerleon further north inland.
- 1.2.2 St Julian's is an 8-span viaduct carrying two lines of the HNL1 over the River Usk. Four spans (spans 2 to 5) are of metallic construction which are supported by three cast iron piers whilst the remaining spans (spans 1 and 6-8) are of masonry arch construction. The structure is on a slight skew to the watercourse with the overall span being 120m and an average width of 8.5m

*Figure 2: St Julian's Viaduct (Southern Shore – receding tide).*

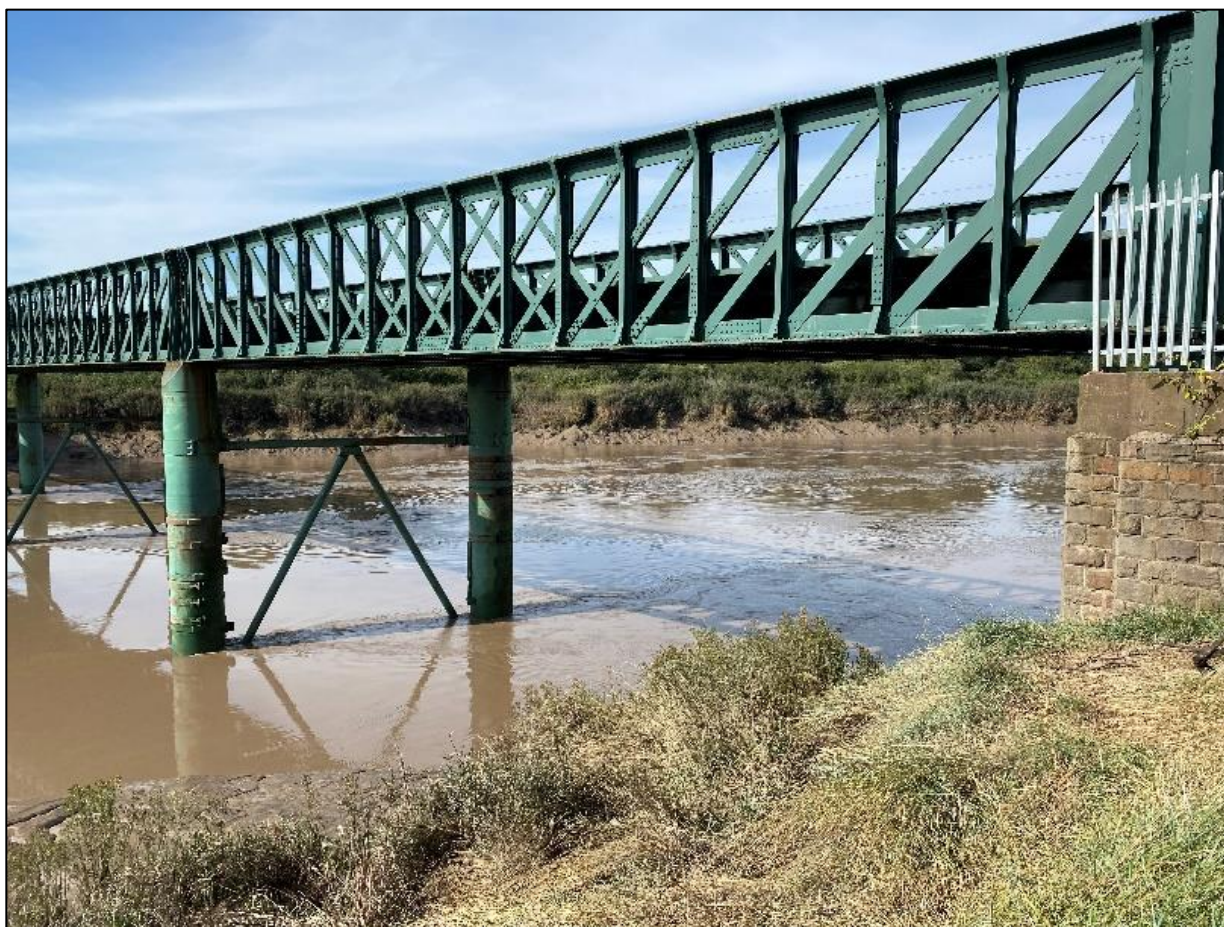
2.1.3 The northern access is to the eastern side of the viaduct via improved grassland leading to the structure and River Usk. The vast majority of habitat within the works footprint is soft intertidal mud.

2.1.4 A sparse cover of Scattered saltmarsh plants (Sea Purslane) is present to the upper marsh bordering the grassland extending approximately 1metre towards LW west and east of the arch. 1-2 isolated plants are present beneath the arch. Sea couch grass is present around the uppermost arch.

*Figure 3: Saltmarsh extent to northern access*

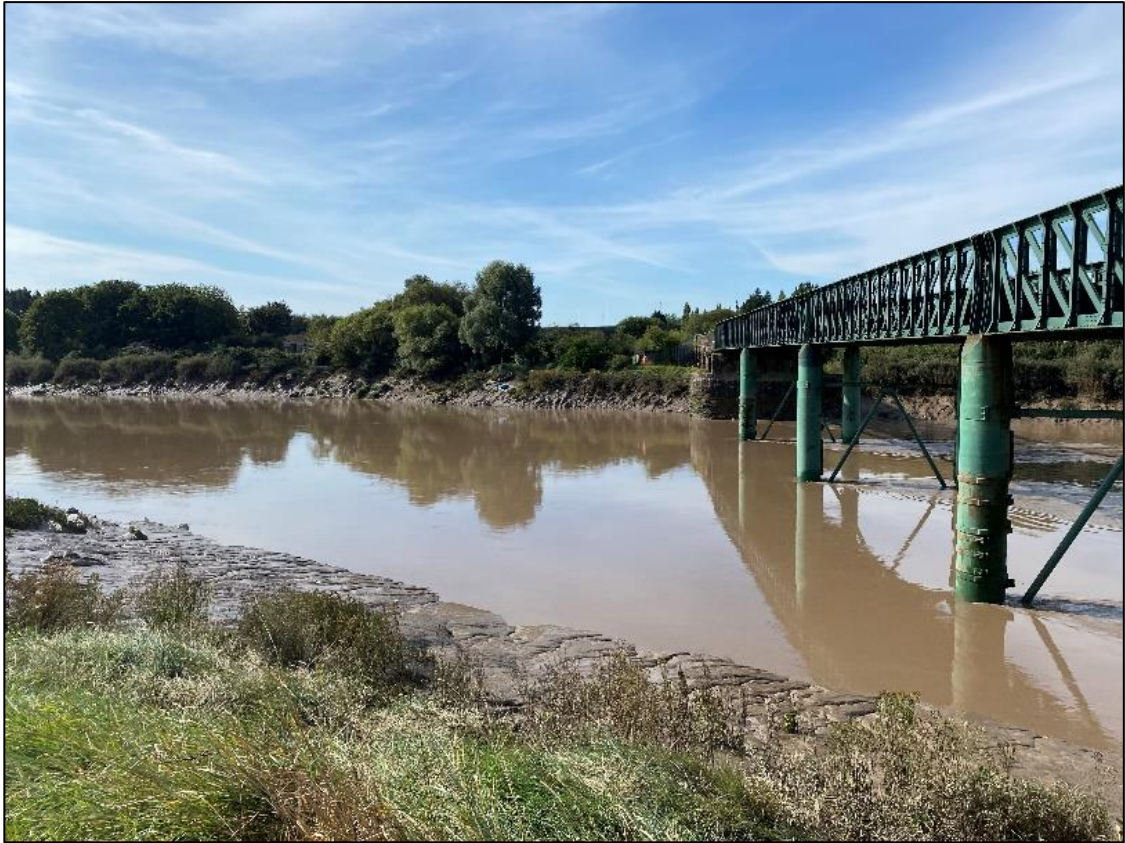
2.1.5 The saltmarsh is accessible to livestock (cattle). A narrow strip of saltmarsh (Scattered plants) extends both east and west of the viaduct.

*Figure 4: Saltmarsh to north-east*

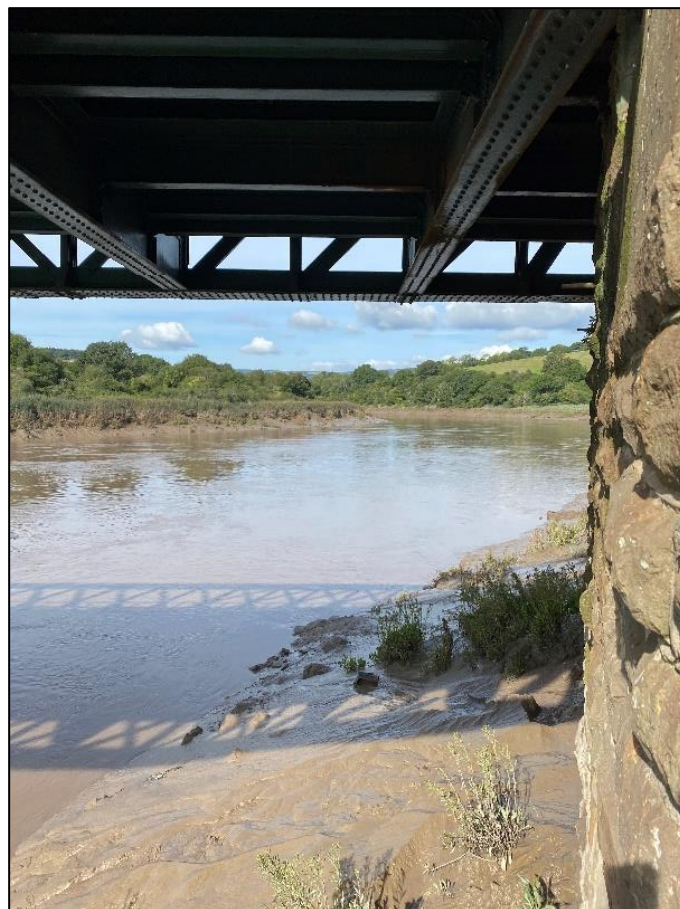
*Figure 5: Sparse plant cover beneath arch*

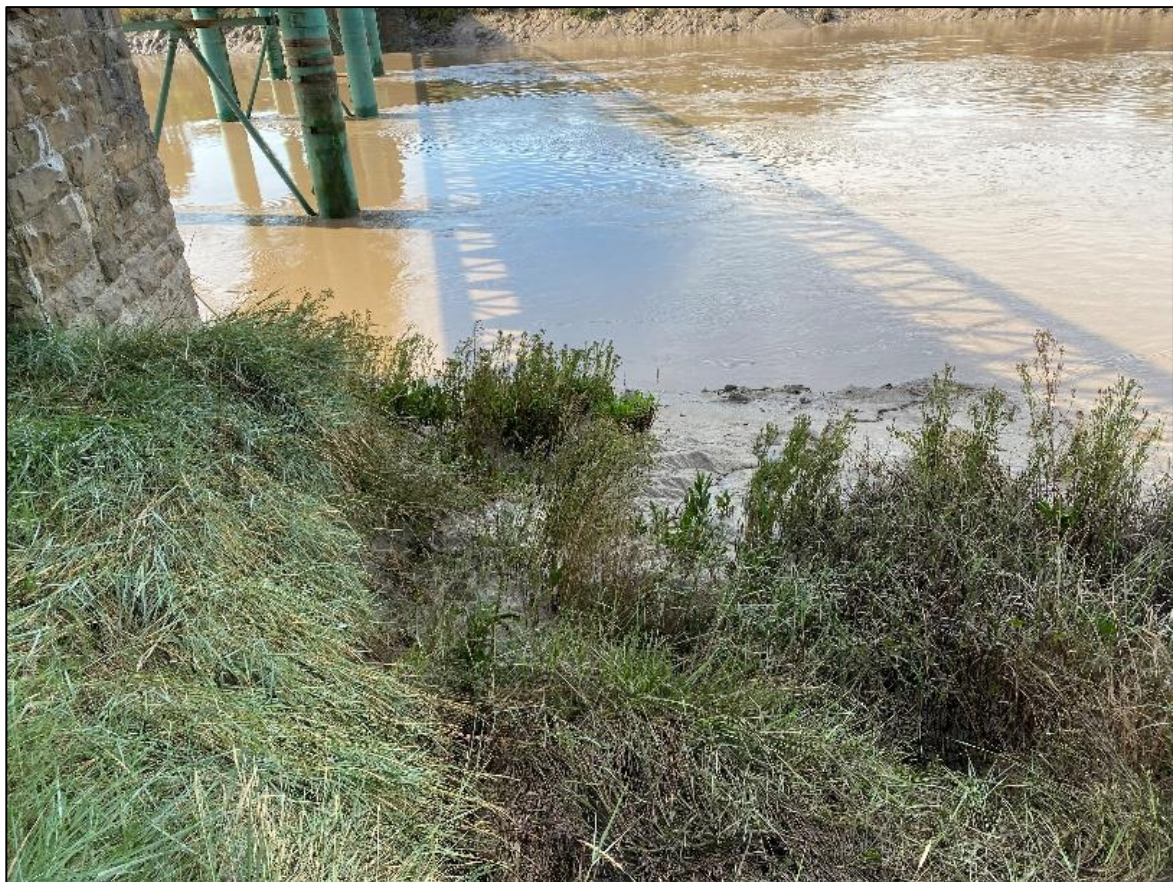
*Figure 6: Scattered-sea purslane and couch grass west side of arch*

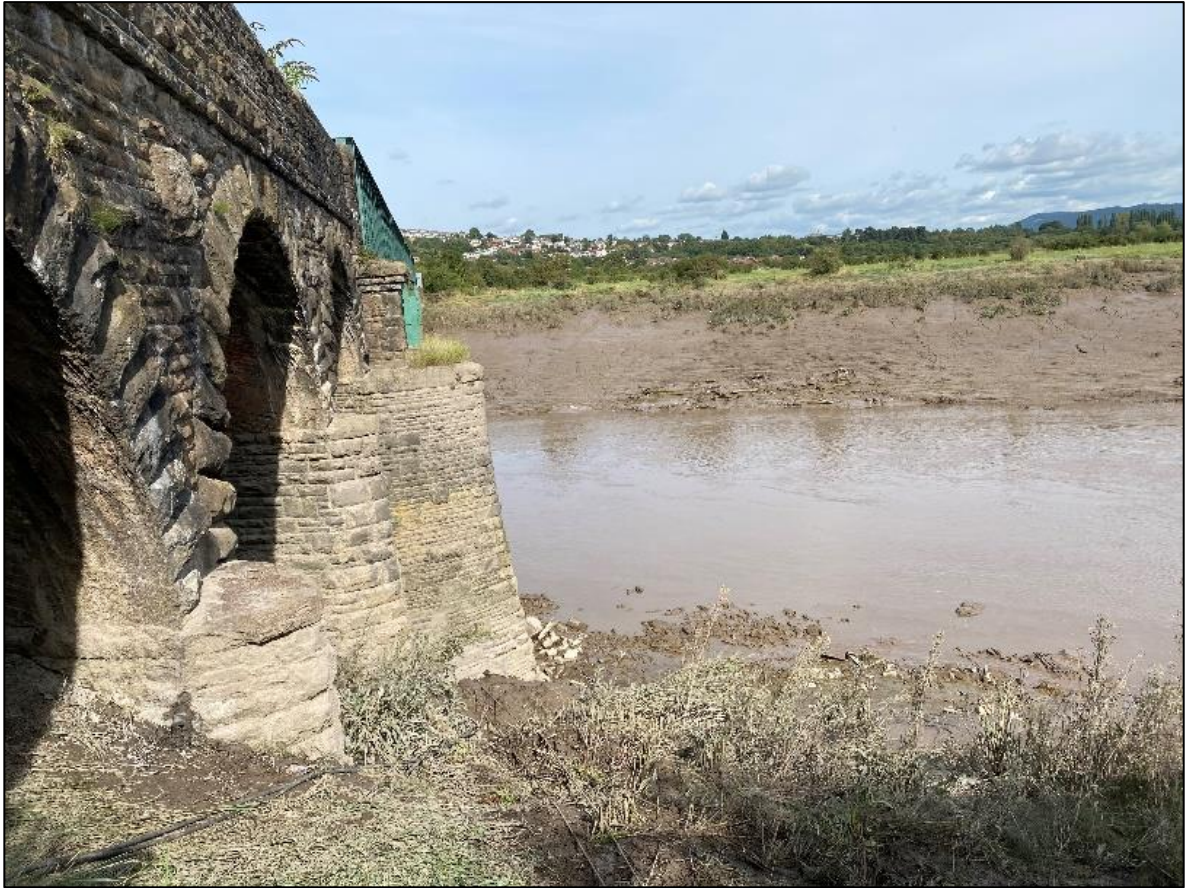
- 2.2.5 Sparse scattered saltmarsh plants are present on the upper marsh to the east of the arch (Sea Purslane and couch grass) with the middle and lower reaches being comprised of mudflats. The saltmarsh covers a small area within the works footprint and gives way to tall ruderal vegetation and scrub to the immediate east in the wider habitat.

- 2.2.6 The saltmarsh has been trampled and is subject to regular disturbance from walkers/dogwalkers and other recreational users. No saltmarsh is present beneath the arches.

*Figure 7: Saltmarsh to southern side*

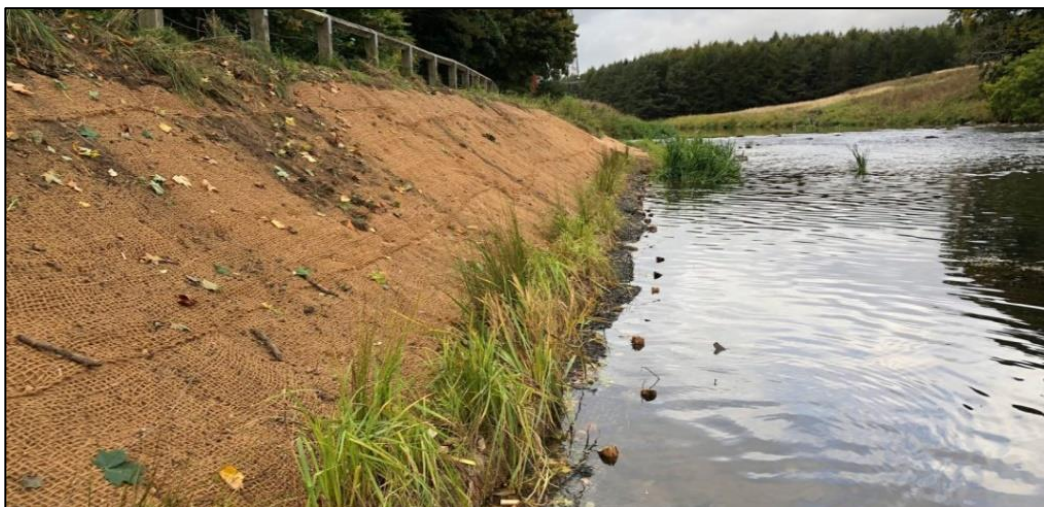
- 2.3.9 Consequently, it has been decided to temporarily translocate the margin saltmarsh to allow for temporary reprofiling of the bank for the haul road. The translocated salt marsh will be retained and maintained with river water being pumped to maintain moisture and required salinity using small submersible pumps.

*Figure 9: CocoBN used to stabilise embankment.*
