**JONES BROS (RUTHIN) LTD**

**FORMER SEIONT BRICKWORKS AND QUARRY, CAERNARFON, GWYNEDD, LL55 2YL**

**SITE CONDITION REPORT AND GROUND CONTAMINATION INVESTIGATION AND RISK ASSESSMENT**

**REPORT No. E0756.SCRGCRA.R1**

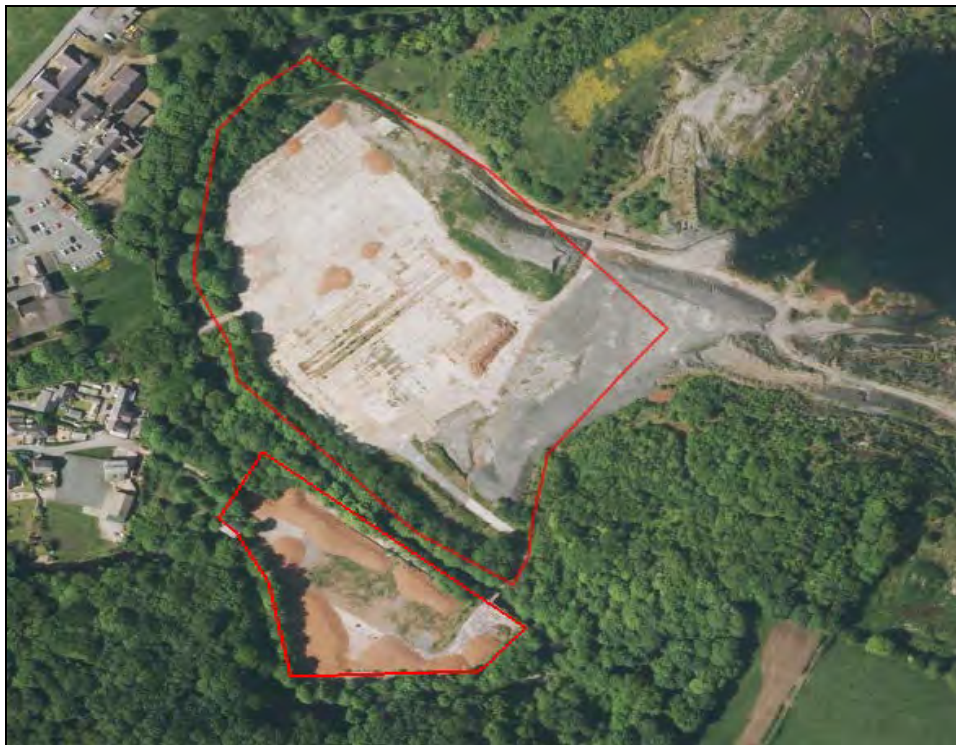
**Figure 3 -Aerial Photograph**

- 2.2.3 The overall ground topography within the site is very flat and level but at a low point in the surrounding area which places the site in a 'bowl'. To the north-east is the former clay pit which is now a lake surrounded by steep quarry face slopes which show significant evidence of instability on the northeast and north sides. An aerial photograph of the site is shown as Figure 3.
