## Compliance Assessment Report

**Report ID:**  
**CAR\_NRW0000142**

Site	Atlantic Recycling Limited	Permit Ref	PP3993VS			
Operator/Permit holder	Atlantic Recycling Limited					
Regime	Waste Operations					
Date of assessment	17/03/2016	Time in	09:40	Out	10:45	
Assessment type	Site Inspection					
Parts of the permit assessed	Reg 37 and SP1					
Lead officer's name	Danter-Hill, Gareth					
Accompanied by	Moggridge, Lara,Haf Peskett,Legal Representatives					
Recipient's name/position	John Edwards/ Compliance Director	Date issued	21/04/2016

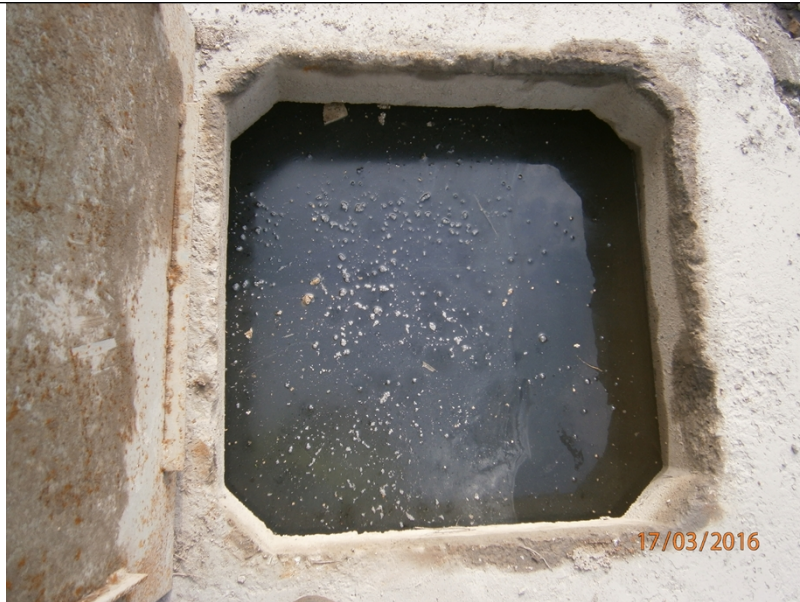
This breach has been scored for the pollution of land throughout the area where waste was stored for approximately 5 years without any of the required infrastructure, this waste pile is known to site and NRW as stockpile 1. The visit that was carried out on 17th March 2016 displayed signs of leachate collection within the 'sump' in the stockpile 1 area. Officers returned the next day with sampling equipment and tested the water within the sump. Upon return of the results from the lab, a reading of 8.845mg/kg for Ammoniacal Nitrogen. Waste was removed from this area throughout November-December 2015 approximately 4 months before the sample was taken. This is extremely concerning as the sample shows that leachate pollution has occurred in this area and it is still flowing through the ground and collecting in the relatively shallow sump.

Leachate was seen to be flowing off the sides of the tarmac area once again and pooling on the made ground. Leachate was also seen pooling across large areas of the tarmac and not flowing to the drainage system on site.

Cracks and surface break up across the concrete on field 1 could also be seen with leachate pooling across large areas. These areas in some cases had cracks running through the leachate presenting a pathway for potential pollution once more.

**ACTION:** The area of land that was used to store the waste pile known as stockpile 1 needs to be remediated. This area needs to be excavated and only when water samples return over an agreed period of time as being clear of leachate and polluting materials can the area be filled in once more to allow infrastructure to be constructed within this area. Please see the e-mail sent to Phil Ridley on 19th Feb 2016 for reasons why NRW are not happy that the land can be left in its current state and that the land needs to be properly assessed before remediation works.
