## Compliance Assessment Report

**Report ID:**  
**CAR\_NRW0031768**

| Site | Cott Wrexham (Calypso) Manufacturing Site | Permit Ref | AB3094FQ | | |
| Parts of the permit assessed | Surface Water Discharge | | | | |

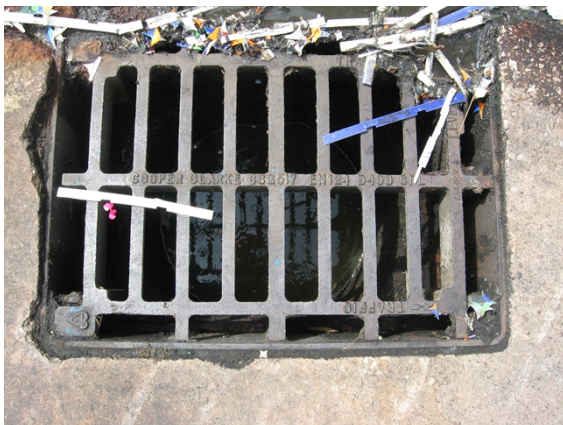
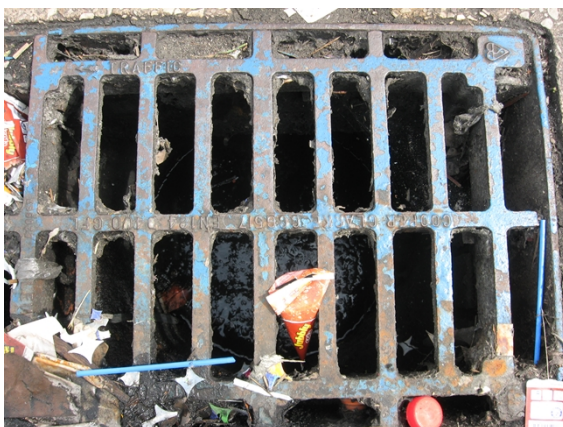
At 10:45, following a review of internal processes, we proceeded outside onto the northern yard, accompanied by you (Liz Huband) and Richard Davies. As we exited the building our attention was drawn towards the compactor location, where a site operative was actively jet-washing the yard. It was apparent that the run-off from the jet-washing was running across the yard and into a surface water drain. In addition, run-off was observed from the area around the orange tanker which was running across the yard into a second surface water drain, and via an overflowing foul drain into the same surface water drain. We immediately asked for the jet-washing to be ceased.

Upon examination, both surface water drains appeared to contain un-clean discharge, and a considerable amount of detritus. See photographs below:

- Block the discharge to stop any further discharge of contaminated effluent to controlled water (you confirmed on the 15th of June that a bung was in place in Manhole C);
- Do not remove the bung from Manhole C until you have provided NRW with confirmation that:
  - no further contaminated discharge will be discharged to the surface water drains;
  - the un-clean discharge in all surface water drains has been disposed of correctly;
  - that the source of the "clear" discharge in Manhole C has been identified (and stopped if required); and
  - the brix meter has been installed in the surface water system and is operational.

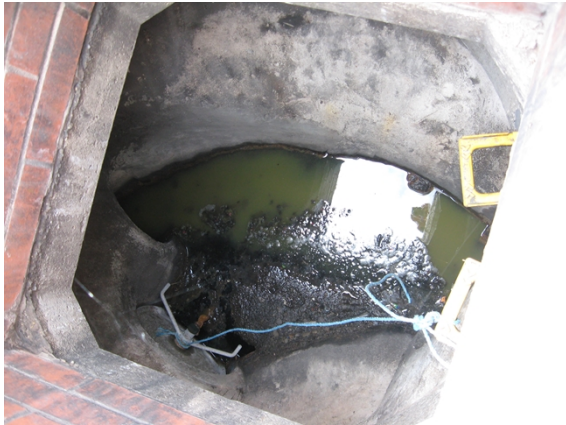
At 10:51, Manhole A was lifted. Upon inspection, it was clear that this leg had not been bunged, and an un-clean discharge with a slow, but noticeable, flow was observed. There was also a

strong odour.

See photograph below:

This discharge is in breach of your permit which only permits clean and uncontaminated rainwater to be discharged to controlled water, **breach permit condition 3.1.1.**

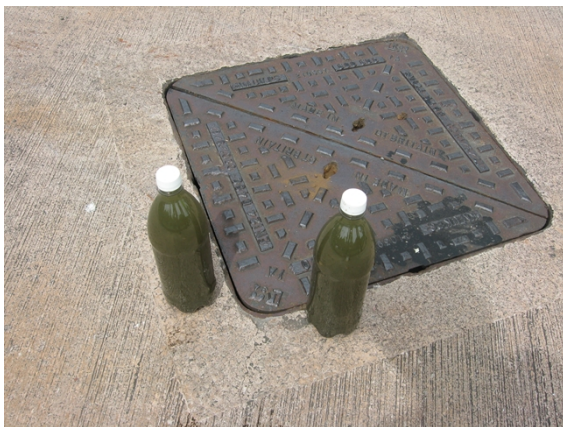
As a result a formal sample was taken and a portion of it left with you, and you were asked to block the discharge to stop any further discharge of contaminated effluent to controlled waters.

See photograph below:

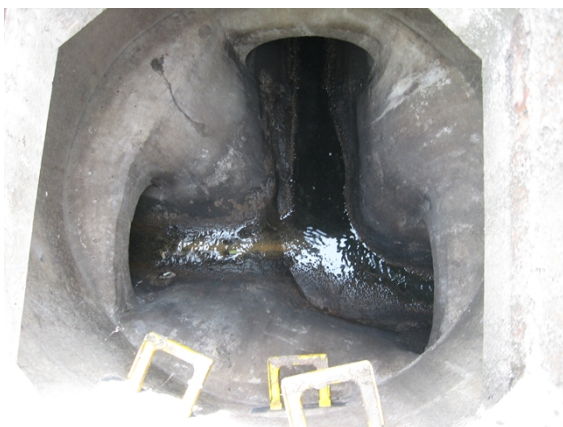
At 11:23, surface water Manhole C (within the front car park) was also lifted. Manhole C also has two legs converging within it. From the western leg, there was a "clear" discharge with a slow, but noticeable flow.

See photograph below:

Considering the dry conditions, it was considered unusual for there to be any flow in the surface water drain. You mentioned at this point that you had recently discovered a leak in the boiler

condenser which may be the source of the "clear" discharge.

- Provide NRW with the results of the camera survey conducted on the 15th of June, and of your investigations into the source of the "clear" discharge and why the orange tanker drain is not emptying;
- Provide NRW with the results of your investigation into the leak from the connection to the orange tanker;
- Provide NRW with a copy of an updated site drainage plan, with the correct layout regarding Manhole C and the interceptor;
- Review the most recent drainage survey results to ensure that there are no further errors on the drainage plan;
- Investigate why the surface water drains have so much debris in them and what measures will be put in place to stop this build up in the future;
- Provide NRW with a copy of the current yard cleaning procedure;
- Provide NRW with a copy of the "improved" yard cleaning procedure, and details as to when staff were trained in it's use.

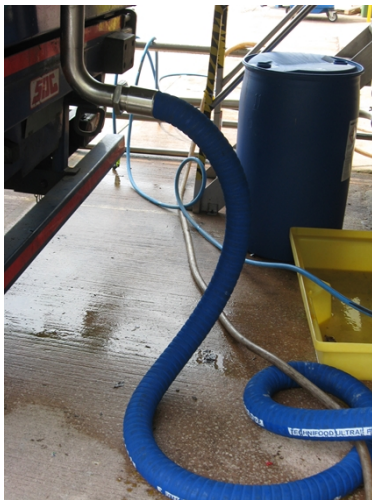
NRW received a procedure entitled Orange Tanker Management on the 7th of April 2017. This procedure states that "Spill tray must be positioned under where the tanker and hose are

connected this will contain any drips which may leak from the connection".

As shown in the photograph below, taken on the 14th of June, this procedure was not being followed, as the spill tray was not in the required position:

The Orange Tanker Management procedure was not being followed on the 14th of June, resulting in a **breach of permit condition 1.1.1 (a) (consolidated in breach above)**.

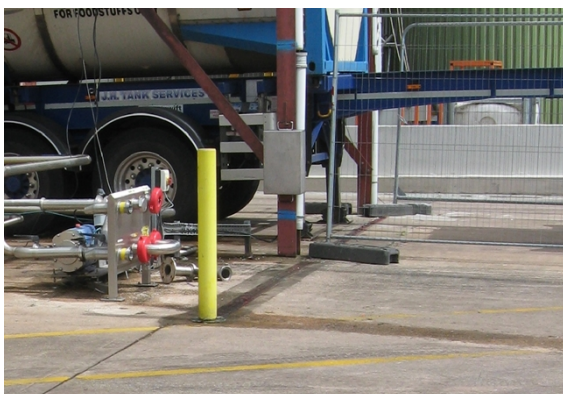
In addition, the procedure states that "Daily checks of the area to be undertaken to ensure that there are no leaks and to empty the spill tray if required". As can be seen in the photograph below, the effluent drain adjacent to the orange tanker was overflowing to the surface water drainage system:
