Site	Harsco Metals Port Talbot				Permit Ref	BP3635MR (as amended)		
Operator/ Permit holder	Harsco Metals Group Ltd							
Date	16 June 2015				Time in	14:00	Out	16.30
What parts of the permit were assessed	See below							
Assessment	EPR - inspection	EPR Activity:	Installation	X	Waste Op		Water Discharge	
Recipient's name/position	Paul Roberts, Environment, Health & Safety Manager, Harsco Metals Port Talbot							
Officers names	DMP Broom & DE Cowie				Date issued		28 July 2015

Natural Resources Wales* (NRW) officers visited Tata Steel Port Talbot to progress an investigation into an iron plating event that occurred on 24 January 2015. We previously investigated this event on 11 March 2015 during a meeting with Tata Steel and Harsco Metals.

Plating event 24/01/15

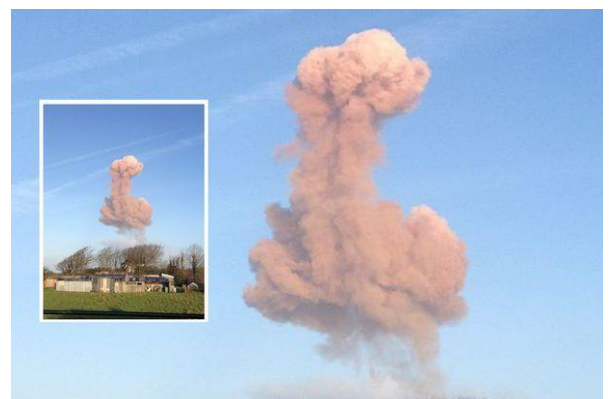
On Saturday 24 January 2015 NRW received a number of complaints about a release from the steelworks. The source of this release coincided with an event while plating molten iron within the steelworks. CAR Form 5854 issued to Tata Steel contains details of NRW's initial investigation which concluded that ground water was not a contributor or source of the water that caused this event. During this visit we viewed video footage of the molten iron pour from the torpedo into plating pit number 3. The photograph shows the release above the steelworks from this plating operation. There appeared to be no discernible effect of this event on the air quality monitors around the steelworks.

The video showed the pour from the torpedo took around 15 minutes to complete. NRW understands the pour should take 30 minutes; at this rate the iron moves slowly enough to allow any moisture to evaporate in front of the advancing metal. After 8 minutes the hot metal reached the end of pit 3 with little release/fume visible. After 12 minutes the far end of the pit started to fume, then boiled and finally erupted like a volcano scattering molten metal into the air that rained down in front of the camera and the 'igloo'. Tata's initial report into this event suggests that damp slag had been used to prepare pit 3, but this cannot be confirmed. Tata showed us a photo of the pit 7 days before it was used and this showed a pool of water visible towards the far end of the pit. Pit 3 was prepared and dressed with slag by Harsco approximately 2 hours prior to the event, although it is not clear how any standing water was dealt with during this process. What is clear is that the eruption took place in the same part of pit 3 where the standing water had been 7 days earlier.
