## Compliance Assessment Report

**Report ID:**  
**CAR\_NRW0017534**

| Site | Port Talbot Steel Works EPR/BL7108IM | | Permit Ref | BL7108IM | |
| Parts of the permit assessed | Sinter Plant | | | | |

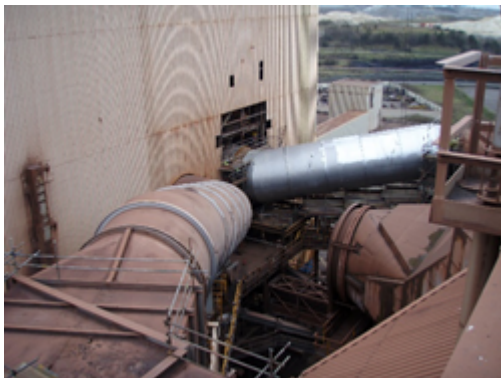
The waste gases from the sintering process are collected in two wind mains - one north and one south. These large ducts pass out of the seaward end of the sinter plant and into two sets of electrostatic precipitators (EPs) - again one North and one South. The photo below (LHS) shows the South duct (silver colour) and the nearby north duct in the lower half of the photo going into their respective EPs and a stub going to a redundant EP that sits between the north and south EPs.

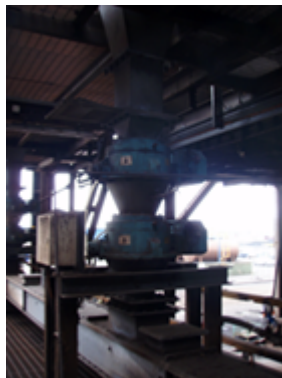
Previously a lot of work was carried out during the October 2015 stop and all the double dome valves (middle photo above) have been installed on both sets of EPs. The new and modified sinter plant conveyors have all been installed on the south side but not

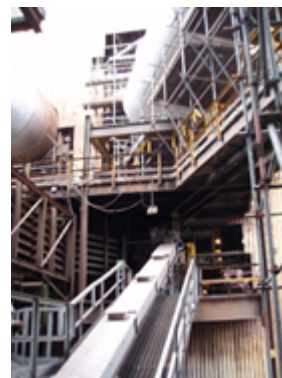
(yet) on the North side (RH photo above).

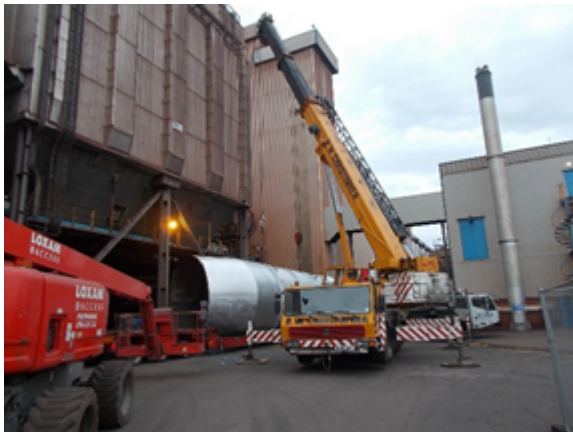
The left hand photo below shows the transition piece being delivered to the sinter plant. To replace the 15m section of wind main, a supporting frame had to be built and then the section was lifted into place and drawn into the sinter plant using the supporting frame. Once the new section was in place, part of the supporting frame had to be cut off and the new transition piece lifted into place. These lifts were carried out using a 1000 tonne crane but the weather and winds caused a four day delay. The project is now struggling to meet the early April 2016 deadline to return to two fan operation.

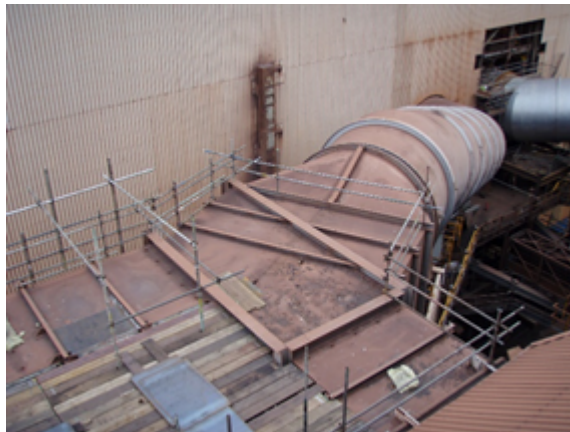
The March 2016 major stop has meant the plant will be run on one-fan operation for 18 days while the South wind main is tackled. During this stop, the transition piece on the south duct was replaced and a large amount of remedial work is being carried out to reduce air ingress into the wind main. This involves replacing a 15m section of the wind main just before the transition piece, replacing the transition piece itself as well as repairing the air leaks from the transition piece up to the main stack. The holes in the top of the pipework visible in the right hand photo below have been caused mainly by corrosion and erosion from the inside of the wind main.

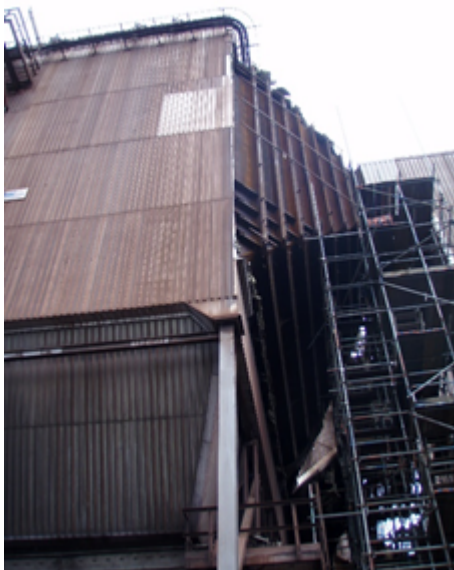
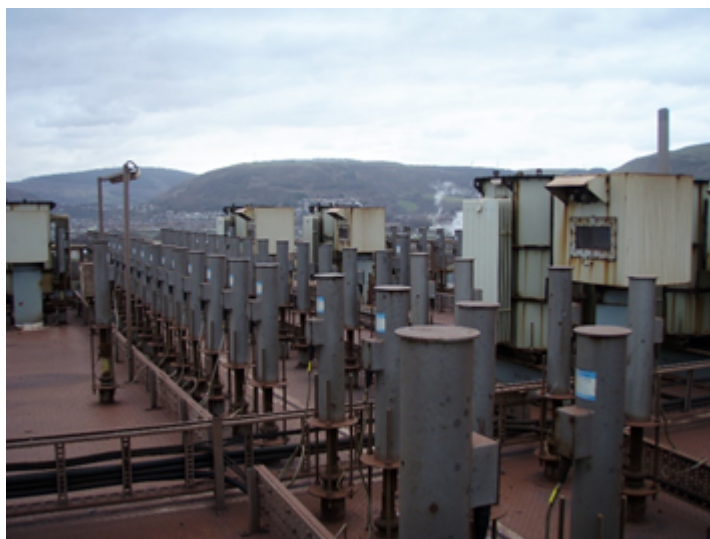
Walking down alongside the wind main, the new sections were in place but despite the work in October 2015 there were still some noticeable air ingress leaks to be heard along parts of the main. Looking down from the top of the EPs, air ingress leaks could be heard and the holes seen as the lagging had been removed to find the leaks and to start repairs (see RH photo above). There are a number of challenges with this system: the ducts are large, high up, the duct is hot when operating and the air ingress i.e. the suction is large. There was a leak on the expansion joint between the north EP and the main stack. The scaffolding operating to access this area had to be blocked as it was unsafe; a scaffolder could have been sucked against or into the hot main.

Subject to funds, the Project is planning to replace the north side EP dust conveyors in the same type and configuration as the south conveyors it is also attempting to repair a number of the air ingress leaks during the major stops.
