## Compliance Assessment Report

**Report ID:**  
**CAR\_NRW0026746**

| Site | Port Talbot Steel Works EPR/BL7108IM | Permit Ref | BL7108IM | | |

To review the complaint issues reported to Tata over the previous quarter of operation (Jul 16 – Sep 16 inclusive). An inspection of Phoenix Wharf oil tank farm was also undertaken following Tata's notification of a heavy fuel oil spill. Finally we inspected the stockyards, sinter plant conveyors and the Blast Furnace No.5 stockhouse.

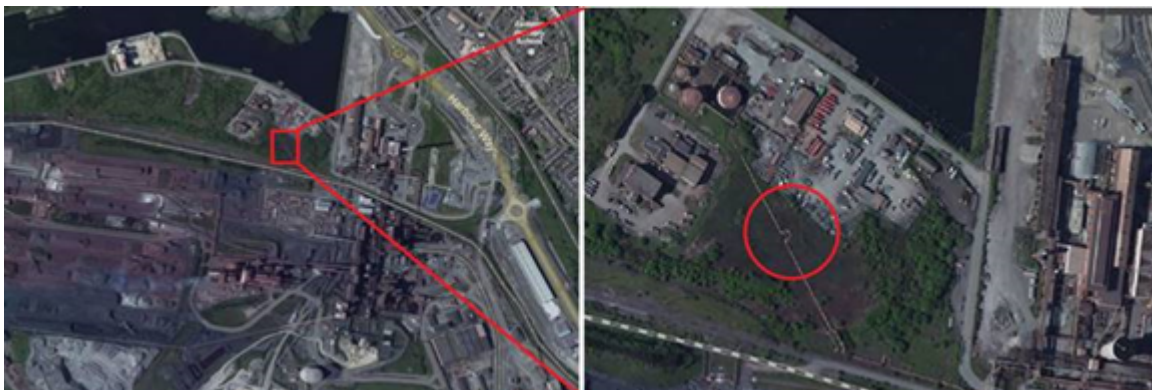
The pipeline transects an area of thick reed bed with standing water approximately 6 feet deep in places. The leak was located near a supporting stanchion where the pipeline makes four 90-degree turns. The area appears landlocked with no watercourses or drains running away from it, resulting in the spill being 'naturally contained'. No oil has been found in Port Talbot Docks or in any nearby storm water systems. The Docks area is being checked regularly for any surface oil.

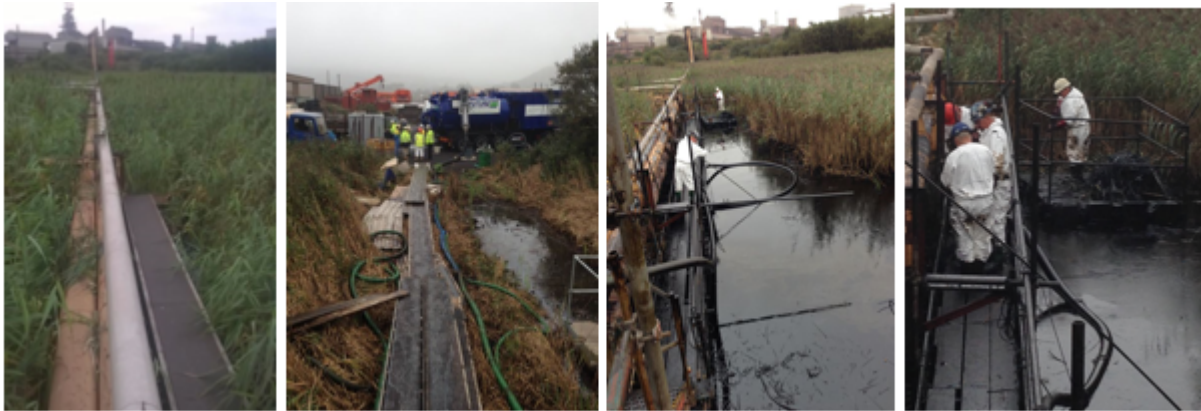
During the week commencing 19 September 2016 we were notified by Tata that access to the spill area had been secured and a temporary boardwalk had been created through a cleared area

of reed bed. From one of the boardwalk platforms we were able to see the location of the leak and the scale of the impact on the surrounding water and land. The oil pollution is extensive but there is no public access to the spill area and the contamination appears to be localised to the steelworks. The photos below show the pipework route, access to the pipework, oil being skimmed and the reed clearance work. Future Industries and EDS have been contracted by Tata to undertake the clean-up work.

NRW will now conduct further investigations into this oil spill. We will write to the operator and issue a separate CAR form addressing this matter in due course.

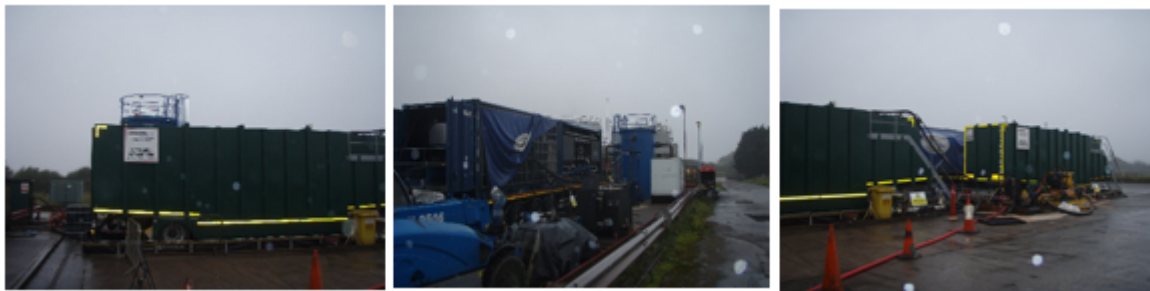
The next set of photos below show the oil recovery system operated by Veolia UK. Skimmed oil and water is directed to a holding tank, heated and separated before being directed to a polishing unit. Separated oil is being returned to a previously unused tank within the Phoenix Wharf oil tank farm for recovery.

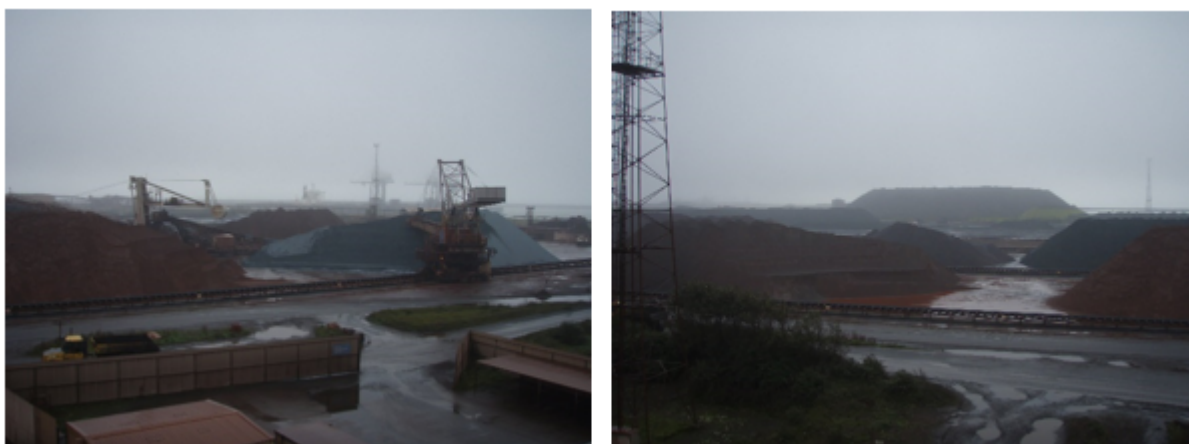
Following on from CAR\_NRW0026744 we conducted inspections of the stockyards, sinter plant and blast furnace stockhouse works areas. The photos below show the stockyard areas looking west from the control tower on this damp and overcast day.

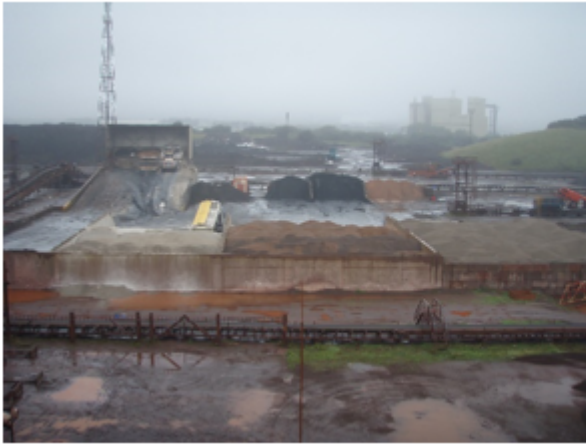
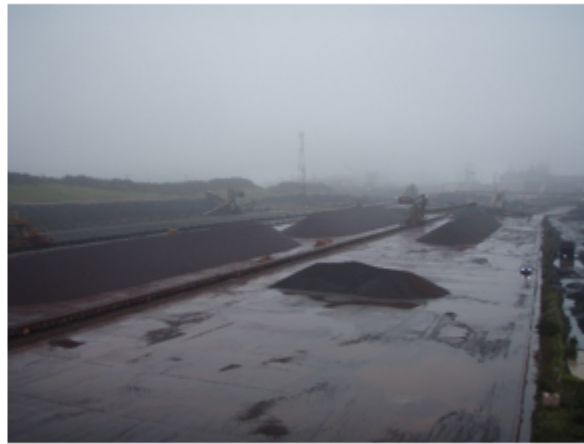
The below photos show the sinter feed preparation (lay-down) areas.

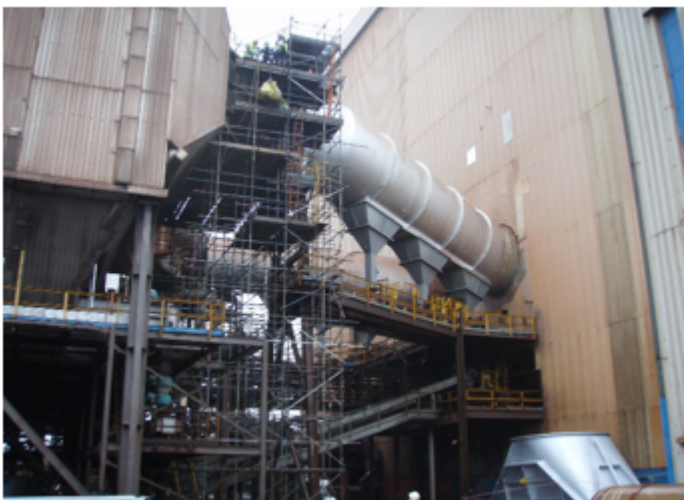
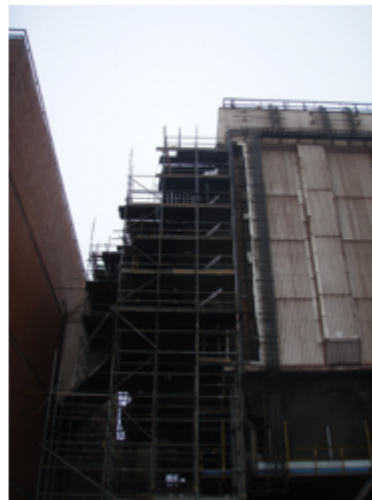
Below are photos of the waste gas main Electrostatic Precipitators (ESPs) at the sinter plant. The refurbished incoming waste gas duct is shown (left photo) with three new dust collectors and scaffolding around the exit of the south ESP going into the main stack (right photo). A major maintenance stop has been taken to deal with air (oxygen) ingress and improving the performance of the sinter plant ESPs.

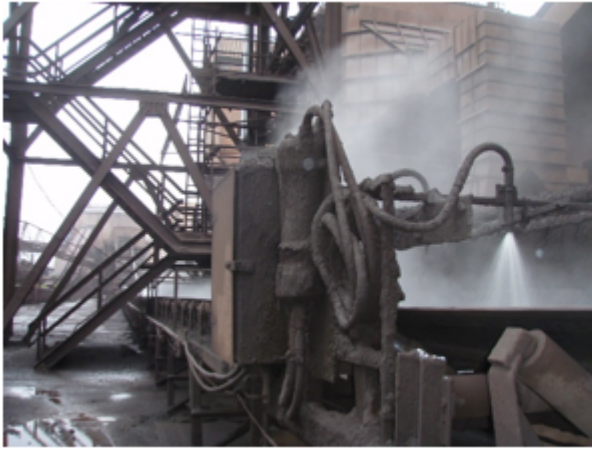
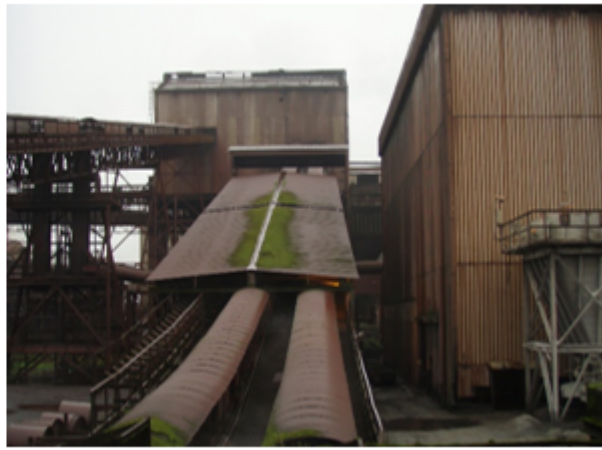
Tata use a foam suppression system that coats the finished sinter product as it leaves the sinter plant (below left photo) by conveyor and travels towards the stockhouses serving the blast furnaces. Tata and its foam contractor Nalco are replacing metal pipework with alkathene to reduce the occurrence of fouling and blockages due to biofilm build-up within the pipes. A biocide treatment system is also being installed to also help reduce this problem.

At the time of inspection the foam suppression systems at the sinter plant were operating normally, although ambient air temperatures were seasonally low and the weather was damp and overcast. The systems are tested to their fullest when conditions are hot and dry e.g. summer months.

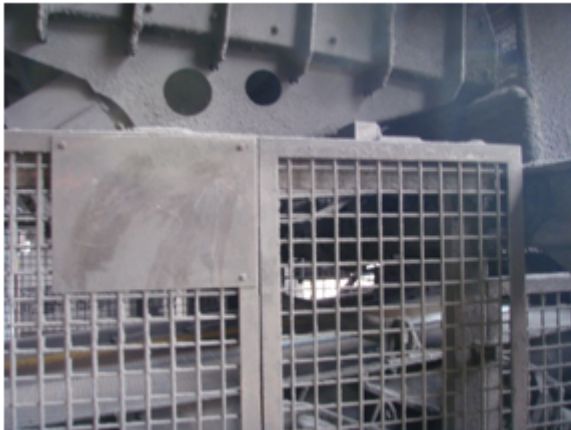
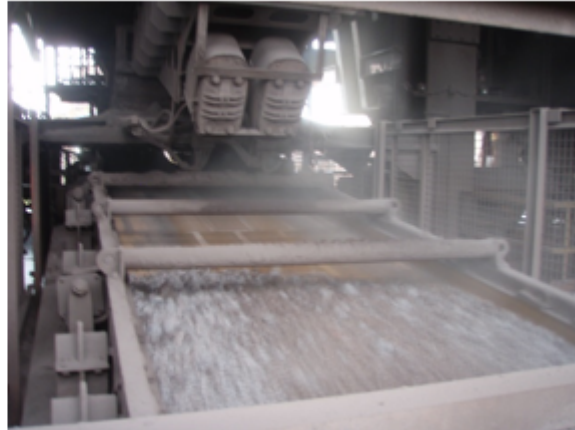
Once the sinter passes through the stockhouse area, there are a series of mechanical screens that have foam suppression sprays fitted to minimise fugitive dust from the movement of raw materials up to the blast furnaces. This is an area NRW has previously scrutinised and was believed to be partially responsible for some of the nuisance dust (fallout) problems encountered in 2013 and 2014. Several interventions have been made by Tata since then including the optimisation of foam suppression systems but also changes to stockhouse loading techniques and cleaning methods.

The next two photos show screens we inspected at the stockhouse serving Blast Furnace No.5, with sinter being carried away from a screen in the right hand photo. We witnessed foam being applied to the moving sinter shortly after each screen started up.

In NRW's view the stockhouse screens are one of the critical areas for fugitive dust suppression in this part of the steelworks and they should be regularly checked and maintained to ensure all foam suppression systems are working correctly. NRW will periodically inspect and check for emissions from these areas.

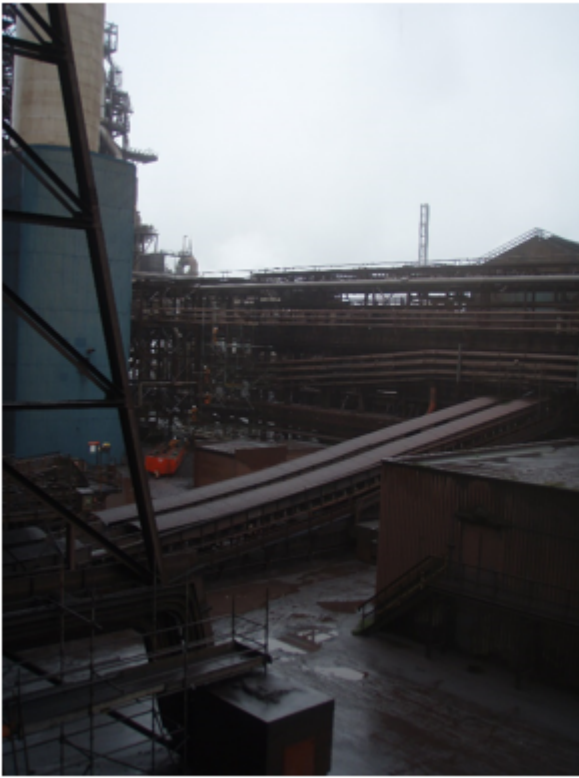
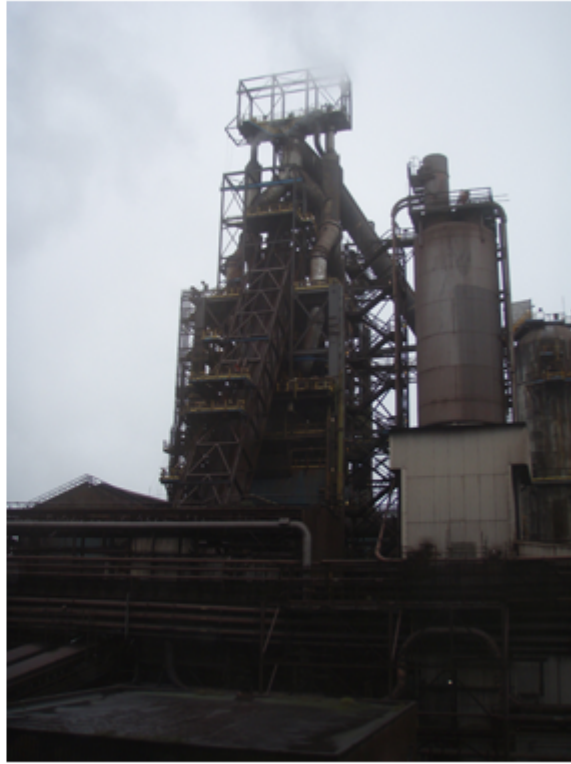
After leaving the screens, the sinter and other raw materials pass along more conveyors and then up a bucket/skip elevator into the blast furnace.
