| | <b>EPR Compliance Assessment Report</b> | | Report ID: CAR_NRW0033602 | |
| Site | Rockwool Pencoed | | Permit Ref | BS6149/Q (as amended) |
| Operator/ Permit holder | Rockwool Ltd | | | |
| Date | 28 <sup>th</sup> and 29 <sup>th</sup> June 2018 | | | |

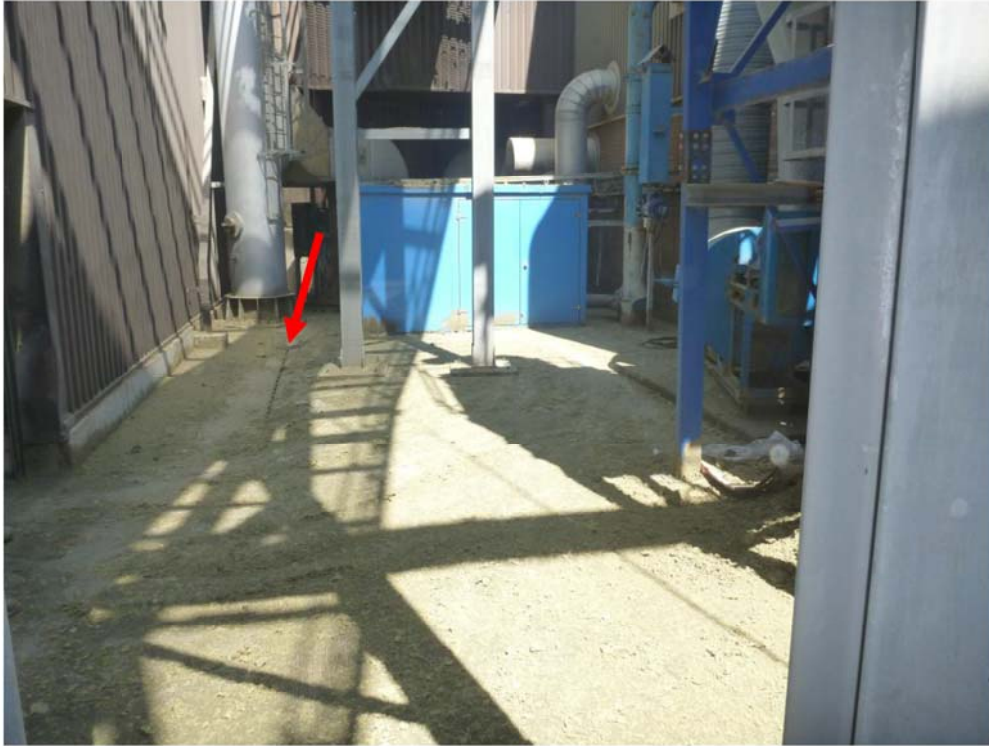
We were shown the large stockpile of waste wool (currently outside the L1 waste bay) that has been allowed to accumulate on the site's yard in recent months. The stockpile has been identified as the cause of some recent surface water emission failures and the environment team have developed an action plan to attempt to address this. The operator has diverted the surface water, that flows from this area, back into the process water system and they are looking at reducing their waste stockpiles.

*Photograph showing extensive wool waste (from PSM 56 cutting section) covering the external yard. Arrow denotes drain.*

**All waste wool must be housed in a covered area with appropriate containment to prevent pollution (e.g. discharges to land, groundwater, surface water and fugitive releases).**

The failure to store potentially polluting materials (e.g. waste wool) in covered bays with appropriate containment is considered a breach of condition 2.3.1 of the permit. A ccs score of 3 has presently been attributed to this failure, c4,

| Section 4- Action(s) | | | |
|---|---|---|---|
| c1, c2 | C3 | All spillages of waste and any other potentially polluting materials to be cleaned up immediately. Inspection of entire yard should now be completed. The areas where we found the spilt waste should now have been cleaned, including fly ash deposit. | Should be completed for spillages noted during visit. Any subsequent spillages should be cleaned up immediately |

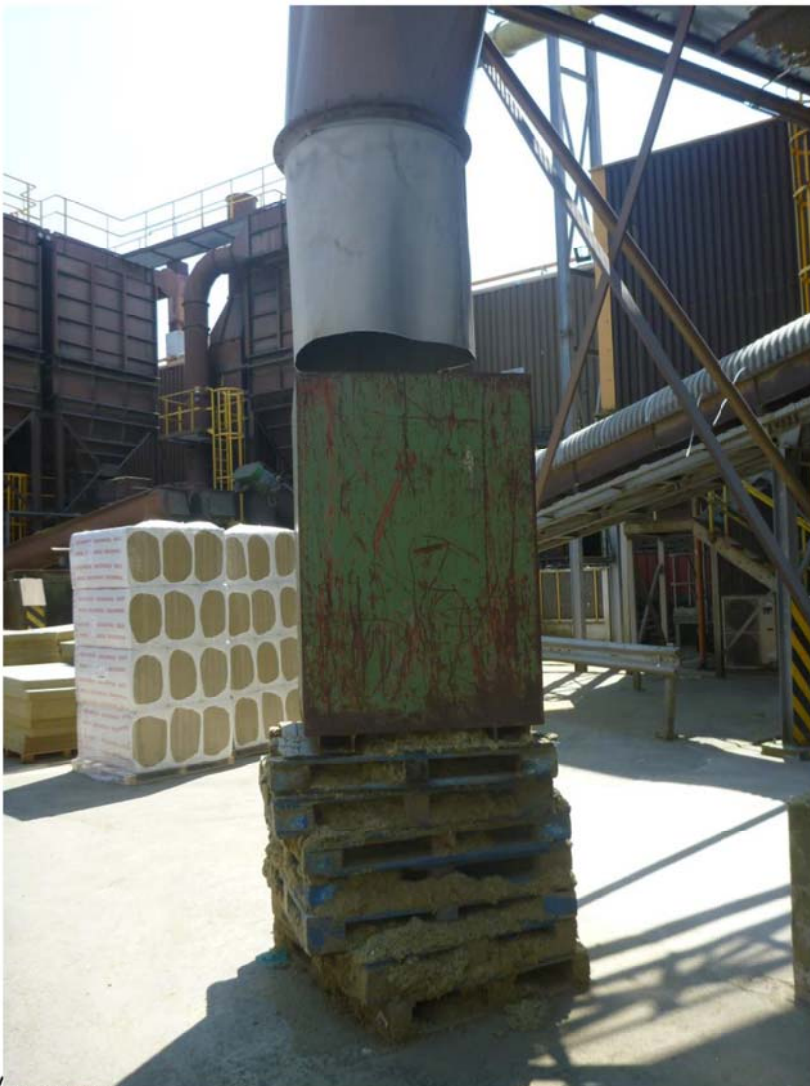
We once again noted that housekeeping measures were not being applied to minimise the risk of surface water contamination. Simple measures such as cleaning spillages immediately and providing suitable containers to collect wastes is not being undertaken, despite their simplicity and limited cost. Examples are shown below (all of the areas noted normally drain to the surface water system and could contribute to surface water emission failures).

Photograph showing siting of waste receptacle too low beneath discharge point resulting in spillages. Container is also balanced on pallets which could easily topple causing pollution or injury.

| Section 4- Action(s) | | | |
|---|---|---|---|
| | | Review of the infrastructure and suitability of containers used to transfer and store materials within the site (i.e. suitability of silo bins, skirting etc) to ensure they reduce risk of dust releases and provide adequate containment. | Within one month of the issue of this report |

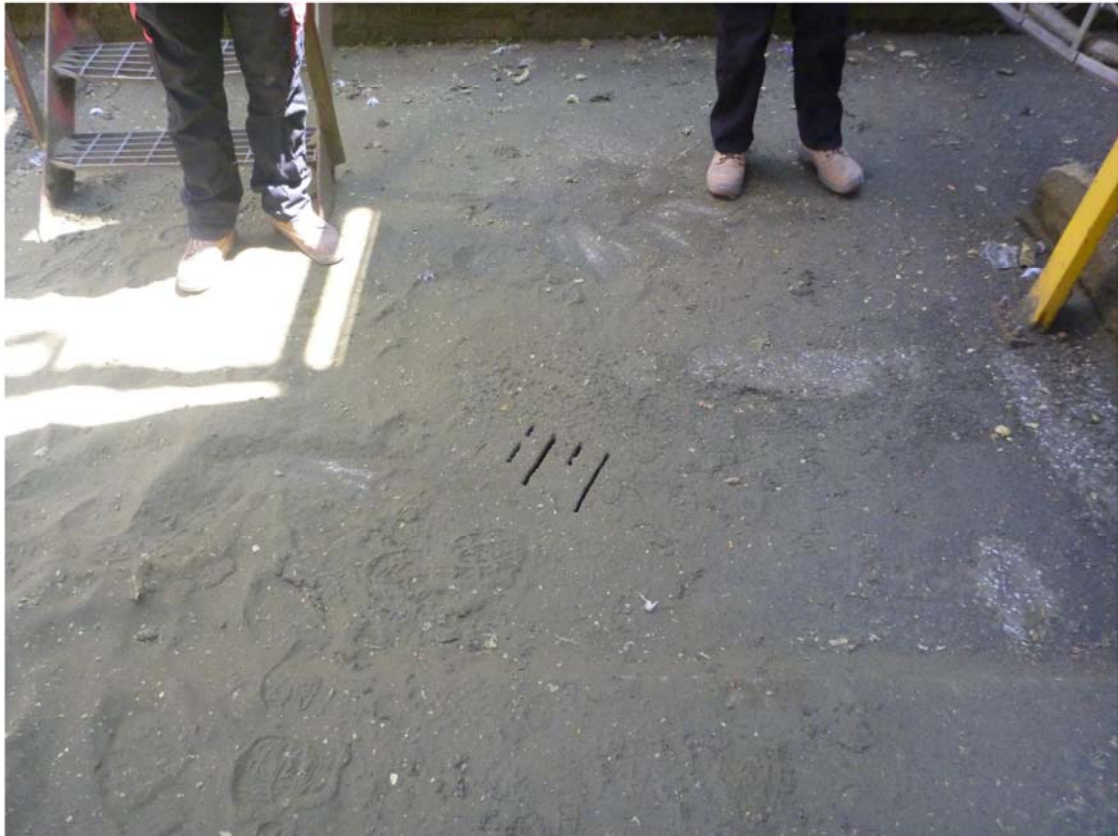
Further dusts/wastes covering drain on yard (adjacent to L1 building)

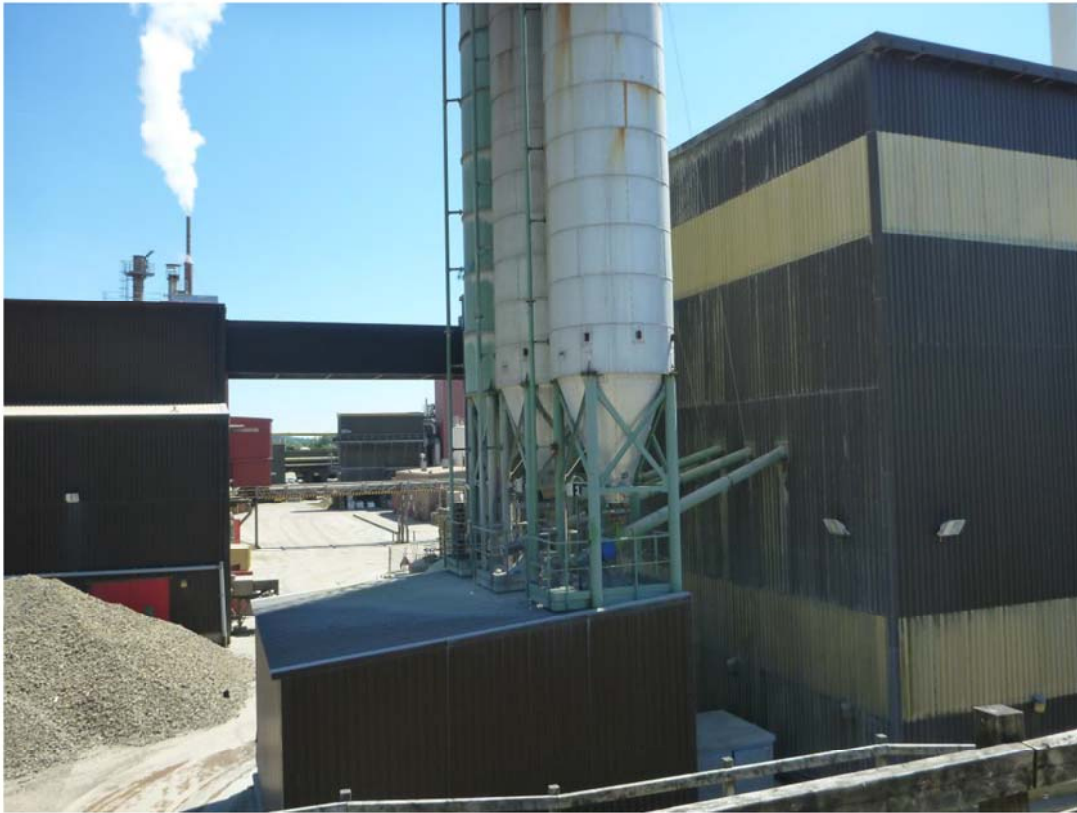
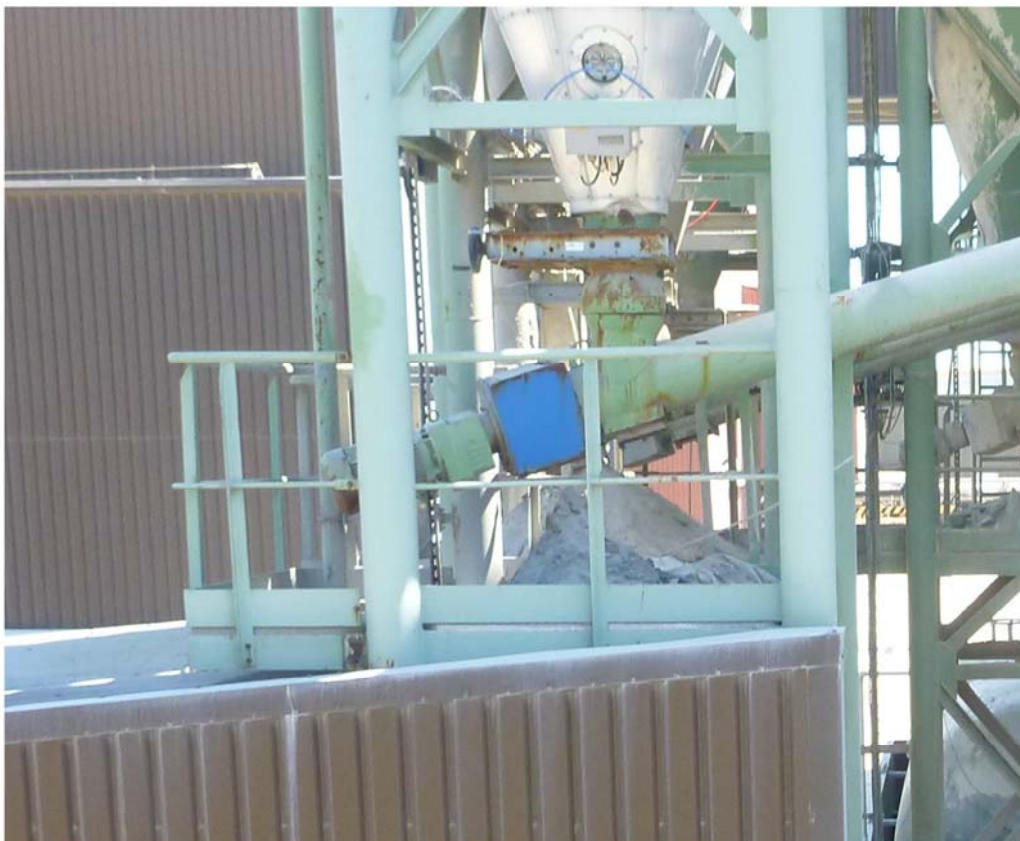
Evidence of extensive spillage of fly ash was noted around the fly-ash silos, attached to the Cement Briquetting Plant (CBP). This area drains into an area which is normally connected to the site's surface water system. It is once again unclear how staff had:

- failed to note the presence of the dust
- failed to clean the dust
- failed to implement an investigation into the cause of the spillages.

**Action:** Operator to arrange appropriate clean up immediately (note: this material may possess potentially hazardous properties and appropriate H&S precautions should be applied). The collected spillage should then be recovered or disposed of appropriately.

**Action:** Operator is presently undertaking an investigation into the fly ash conveyor system on the silo to identify the cause of the spillages.

**Action:** staff training has already been identified<sup>2</sup> by the operator and scheduled, however the team/s responsible for this area should be prioritised for immediate re-training.

The failure to implement simple housekeeping measures (i.e. cleaning spillages) is considered a breach of conditions 1.1.1a and 1.1.1 b. ccs scores of 3 have been allocated to these failures, against the c2 and c1 compliance headings.

| Section 4- Action(s) | | | |
|---|---|---|---|
| | | Investigation into the cause/s of the fly ash spillage. | Within one month of the issue of this report |
| | | Appropriate mitigation to then be implemented to prevent further fly ash spillages | |
