## EPR Compliance Assessment Report

Report ID: BU0800IZ/0198481

| Site | LLANDDULAS LANDFILL SITE | | Permit Ref | BU0800IZ | | |

Follow-up technical gas extraction system review and audit of fugitive emissions on site.

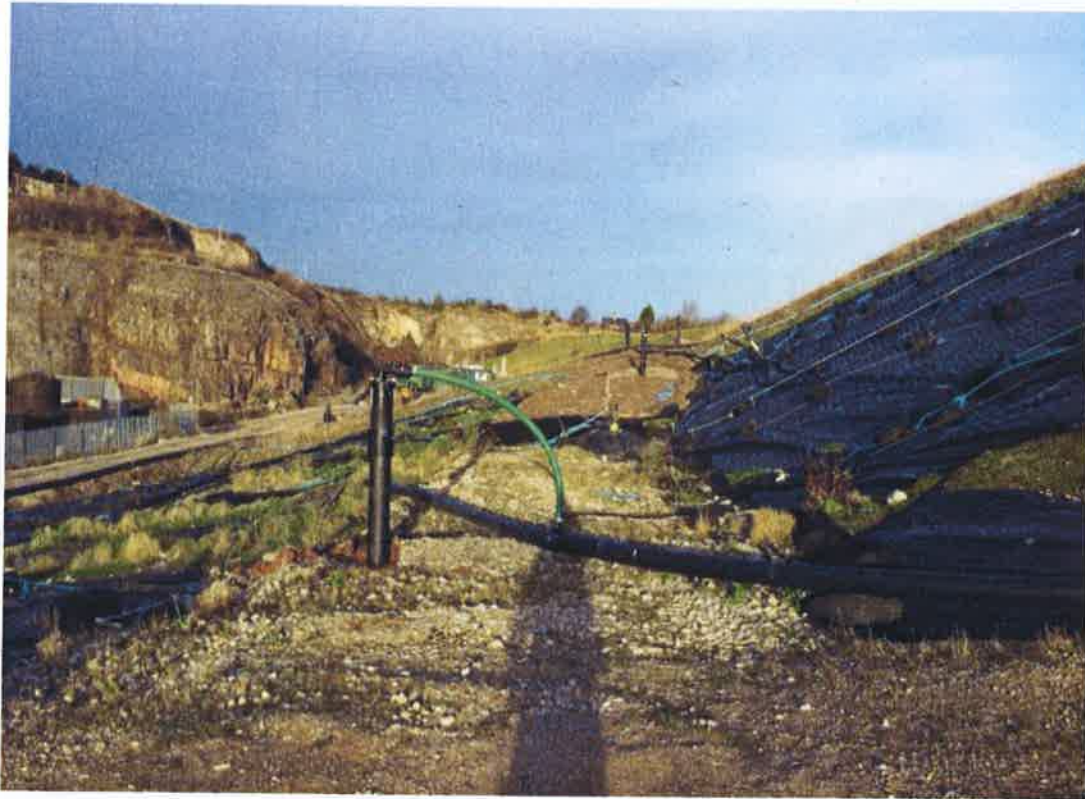
**Gas Wells C152 & C154 (pictured above)** – This gas infrastructure installed on the 24/10/13 was under negative pressure with good audible flow. Live readings with the GA2000+ unit showed typical landfill gas make up with low levels of oxygen. No fugitive emissions were detected in this area, which is an improvement from the previous audit in July 2013.

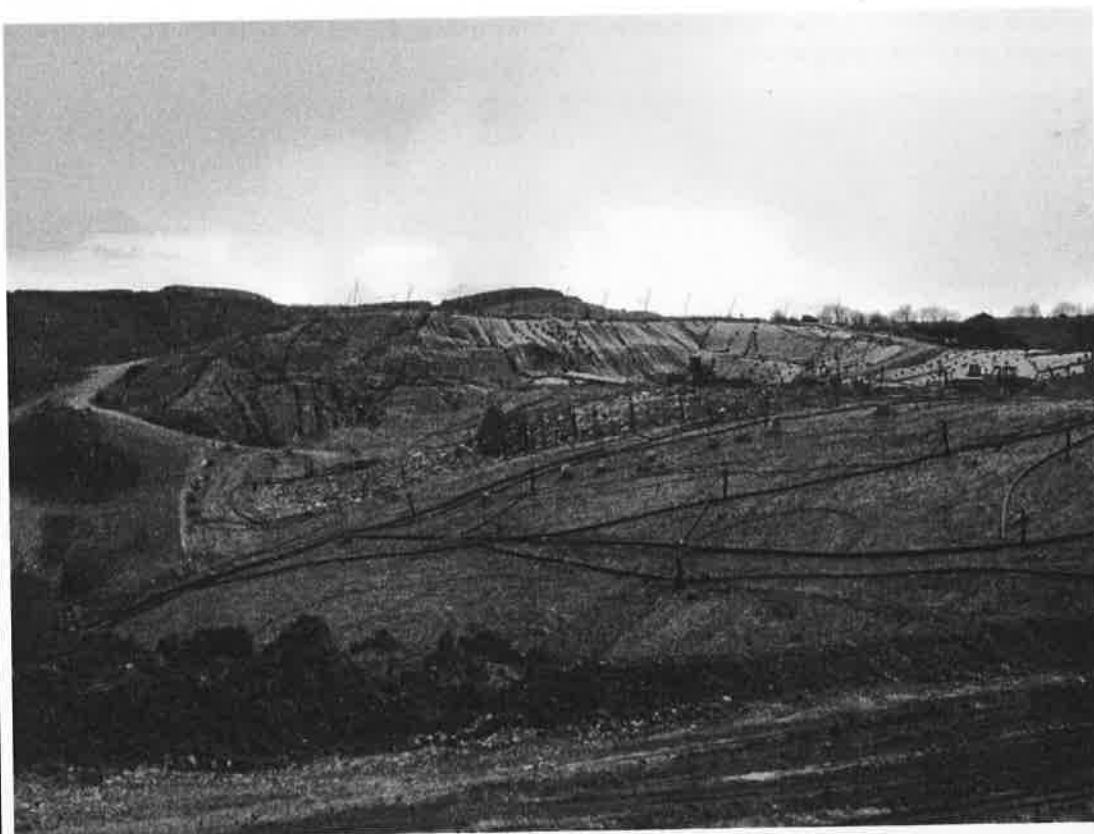
Capping and gas infrastructure on Northern flank of Phase 3A North:

**Northern Flank of Phase 3A North (pictured below)** – Some minor odour was encountered on this flank during the audit, although ambient emissions detected remained relatively low. The improvement in emissions from this area is reflective of the investment in permanent capping and new gas infrastructure over the course of 2013.

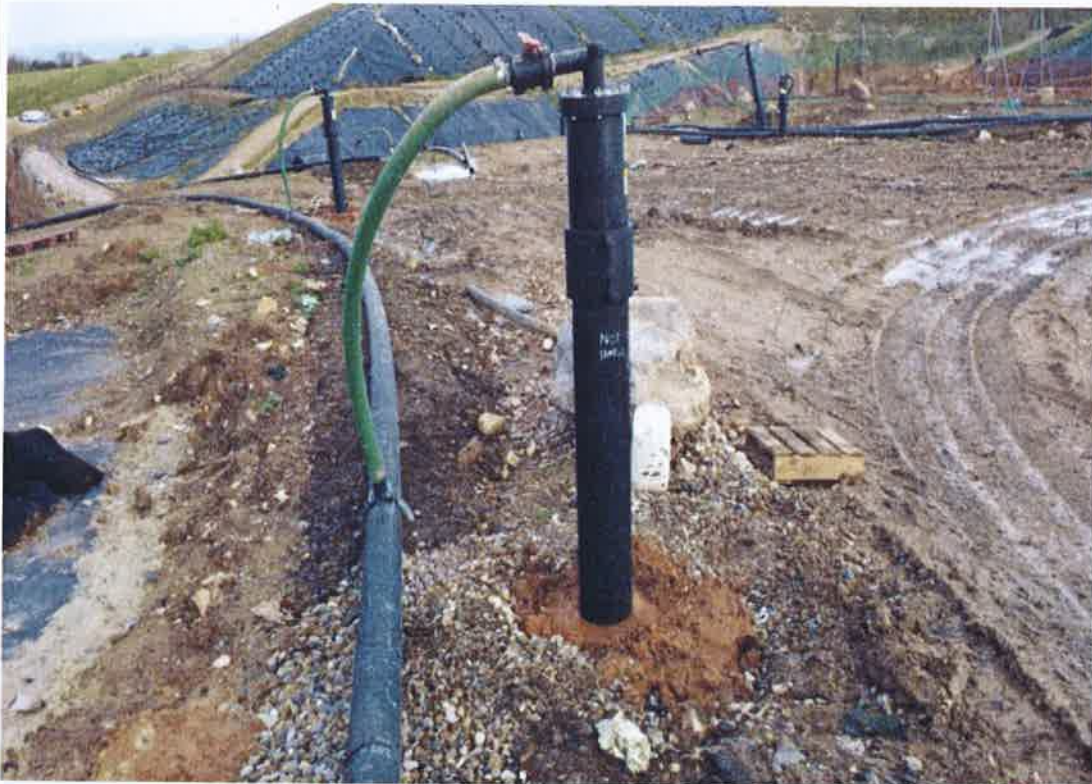
- 1300-1500ppm fugitive landfill gas detected around the line of the old pin wells adjacent to the haul road on Phase 3A North. This corresponded to gas wells D264 that in-field gas readings suggest is either inhibited or blocked with leachate. H<sub>2</sub>S was off the scale at this well and no apparent gas flow.

- Up to 5000ppm detected from outside the bentonite seal on gas well D266. This well was exhibiting similar readings to D264 above.
- We recorded significant odour around D268 and the well exhibited similar readings to the above.

**Gas Wells D264 – D266. (D264 pictured below)** – These three wells are located adjacent to the current haul road and replaced a line of saddled pin wells previously located in the same area.

**D264** was showing very little flow, with high methane levels recorded (63.3%) and H<sub>2</sub>S off the scale off the instrument. These in-field readings suggest the well is blocked or compromised by high liquid levels; a fugitive emission of up to 1500ppm methane was detected outside of the bentonite seal for this well.

**D266** was noted as being under high relative extraction pressure (-75mb). This well also showed little signs of actual flow, a high H<sub>2</sub>S reading (355ppm) and a fugitive emission varying between 1600 – 5000ppm from outside of the bentonite seal. Again, this data suggests that this well is compromised by high liquid levels.

| <b>Section 4- Action(s)</b> | | | |
|---|---|---|---|
| B1 | C3 | Gas wells identified as potentially being inhibited by high liquid levels should be pumped to dewater the infrastructure and improve gas collection efficacy. In some instances wells may require de-silting alongside dewatering to improve the gas collection. | 31/03/14 |
| E1 | C3 | All emissions identified above 1000ppm identified during the audit should be remediated as a matter of priority. | 31/01/14 |

1. **Repair of emission identified during the audit** – All defects identified during the audit in excess of 1000ppm ambient methane should be repaired as a matter of priority and no later than the end of January 2014.
2. **Gas Well Dewatering** – Those wells identified as having a high level of fugitive emissions should be investigated for perched leachate / high liquid levels and dewatered to improve landfill gas collection. Where dewatering is not considered viable other measures to improve gas collection efficacy should be considered.

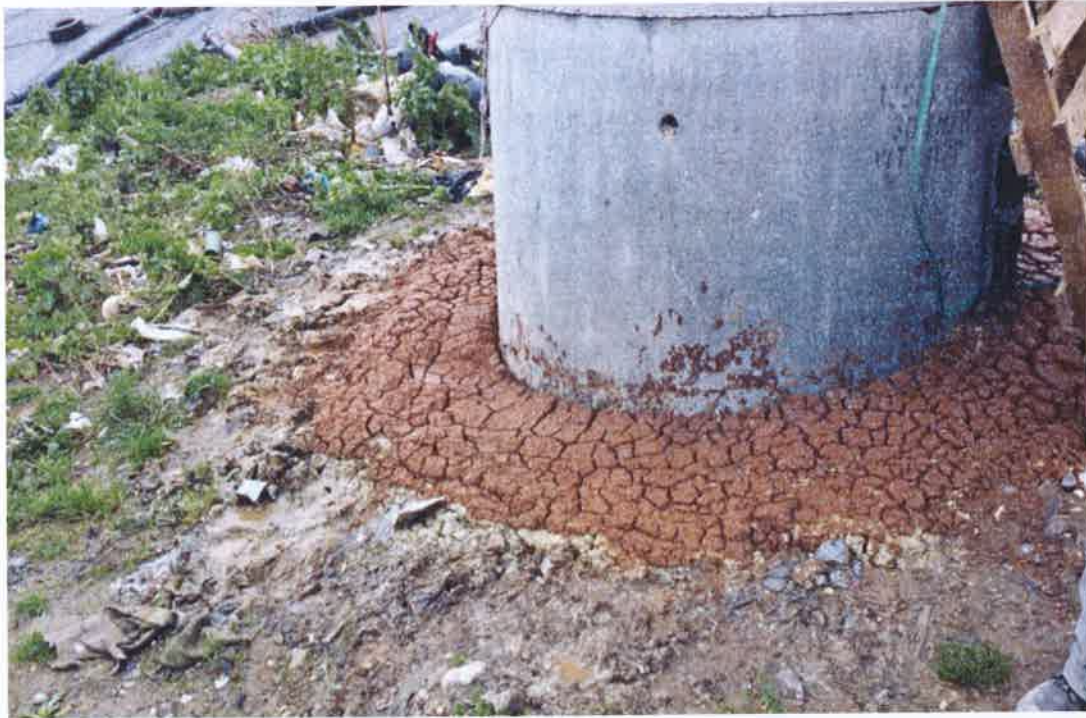
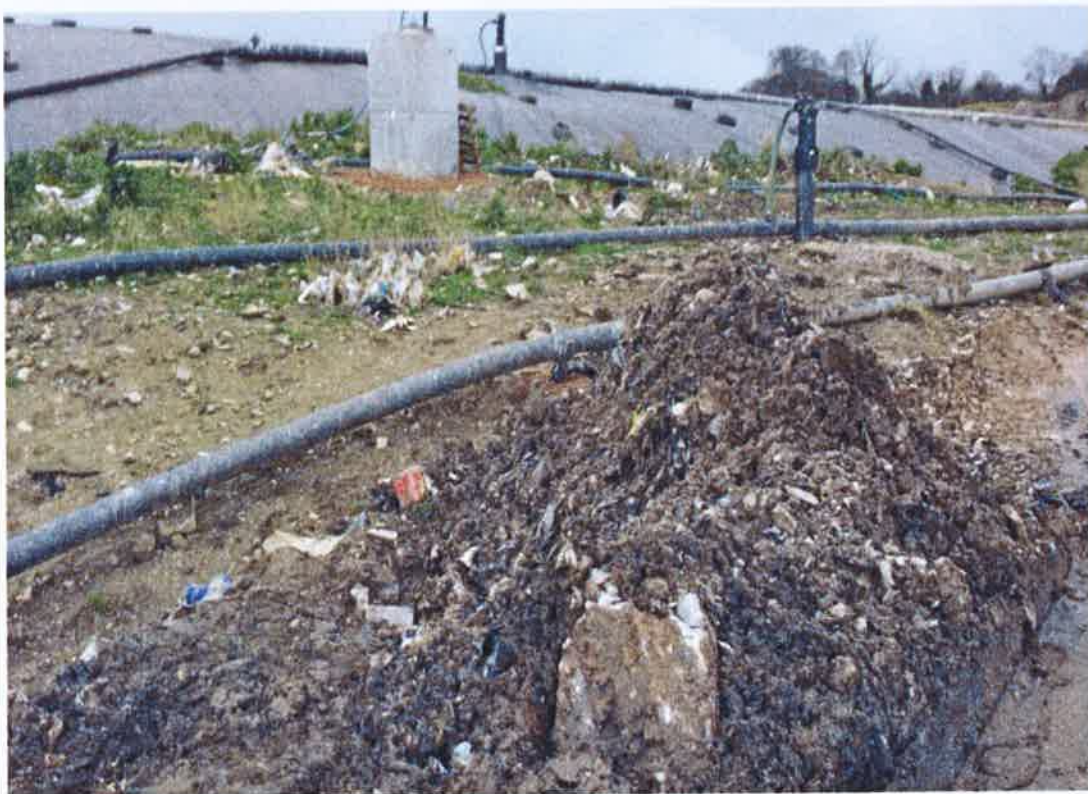
Pictures of this infrastructure and area of high ambient methane readings are included below:

- 5% Methane (50,000ppm) detected from around bentonite seal on LC3A, significant odour in this area.
- Odour and high ambient gas levels (500ppm) around a recently excavated area adjacent to the haul road and LC3A.

**LC3A** – A fugitive emission of 5% gas by volume (50,000ppm) was recorded from the bentonite seal around this leachate tower / monitoring point. Significant odour was present downwind.

A high ambient reading for methane was also recorded around the area of this infrastructure (500ppm) adjacent to an excavation near the haul road. It was unclear if this reading was as a result of the emission from LC3A or some other source in the area.

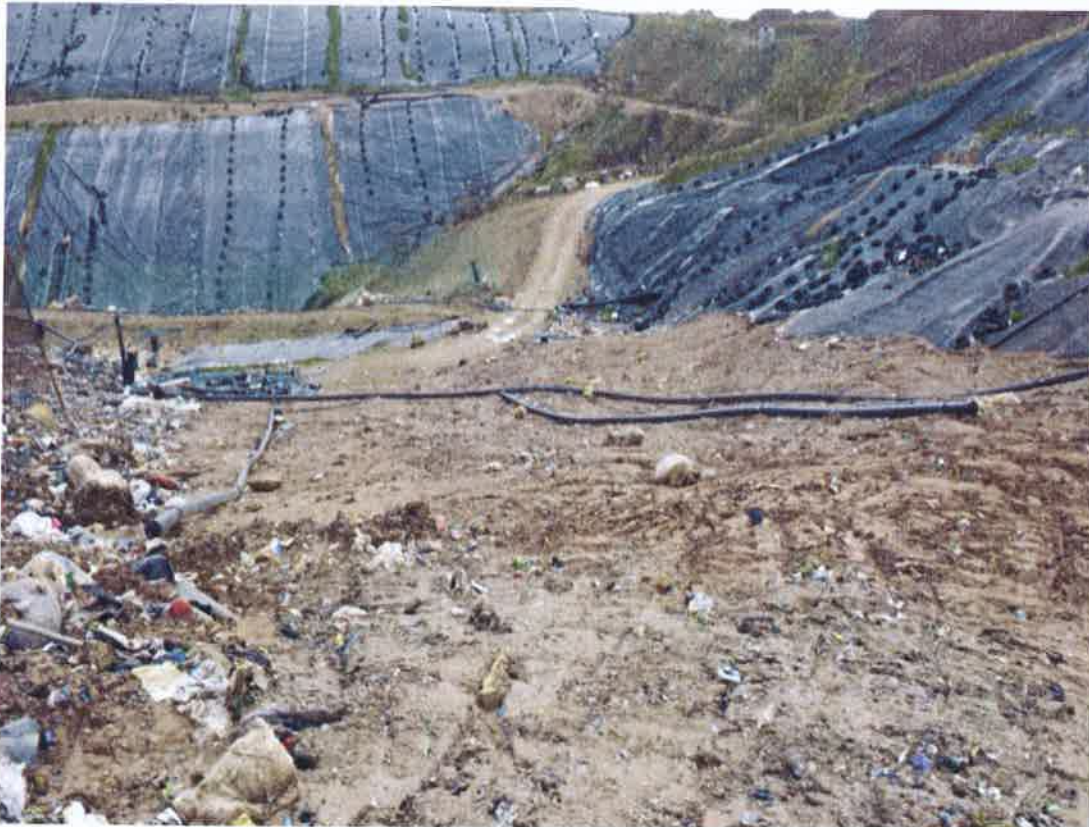
- Up to 10,000ppm detected directly from the bentonite seal on gas well D270.
- We noted the generally low level of gas odour around the lines of new pin wells that have been installed on the tipping area.

**New Lines of Pin Wells on Phase 3A North (pictured below)** – These pins wells were recently installed adjacent to the current active tipping area. No significant fugitive emissions or odours were recorded in this area as a result.
