**Saint Ishmaels & Ferryside  
Defence Maintenance  
Water Framework Directive (WFD)  
Assessment**

| DOCUMENT INFORMATION | | | |
|---|---|---|---|
| Project | Saint Ishmaels & Ferryside Sea Defence Maintenance | | |
| Title | Water Framework Directive Assessment | | |
| Document Ref | EV000867/WFD-2 | Issue / Revision | 2 |

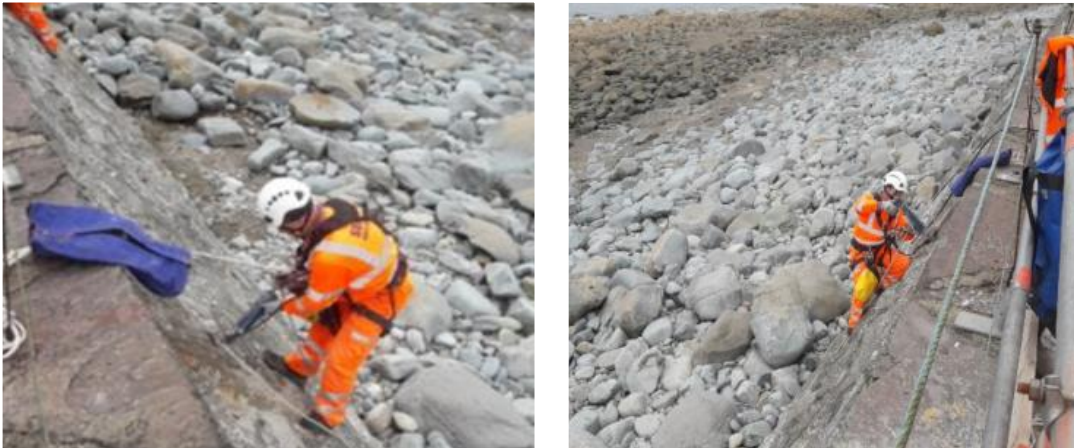
*Figure 2: Selection of images of previous minor wall repairs on a different rail route.*

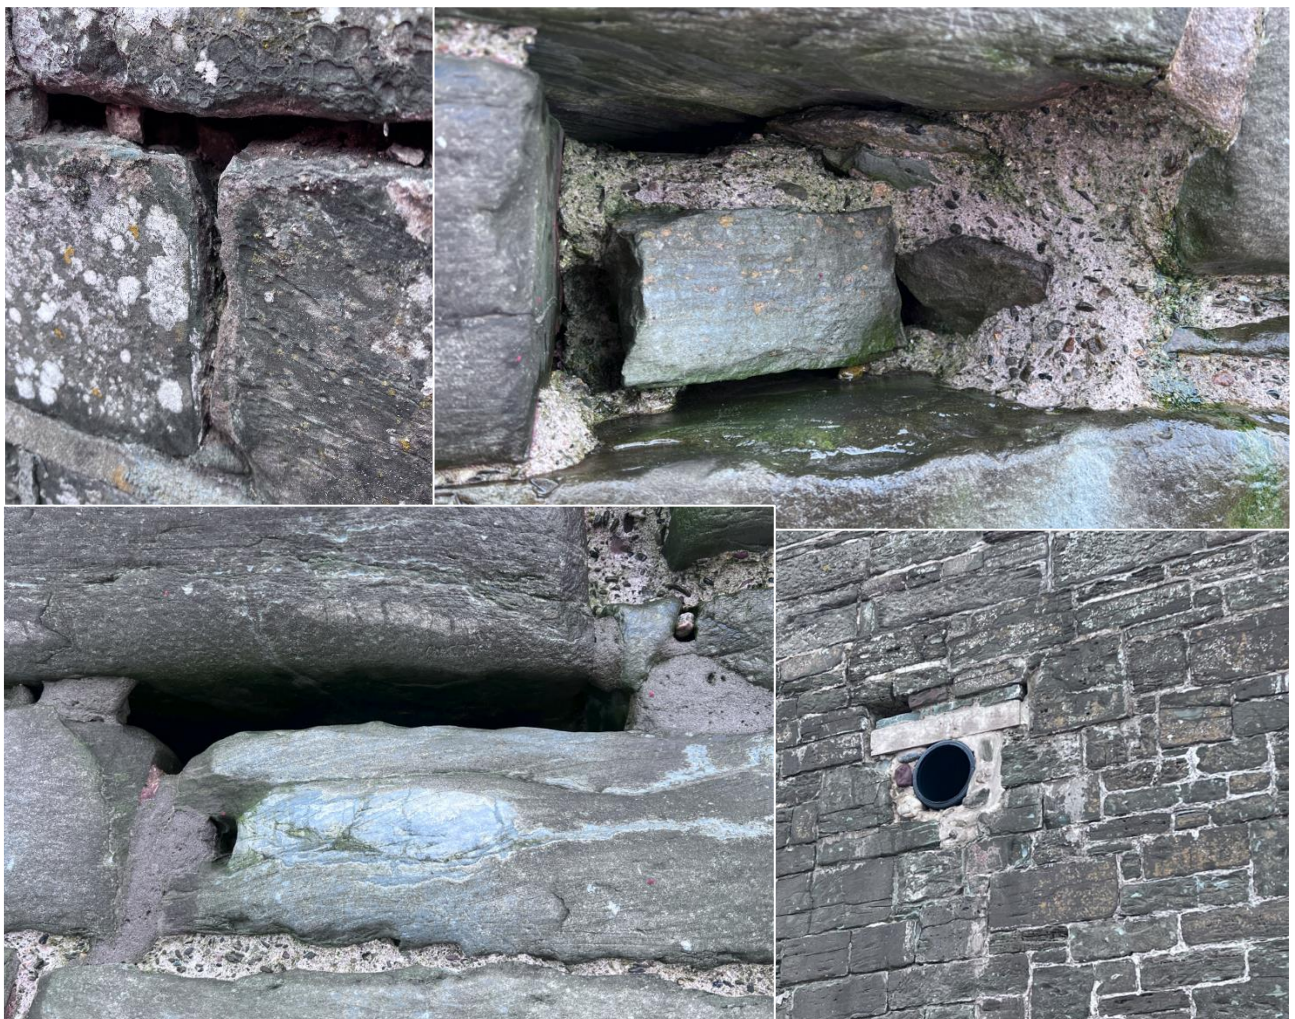
*Figure 3: The figure above provides a visual assessment of the 2020 condition of some SWM2 Sea Wall observed using a drone recording camera, (Images from spring 2020, via Network Rail).*

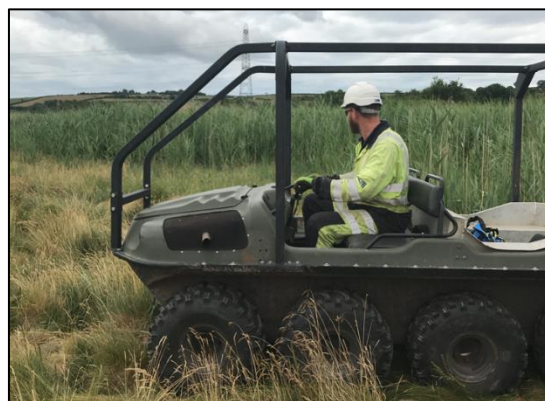
**Figure 6: Argocat Vehicle.**

- 4.4.3 In terms of light vehicle, due to the distance the defences stretch along this section of coast, and potential lack of safe rail access (primarily to the north) and Argocat vehicle is proposed to be used, to assist teams with moving equipment along the beach front.

- 4.4.5 In terms of agreed routes, the Argocat will be limited to use on the harder shingle and sand substrate only and will not be permitted further out into the estuary in such a manner that mudflats could be impacted.
