## Compliance Assessment Report CAR\_NRW0040239

| <b>Permit number</b> | CB3393ZB | <b>Operator name</b> | GLJ Recycling Limited |

| <b>Site name</b> | GLJ Recycling Limited |
| <b>Assessment type</b> | Inspection |

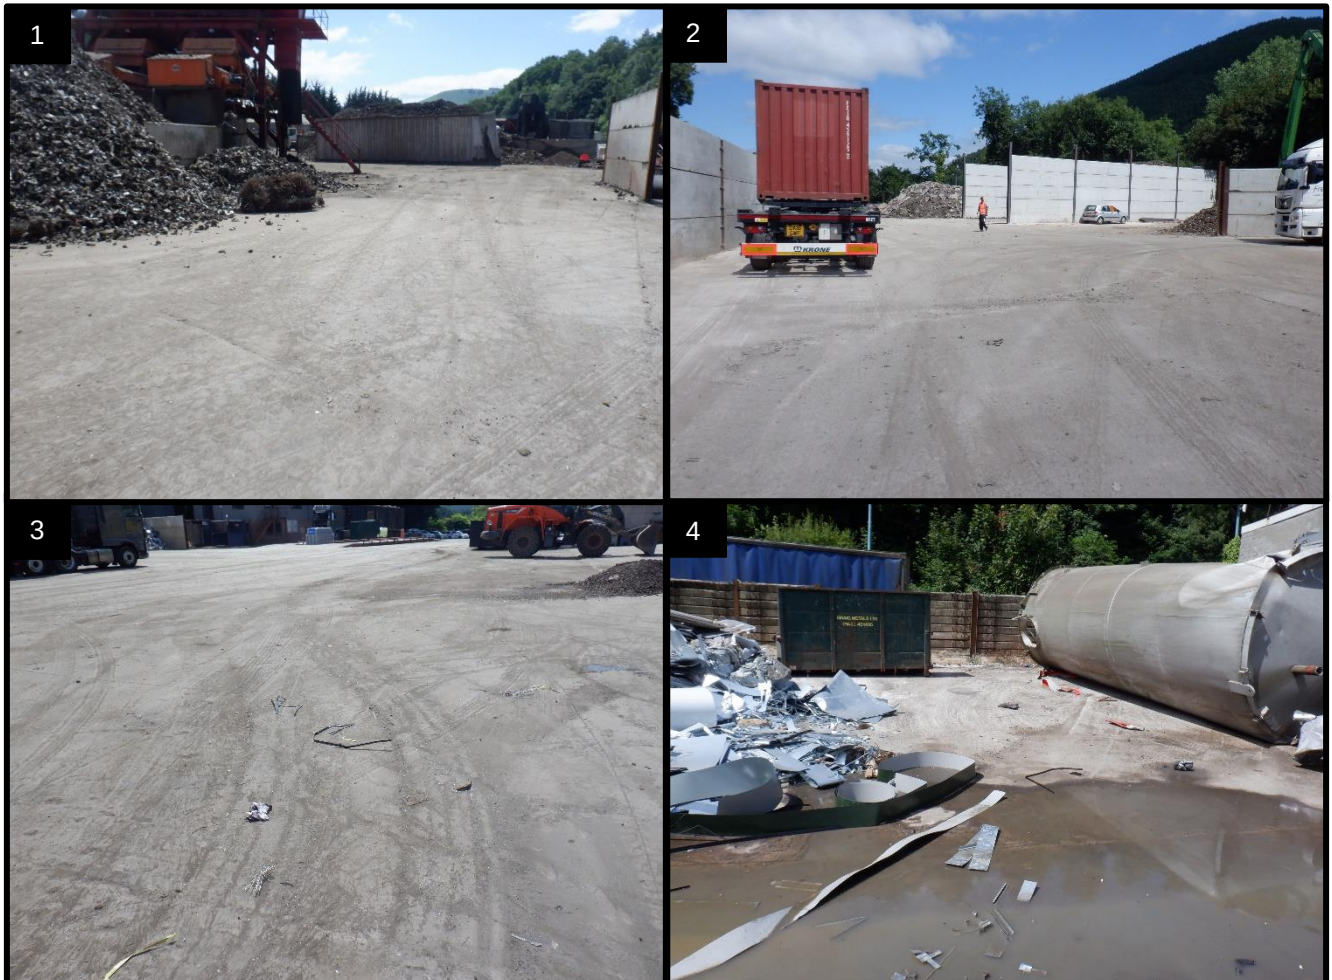
During the site inspection I observed extensive areas of newly constructed engineered concrete impermeable surface (see photographs 1- 4). I observed some pooling of rainfall dependent surface water (see photograph 4) which the operator confirmed would be addressed with the instating of additional drainage infrastructure. An area to the south of primary shredder had been cleared of all wastes and the surface was being prepared ready for concreting work to commence in August 2022. An area to the east of the primary shredder contained pockets of damaged concrete (see photographs 5 & 6). This area is a high traffic area where heavy tracked plant operate throughout the working day. The schedule of works indicated that this area is to be repaired by the end of 2022 (weather permitting). The northern quarter of the site is the subject of a planning application for a new shredded waste heavy fraction treatment building and is not currently used for any existing waste storage or treatment activities (but is inside the permit boundary). Works are to commence in this area pending the outcome of the planning application.

Photographs 1-4. Areas of newly constructed engineered concrete impermeable surface

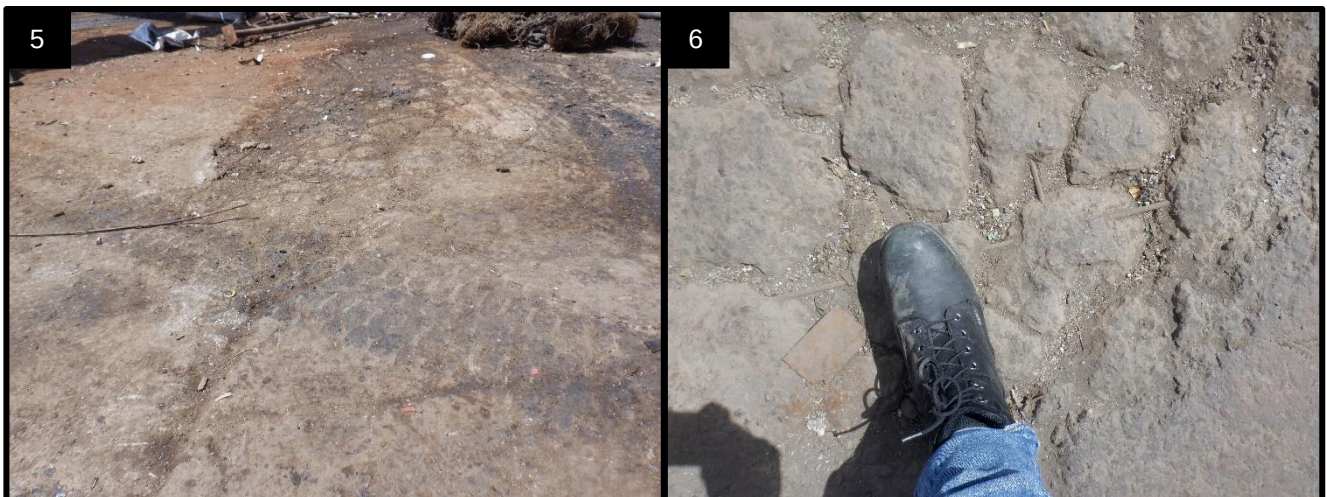
Photographs 5 & 6. Areas of damaged concrete impermeable surface.

The operator has invested considerably in the integrity of its working areas and large areas of the impermeable surface have been repaired or extended, at significant financial cost. The operator has a schedule of works to undertake further repairs by the end of 2022, including an area of high traffic which is likely to cause some disruption to site activities during construction. We appreciate that this work may impact on business but are pleased that the operator recognises the importance of maintaining the impermeable surface to protect the environment. We observed some areas of the impermeable pad where potentially contaminated rainfall dependent surface water may escape the site and evade the drainage system. The operator acknowledged the issue and committed to undertaking the necessary work to understand surface water flow behaviour and instate the necessary control measures.

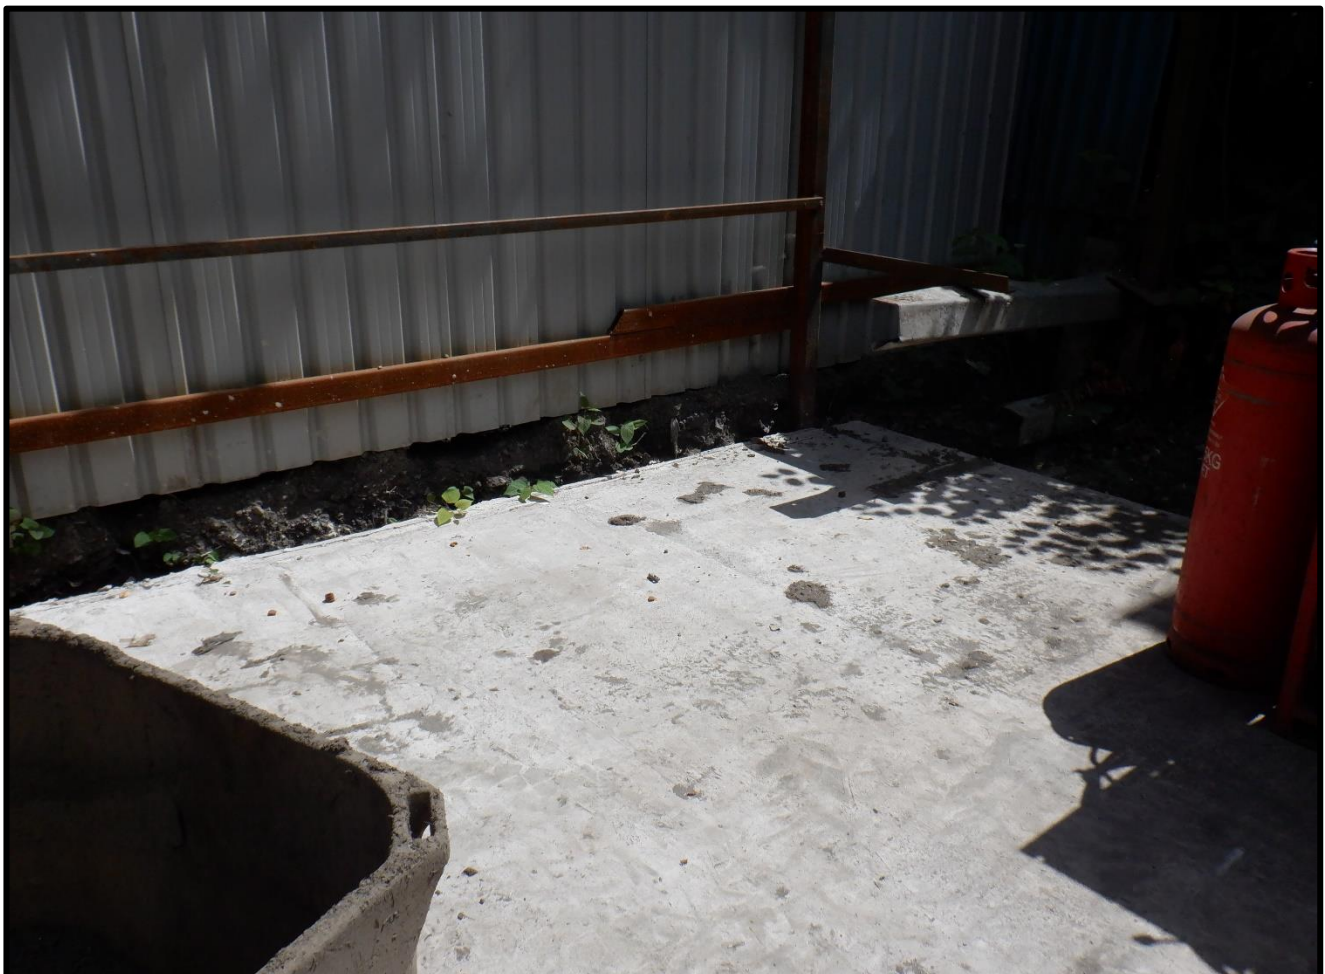
However, some areas of the site did not appear to have any engineered infrastructure preventing potentially contaminated rainfall dependent surface water escaping the edges of the impermeable pad and evading the drainage system (see photograph 7).

Photograph 7. Potentially contaminated rainfall dependent surface water may escape the edges of the impermeable pad and evading the drainage system.

*Action 2: Investigate surface water flow behaviour at the edges of the impermeable pad. Where the investigation identifies areas where there exists a risk of potentially contaminated rainfall dependent surface water escaping the edges of the impermeable pad and evading the drainage system, instate appropriate above and (where necessary) below ground infrastructure to redirect surface water into the site drainage system.*
