## Compliance Assessment Report

**CAR\_NRW0038792**

| <b>Site name</b> | Haverfordwest Creamery |
| <b>Type of assessment</b> | Pollution incident response (ref: 2107754; 17 September 2021) |

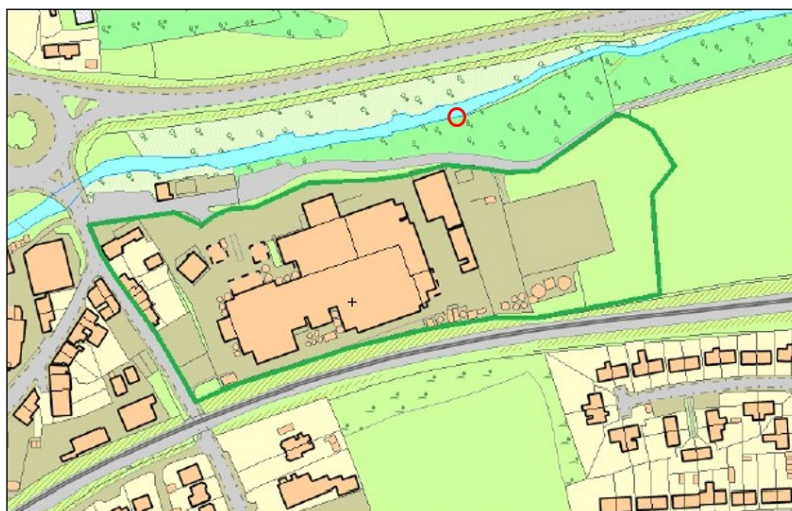
Natural Resources Wales' regulating officer for Haverfordwest Creamery responded to a pollution incident affecting the Merlin's Brook on 17 September 2021<sup>1</sup>. A discharge of pale, milky effluent was identified entering the Brook at National Grid Reference (NGR) SM 94965 14588, shown as the red circle in Figure 1 below.

The discharge point is the same location as a previous pollution incident attended by NRW officers between 04 – 05 August 2021, as detailed in our report CAR\_NRW0038790. This is located close to permitted installation EPR/XP3830UR (Haverfordwest Creamery), outlined in green within Figure 1 below.

*Figure 1: installation boundary (green line) and discharge point (circled in red) at NGR SM 94965 14588*

On the day of the incident, the operator – with specialist contractor assistance – commenced excavation of an interception trench close to the discharge point. This trench successfully cut through a buried land drain and allowed the operator to halt the effluent discharge into the Merlin's Brook at approximately 1800hrs on 17/09/21. A sump was then created within the trench and an over pumping system set up to deal with ongoing effluent flows. This arrangement has allowed the operator time and flexibility to investigate and rectify the drainage fault beneath the Creamery during a major plant (maintenance) shutdown in October 2021.
