Desk Based Assessment  
Hirael Flood Alleviation Scheme

Document Number B2004.DBA.01

## Hirael Flood Alleviation Scheme

Desk Based Assessment

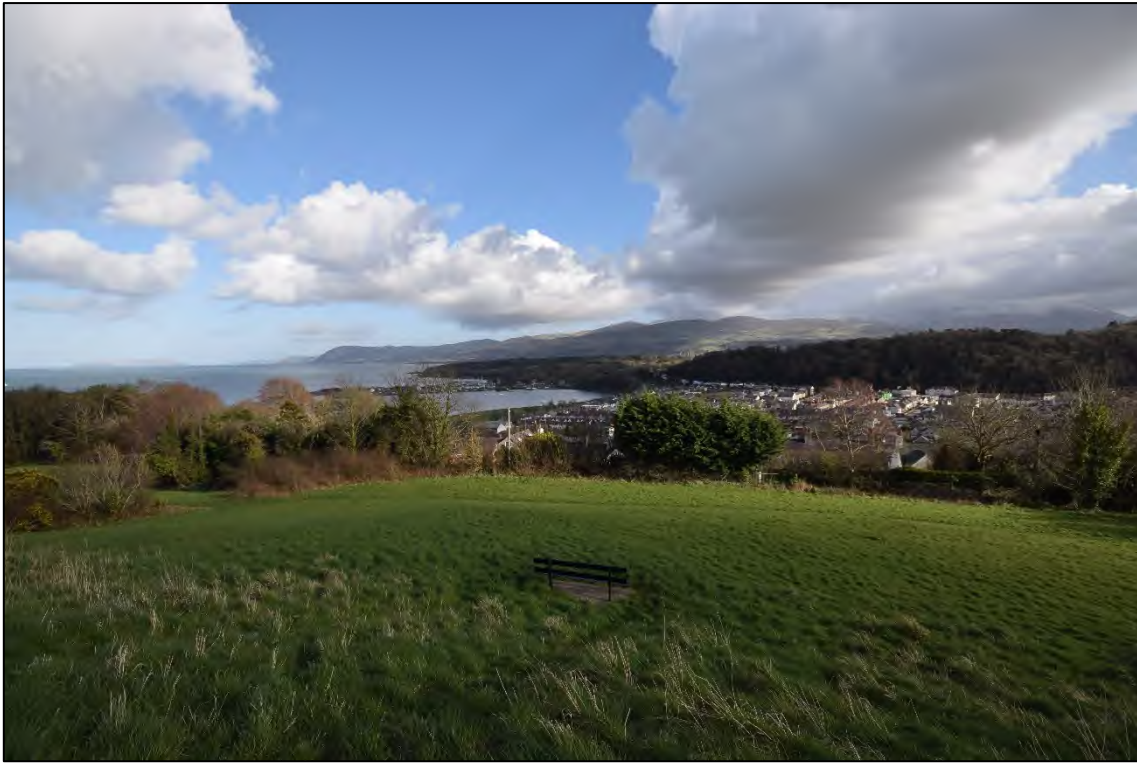
LiDAR data and the field visit confirms that the development would be visible from parts of Pier Camp including the top and eastern side of the eastern bank but would not be visible from the interior.

The proposed development would be visible from the asset but the scale of the development is unlikely to have a negative impact on the monument or it's setting.

Plate 1: View of proposed development area from Pier Camp, view from west.

Elements of the development would be visible from Pier Camp but the scale and distance would not cause significant impact.

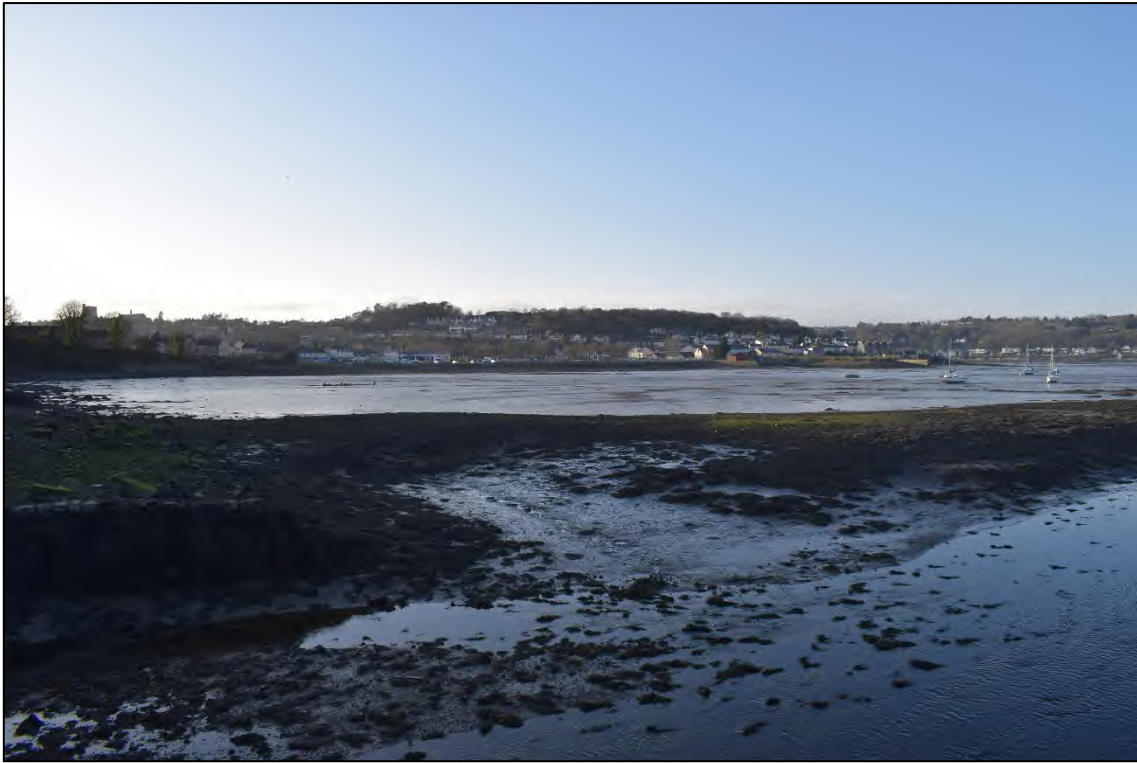
The proposed development would be visible from the asset but the scale of the development is unlikely to have a negative impact on the monument or its setting.

Plate 2: View of proposed development area from New Dock, view from east.

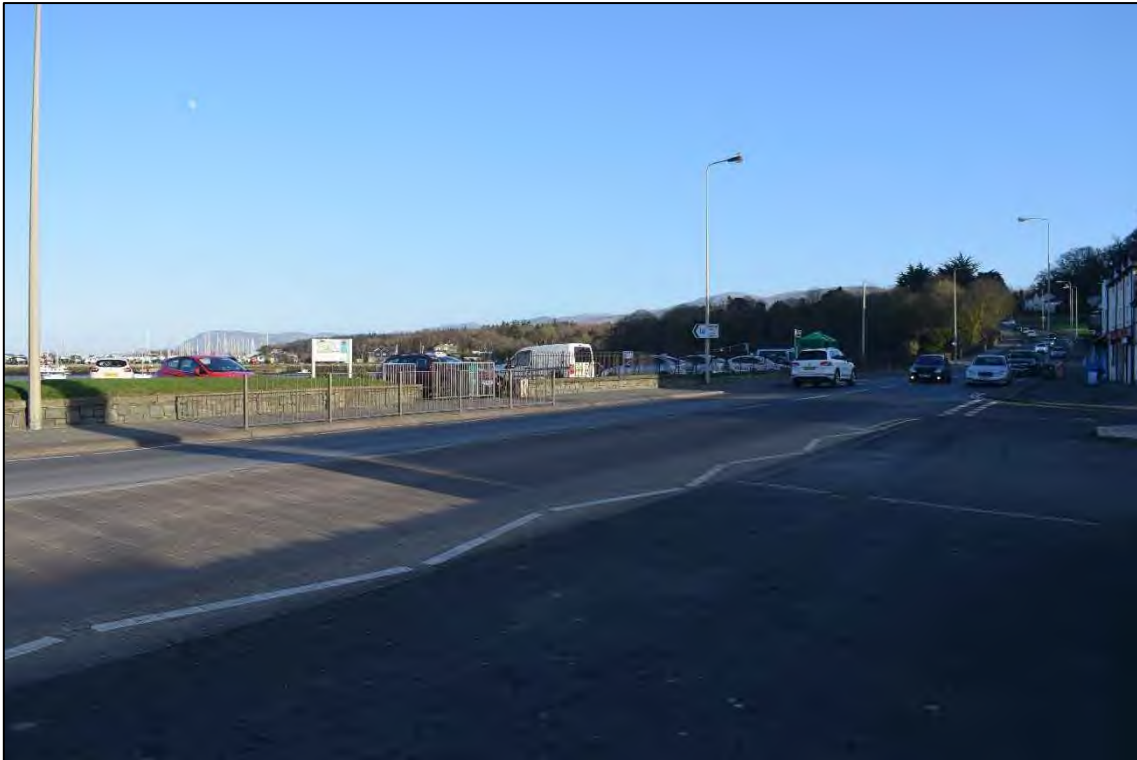
The development would be clearly visible from the asset and the raising of the Beach Road car park may affect views towards Porth Penrhyn from street level. The positive impact of the reduction of risk of damage from flooding is likely to outweigh any visual impact.

Plate 3: View of Beach Road car park, No.8 Beach Road to left of shot. View from west.

Although the scale of the coastal wall has not been confirmed it is not expected that it would cause excessive visual intrusion. The main visual impact is likely to be experienced from Listed Buildings at the northern end of Seiriol Road and No. 8 Beach Road.

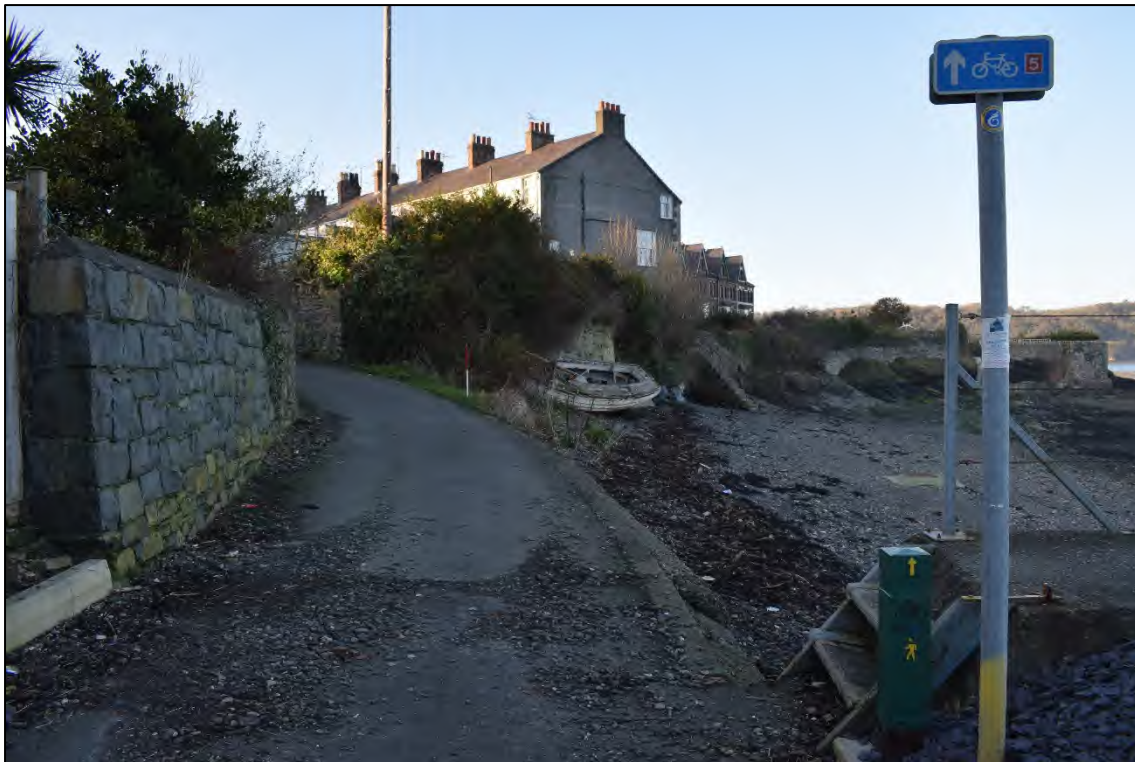
Plate 4: Location of proposed northern section of coastal wall, Glandŵr Terrace beyond. View from south, scale:1m

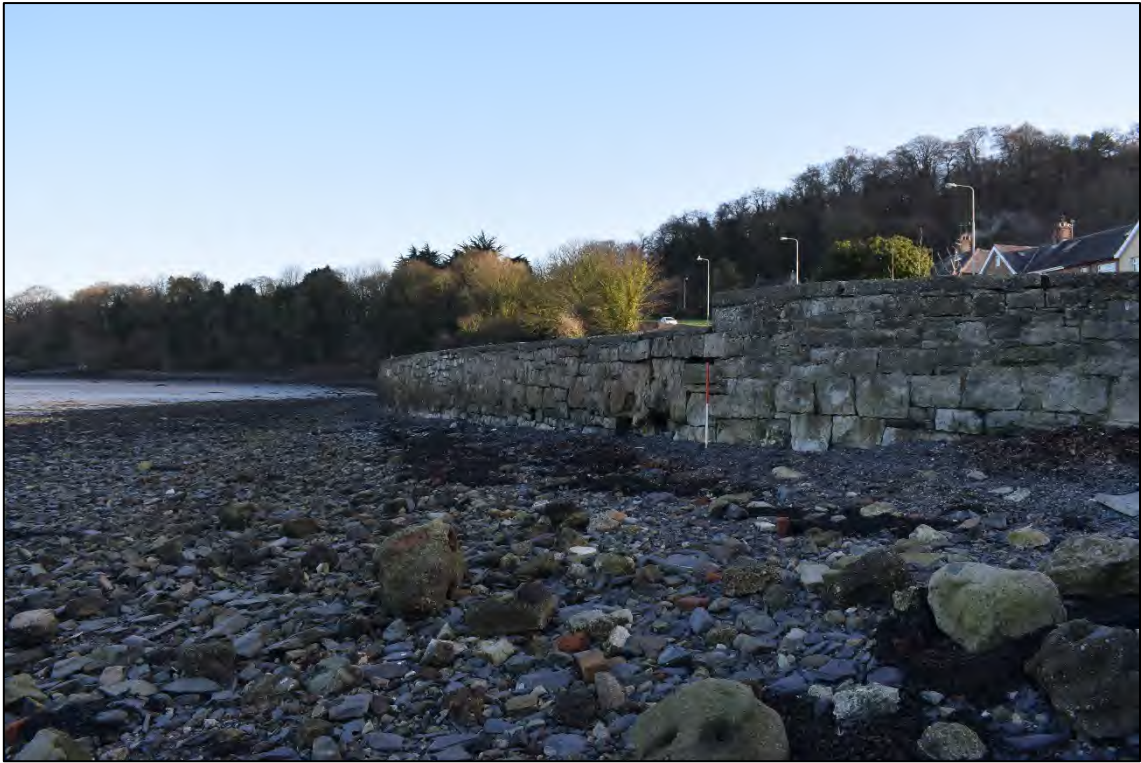
Plate 5: Existing coastal wall east of Beach Road car park, possibly associated with Timber Yard. View from north west, scale:1m

*It is possible that part of the current coastal wall is associated with a Smithy and Timber Yard shown on early Ordnance Survey maps and should be recorded in advance of development.*

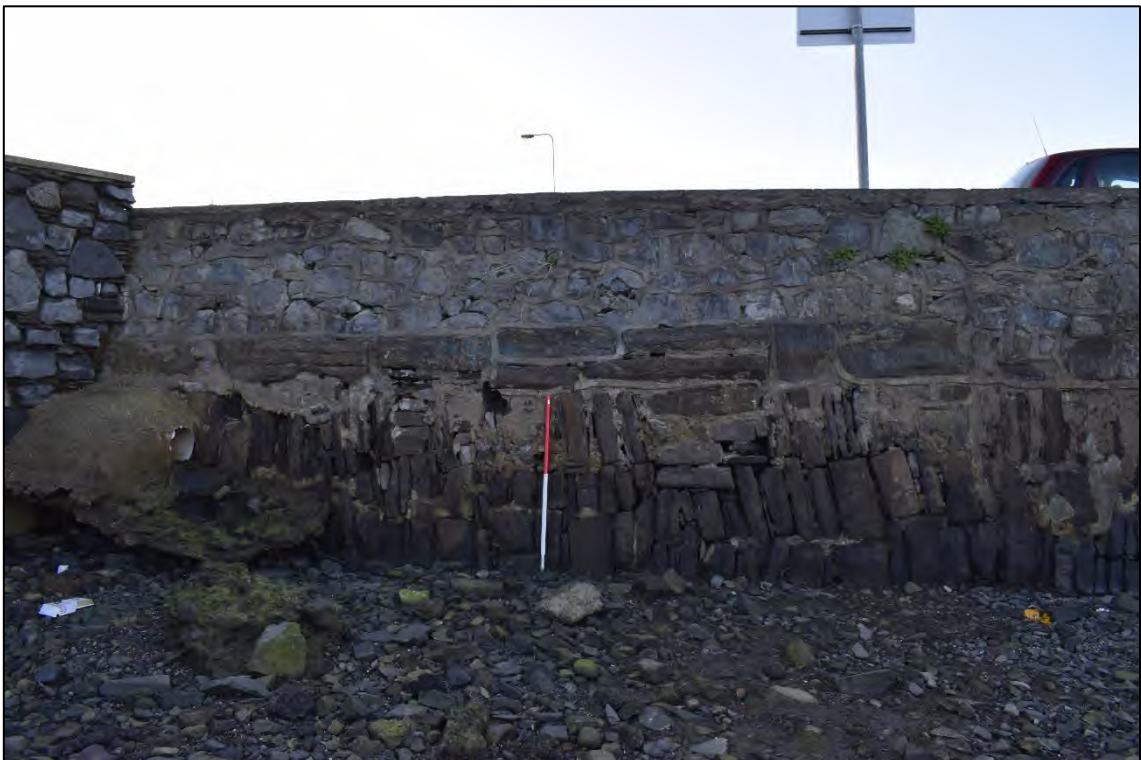
Plate 6: Existing coastal wall at Beach Road car park, possibly associated with Timber Yard. View from north east, scale:1m

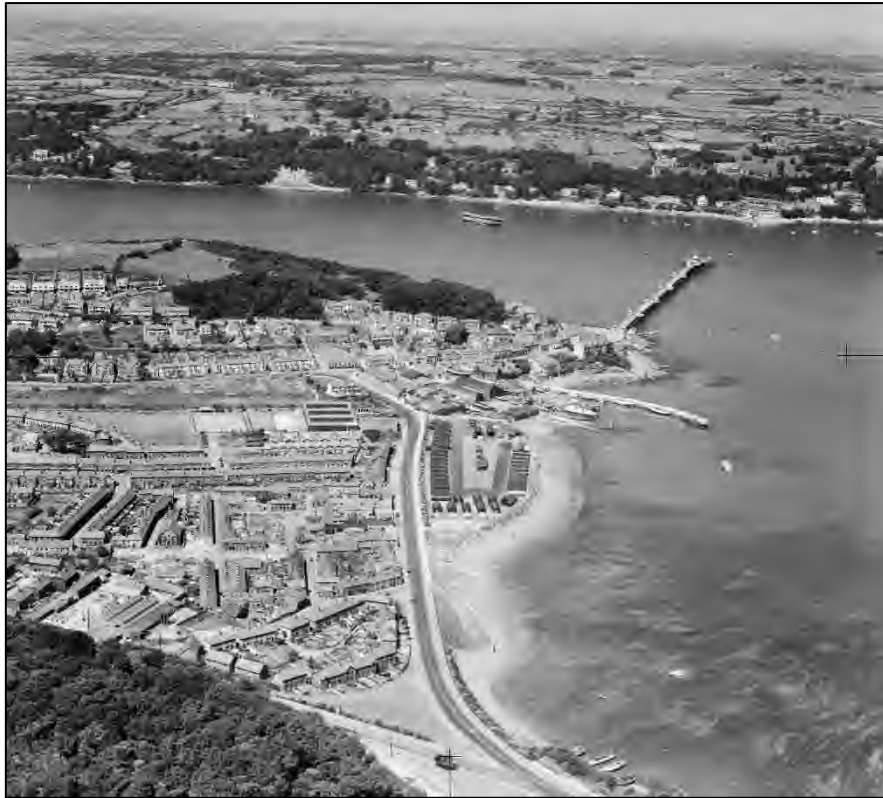
Plate 7: View of Bangor showing military camp on site of St George's Field Playing fields © RCAHMW.

| PRN | Site Name | Description | NGR |
|---|---|---|---|
| TBC | Military/ Prisoner of War Camp<br><i>See Plate 7</i> | A military camp was established on St. George's field at the outbreak of the Second World War. 40 Nissen huts were erected at the site to house troops of the Cheshire Regiment, Royal Irish Fusiliers and South Lancashire Regiment. In 1944 American troops were stationed at the camp whilst training for the D-Day invasion. Shortly after the Americans left Italian Prisoners of War were held at the camp. | SH58657280 |

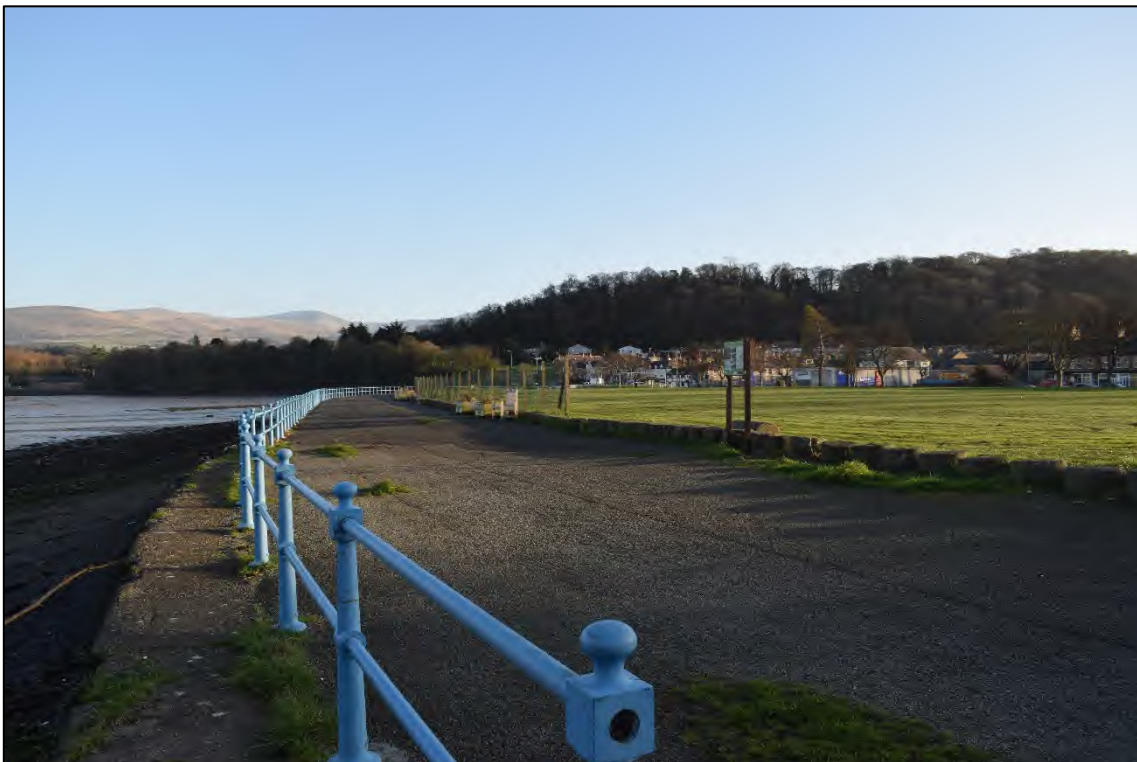
Plate 8: General view from pumping station towards Beach Road car park, former location of Military/Prisoner of War camp. View from north west.
