**Cwm Environmental  
(Nantycaws)  
Composting Facility**

**Bioaerosols Monitoring**

**30<sup>th</sup> November 2022**

**4th Quarter Report 2022  
'Open Windrow Composting'  
(IVC Compost Processing has ceased)**

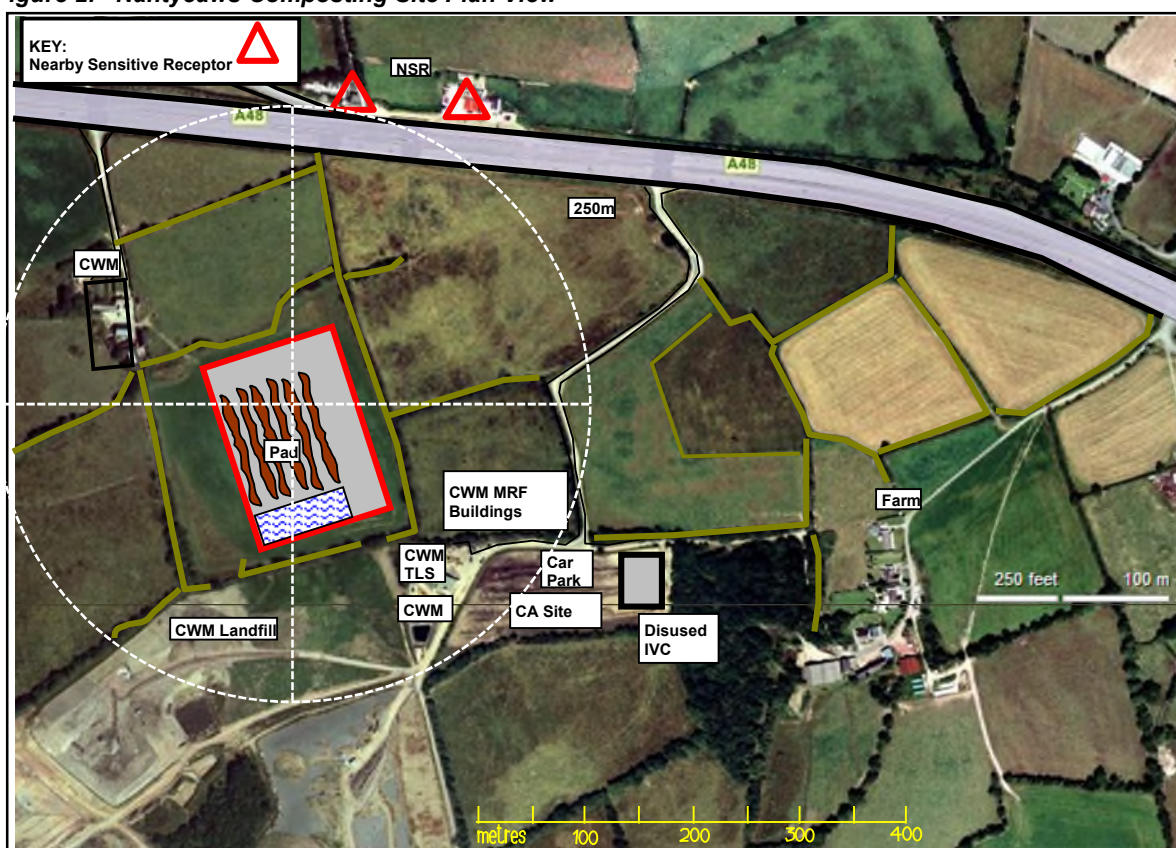
Figure 2: Nantycaws Composting Site Plan View

The open windrow Composting Facility at Nantycaws is situated within 250m of third-party workplaces and/or dwellings (see fig 2). These have been taken account of during monitoring.

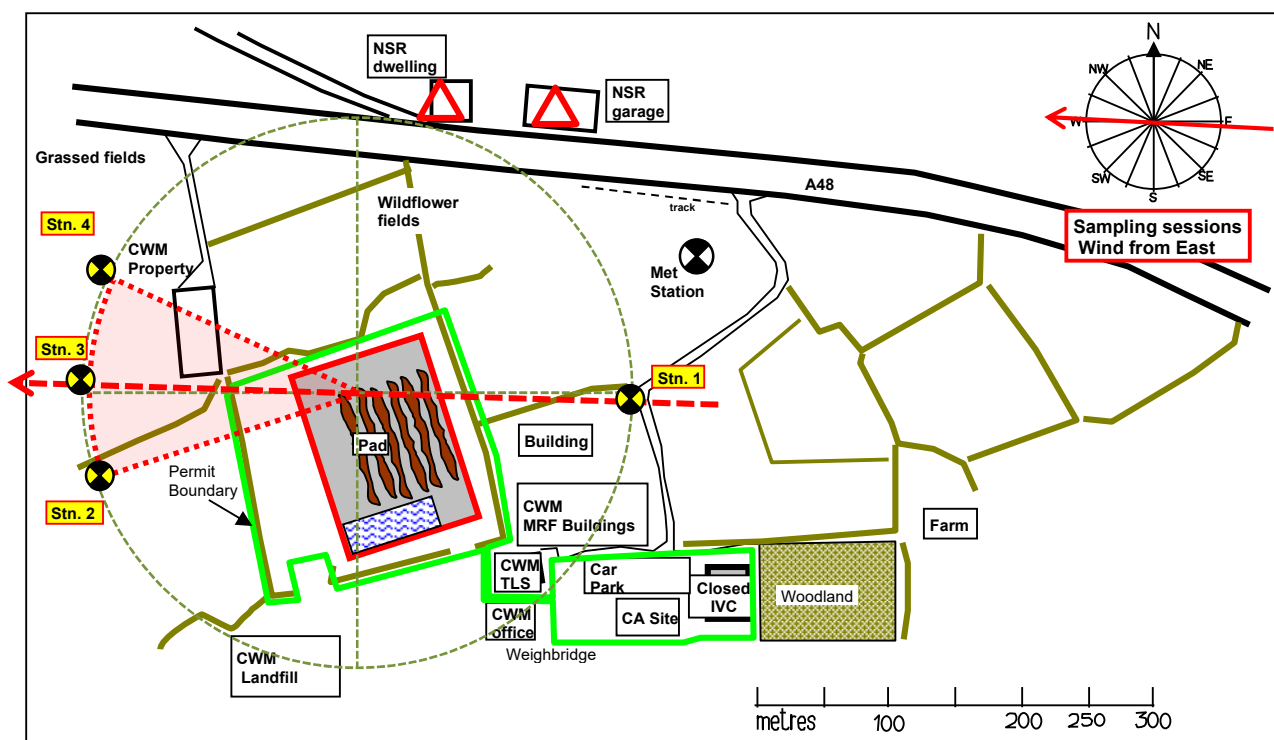
Figure 3: Sampling Station Locations – Open Windrow Composting Facility - SA 32 8BG

The following plan for sampling stations was utilised. The wind from the **East** was consistently towards the **West** throughout the session and the sampling stations were located to provide data in accordance with the 'upwind' and 'downwind'; at locations as shown in Figure 3.

| Station 1. | SN 47359 17720 | Located to the <b>East</b> , 120m from the site 210m <b>UPWIND</b> of the activity. |
| Station 2. | SN 46937 17670 | Located <b>170m from the site to WSW</b> , 215m from centre of activity to provide the <b>DOWNWIND</b> sample to the <b>LEFT</b> of the centreline. |
| Station 3. | SN 46920 17798 | Located <b>170m from the site to West</b> , 215m from centre of activity to provide the <b>DOWNWIND</b> sample directly <b>DOWNWIND</b> of the <b>Composting Pad</b> . |
| Station 4. | SN 46939 17891 | Located <b>170m from the site to WNW</b> , 215m from centre of activity to provide the <b>DOWNWIND</b> sample to the <b>RIGHT</b> of the centreline. |

The sampling station locations are shown at figure 3.
