## Compliance Assessment Report

Report ID:  
CAR\_NRW0033471

| Site | Palleg Landfill Phase II EPR/BT1908IX | | Permit Ref | BT1908IX | |

### Site inspection 5th June18

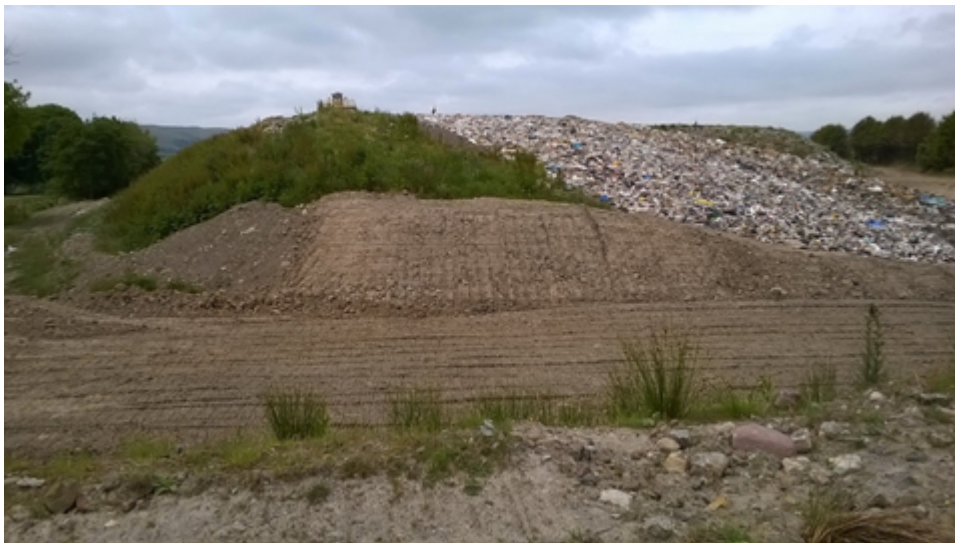
Cell 5 filling and re-profiling on going. JLA detailed the preparation that has taken place in relation to sub cell 6, including excavating clay to formation levels. This will be completed by the end of the week. CQAP provided and being considered by NRW (see update below)

Photo 1 showing sub cell 5 tipping.

Inspection of cell 5 tipping area revealed predominance of plastics and foam material mixed with dry fines. Low degradable fraction and settlement potential.

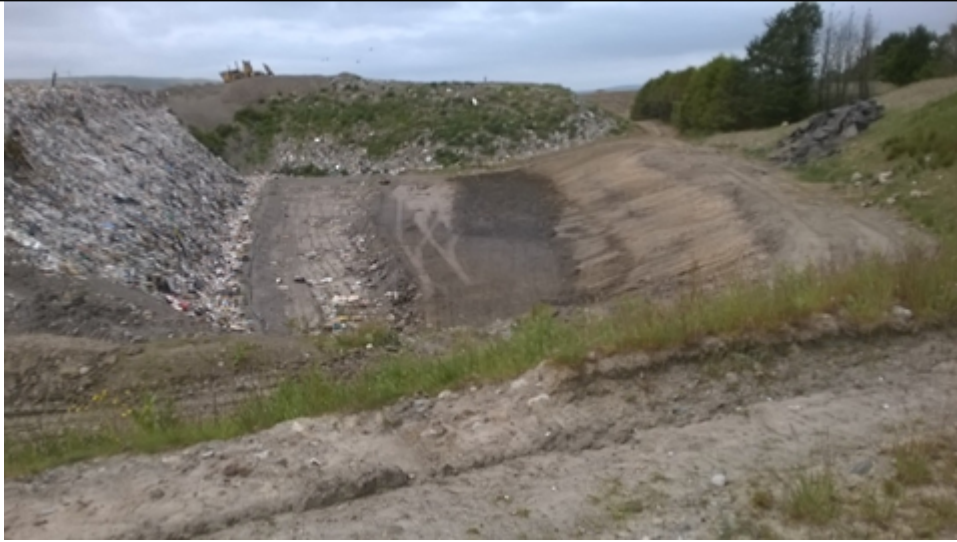
Photo 2 showing layout and formation levels for sub cell 6

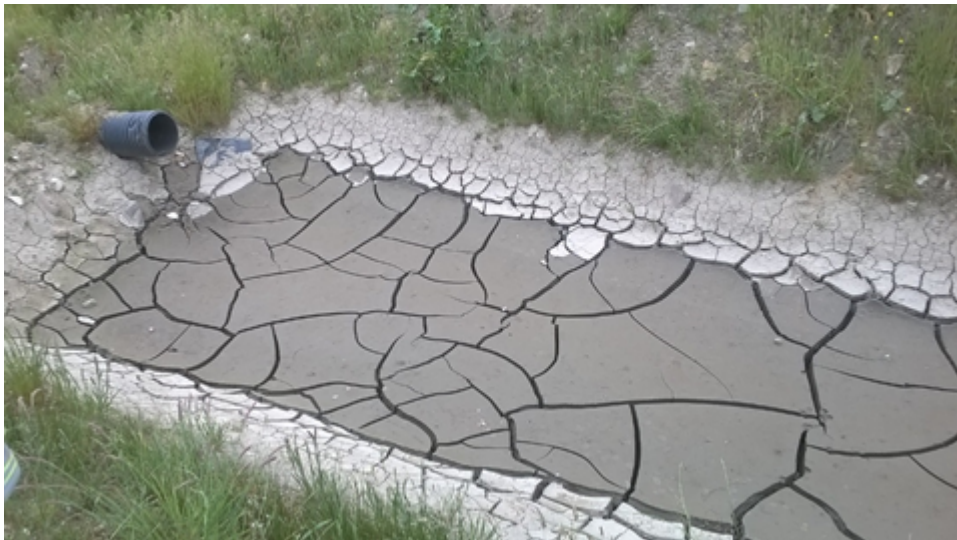
The SWMS pipe-work has been improved between the holding lagoons which now seem to be performing as designed. The ground was very dry during visit and there has been no pumping or discharge for ~3 weeks. It was therefore not possible to check quality, though the Q1 sampling results show a positive improvement. Agreed to provide quarterly results for information.

Photo 3 shows the dry conditions in valley feature holding lagoon

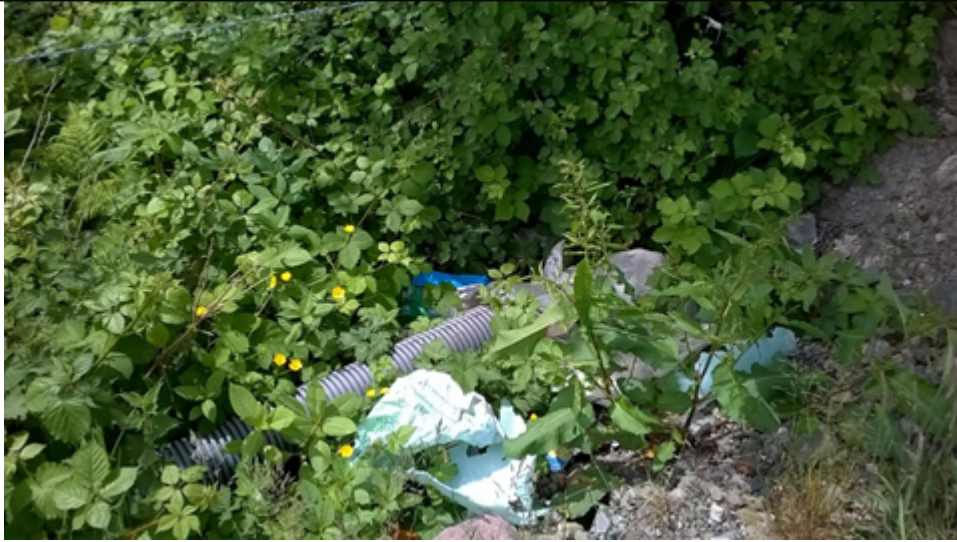
Along Sub cell 4 south flank and in the perimeter ditch / stream / SW3 /SW4 sample points there are numerous pieces of windblown litter - this should be retrieved as soon as practicable. Potential for contamination in water considered non compliance CCS3 in first instance.

Photo 4 showing litter at SW4 sample point.

| Criteria Ref. | CCS Category | Action required/advised | Due Date |
|---|---|---|---|
| C2 | C3 | Ensure waste is retrieved as soon as practicable in accordance with management systems. | 31/08/2018 |
| F3 | C4 | Minor windblown litter observed in adjacent field, to be retrieved as soon as practicable | 30/08/2018 |

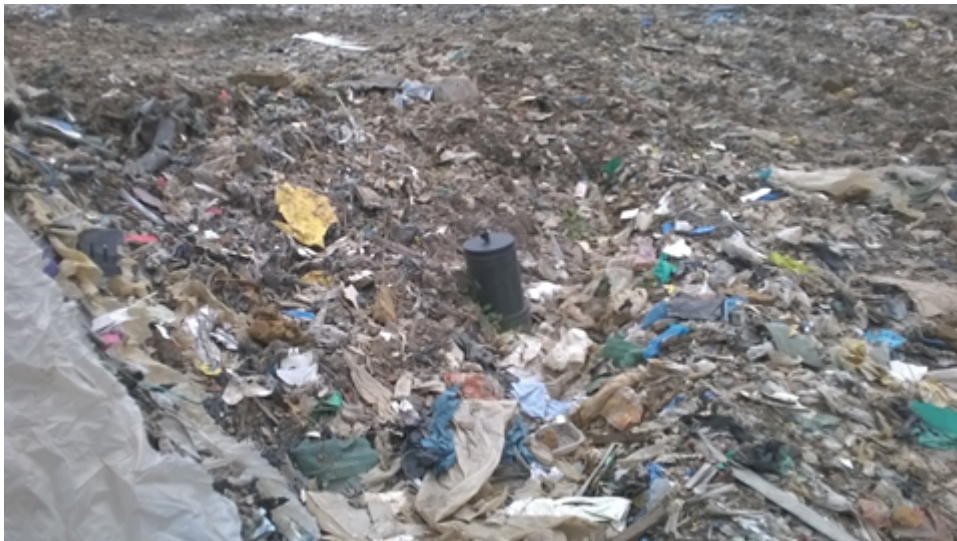
We discussed H&S around gas/leachate wells and the use of I/R Thermal imaging camera to monitor emissions. The camera will help to identify the main features so sealing can be improved.

Photo 5 showing In-waste lfg / leachate well 2

| Criteria Ref. | CCS Category | Action required/advised | Due Date |
|---|---|---|---|
| F1 | C4 | Review and seal main emission points, by use of thermal imaging camera. Reduce area of exposed flanks | 30/09/2018 |

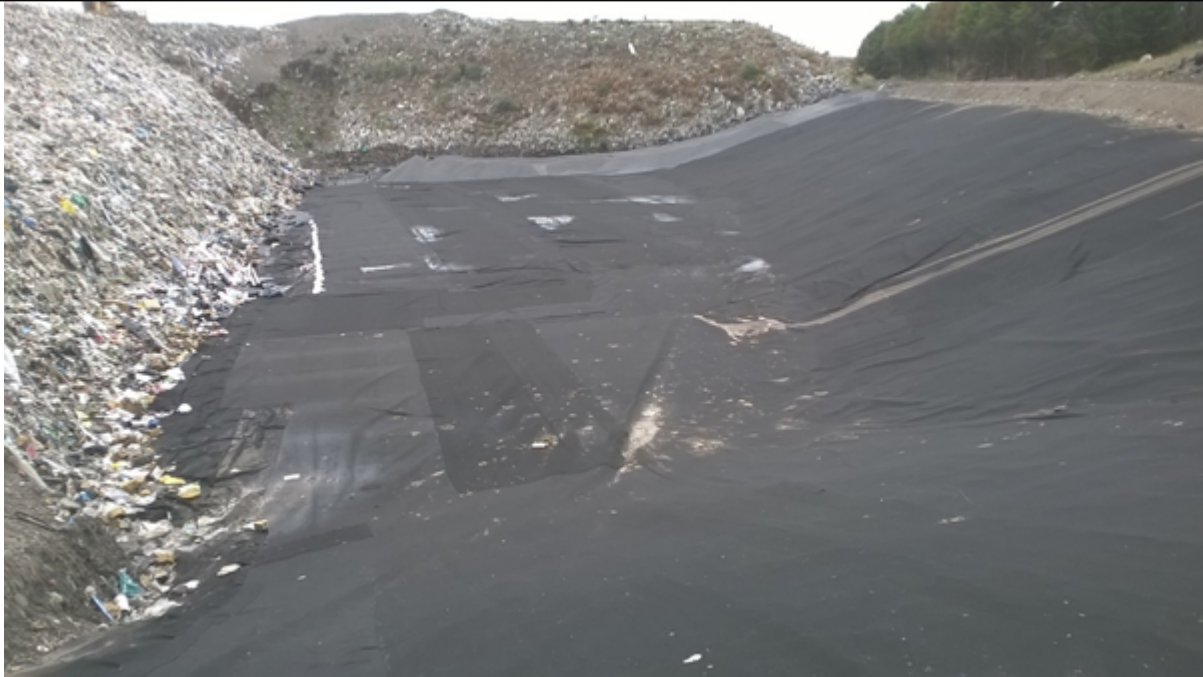
1. The 0.25m clay regulating layer was constructed during the dry weather period last month. The CQA Engineer noted that it was drying out and is concerned that the permeability results won't meet the specification set.

2. We were informed on site that there will be no target pad constructed within the cell. It was also apparent that none of the former cells have been constructed with a target pad. Whilst this is not a requirement of the permit it is now seen as best practice within LFE guidance such as 'Landfill Engineering: Leachate Drainage, Collection and Extraction Services, R&D Technical Report P1-397/TR'. We would therefore strongly encourage that best practice is followed and a pad be installed within this cell.

3. Leachate pipework is being jointed by automatic electrofusion welding. A leak detection survey will be carried out following completion of welding. This is line with the relevant guidance however we would recommend that the operators of the electrofusion welders are required to demonstrate competency for CQA purposes and demonstrate accreditation with an appropriate body.

Photo 6 showing sub cell construction

- Could photographs be provided of the clay layer before the FML was laid?
- Was there any evidence of shrinkage and or desiccation?
- Please provide the location of validation sampling points for permeability, and detail whether these were located randomly or selectively?

The CQA plan, sections 9.5-9.7 requires that the CQA engineer inspects material prior to and following construction for compliance. If the material doesn't meet the specification set out in the Construction Specification (Ref 1807r1v1d0018), it will be considered non-compliant or out of-spec, in which case there is a chance that the clay may have to be reworked and re-laid if material suitability can't be justified.
