**Schedule 5 request for more information EPR/XP3830UR/V007 (PAN-019159)**

**Project Augerre permit variation application.**

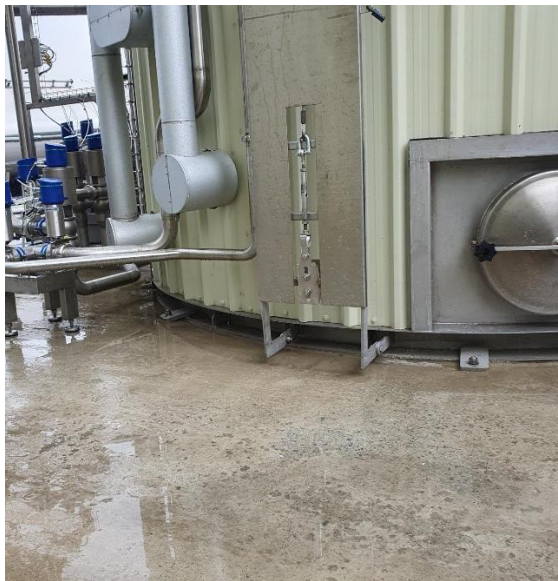
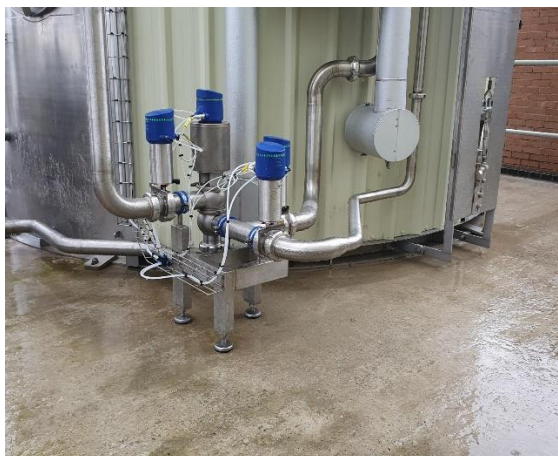
Photo 1 – milk silo

We can confirm that the surface where the new silos and vats are located are hardstanding.

Please see below photos for your reference of the milk silo bases (external) and cheese vat location (internal as previously described).

Please note, the new milk silos are on an extension the silo bed that houses the historic milk silos and that the new cheese vats, as mentioned previously, are located next to the existing vats inside the building within the Cheeseroom.

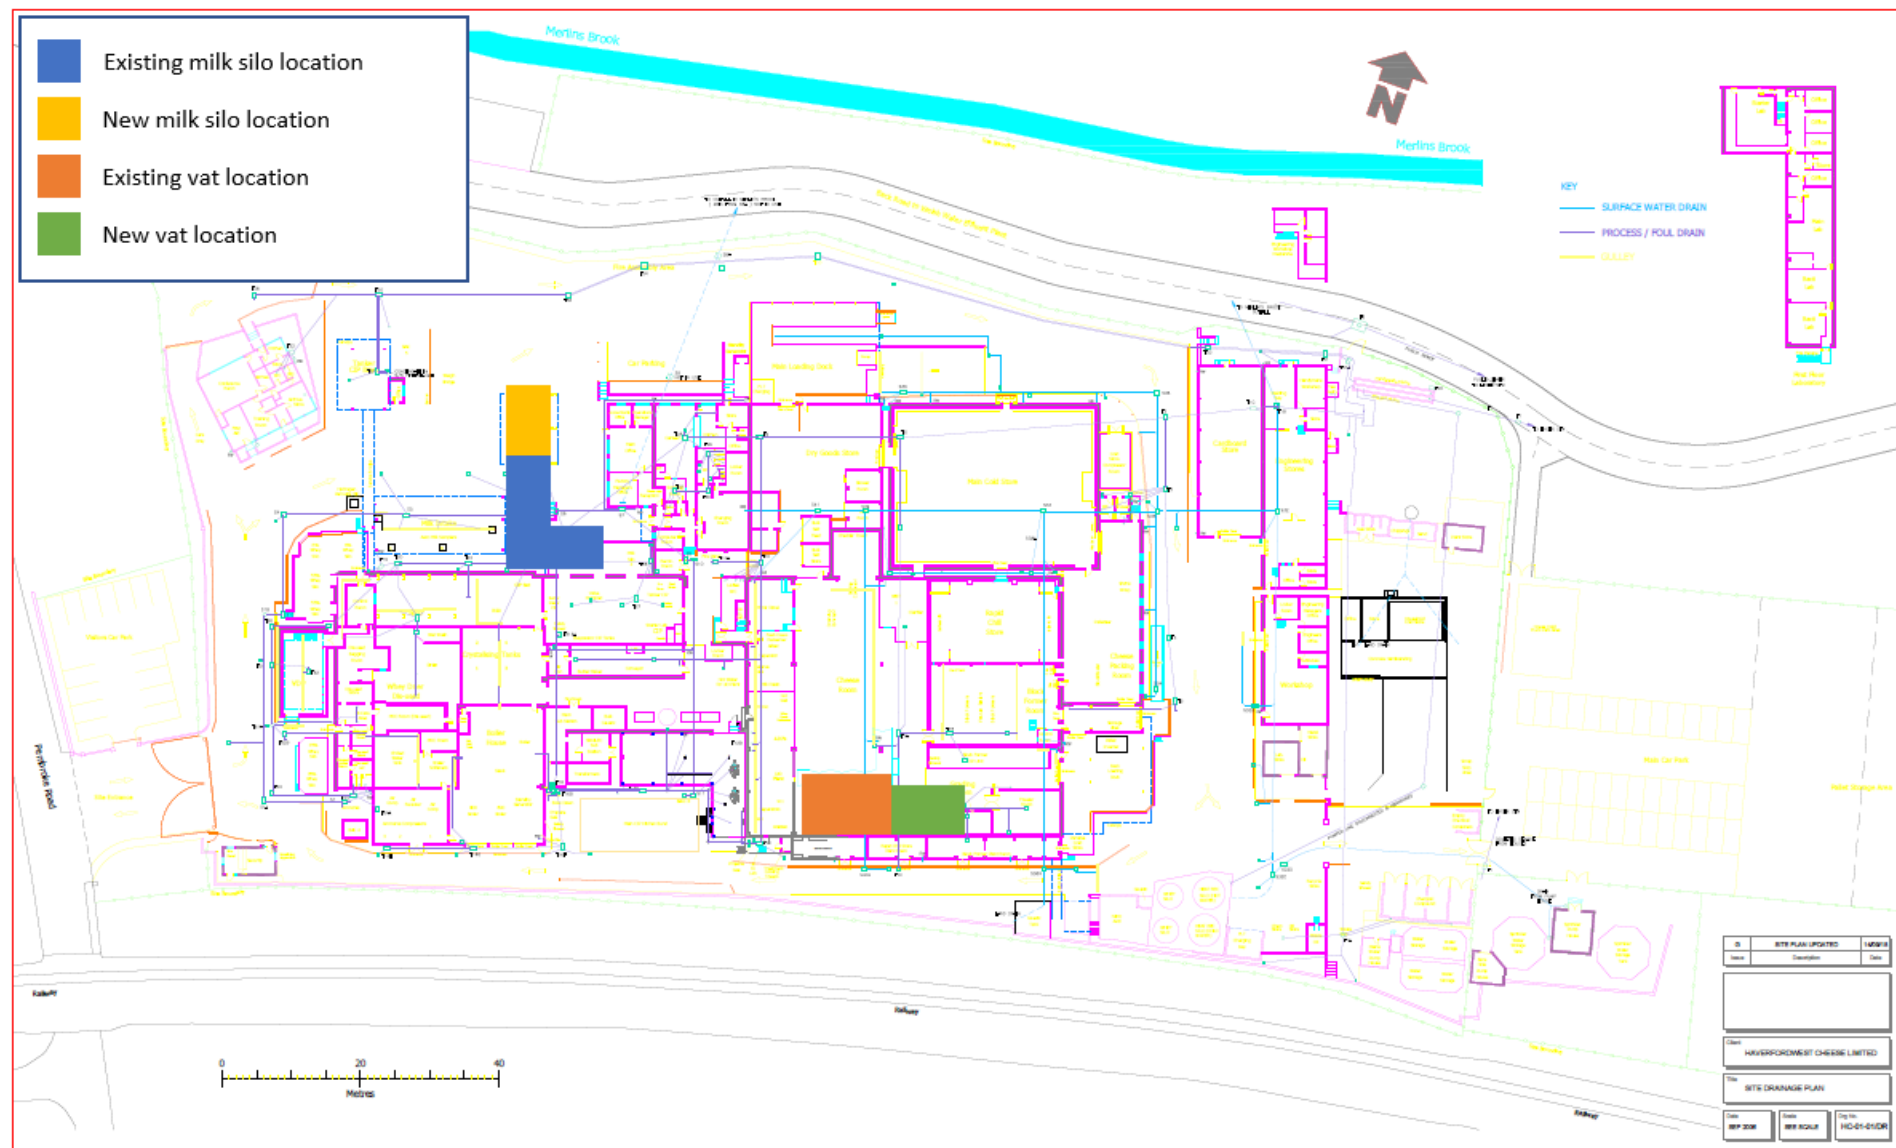
Appendix 1 – drainage place with locations annotated.

However, please find attached our existing site drainage plan with the new silo and vat's location annotated on for your attention.

We do not currently have an updated drainage plan that shows the new silos and vats.
