Silent Valley Landfill

2018 Biological Monitoring of Nant Merddog Stream

1772760.B.0

February 2019

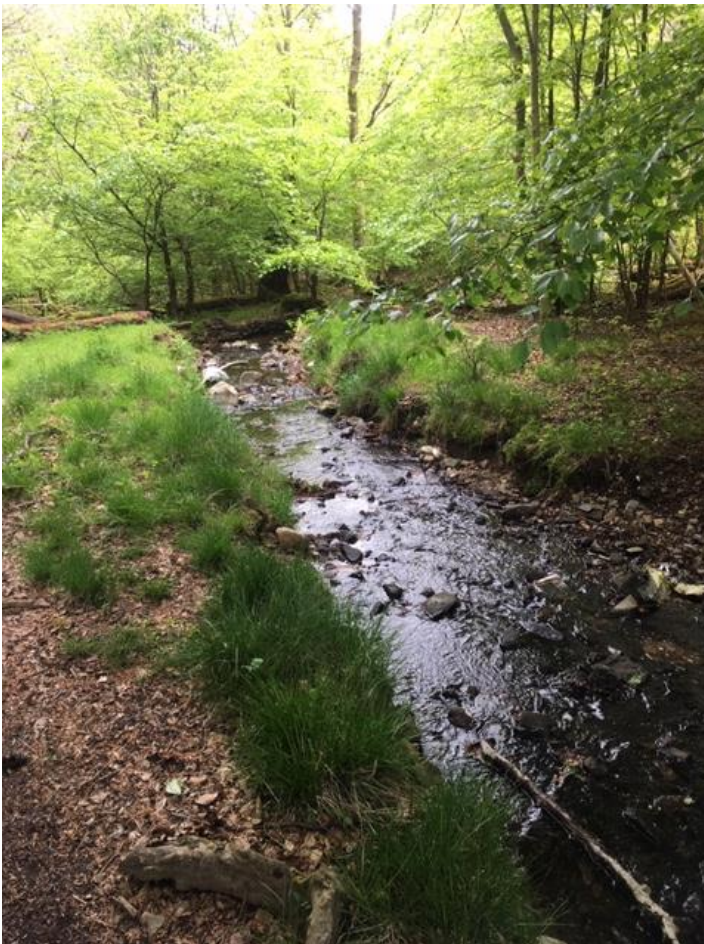
Figure 1: Site 1 looking down stream

Water levels within the Nant Merddog during spring were moderate. Leaf litter and silts were observed, with most organic detritus being noted toward the lower reaches of the sample area around reaches (Sites) 1 and 2. This is consistent with the presence of riparian woodland. Water clarity was good throughout and no appreciable odour was noted.

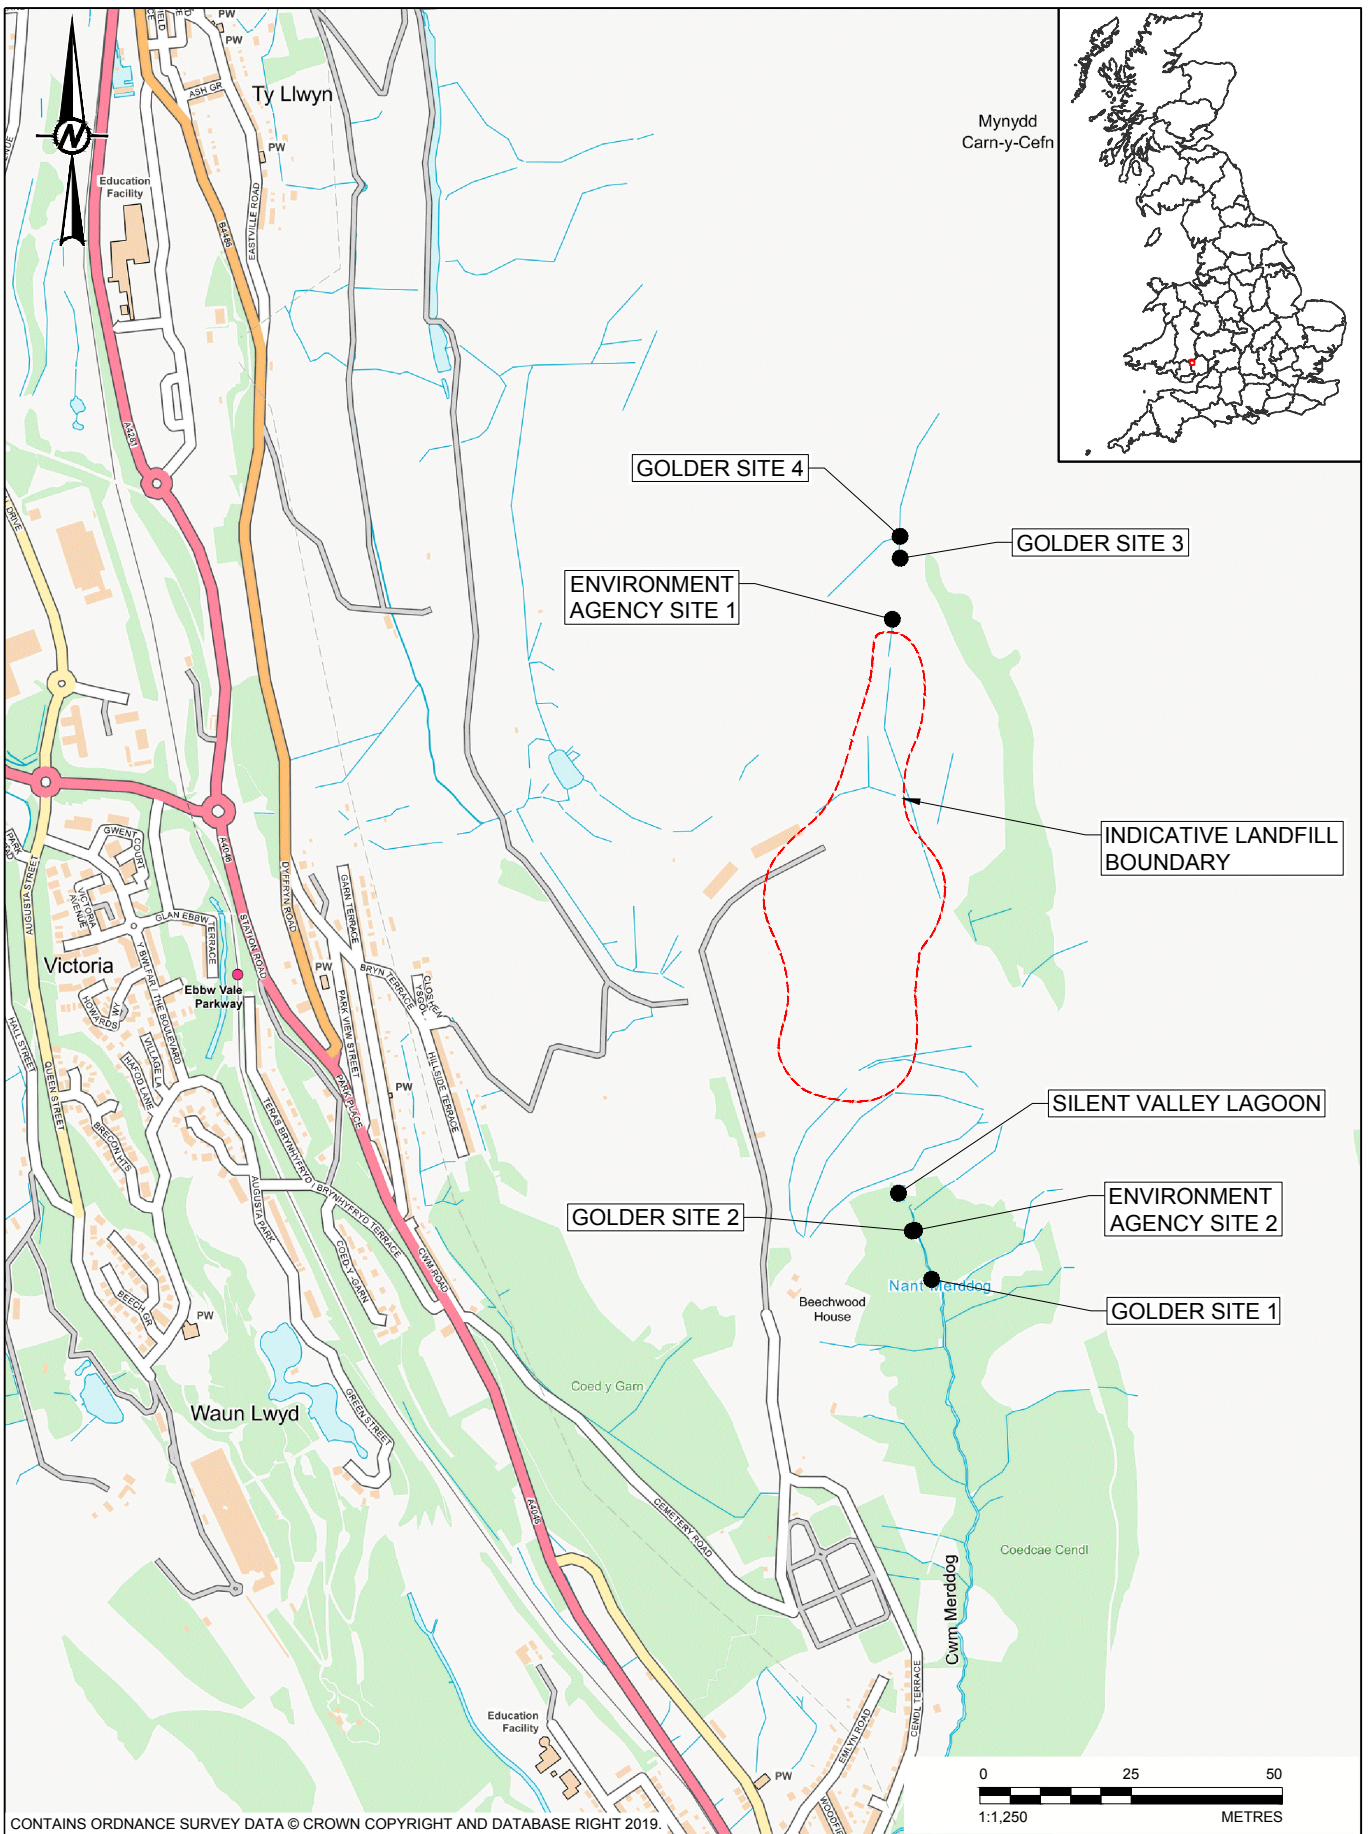
TITLE
AQUATIC INVERTEBRATE SAMPLING LOCATIONS

Samples were taken from four sites during the monitoring events, at the same locations used since commencement in 2010. Two were taken from upstream of the culvert, and another two from downstream of the discharge point (Drawing 1). This approach is consistent with that used by NRW for their surveillance of 'main rivers'.
