## Compliance Assessment Report CAR\_NRW0041465

**Permit being assessed:** CB3197HF.

For: Davies Motors, held by Mr Gareth Lloyd Davies and Mr Arwyn Lloyd Davies

At: Mill Garages, Betws Gwerfil Gich, Corwen, LL21 9PU.

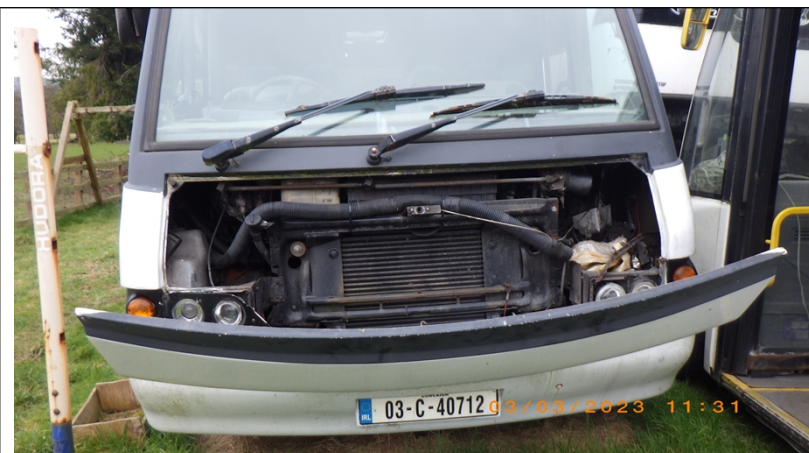
There were numerous vehicles parked at the front of the site and around the de-pollution building. Some of these vehicles which appeared to be waste were being stored on unmade ground and had not been de-polluted.

**Un-depolluted vehicle stored on unmade ground**

This is in breach of section 2.3 of your permit, only fully de-polluted vehicles can be stored on hard- standing and all other wastes shall be stored on an impermeable surface with a sealed drainage system. This has been scored as a Cat 3 breach.

**Ensure all un-depolluted waste vehicles are stored on an impermeable surface with a sealed drainage system.**

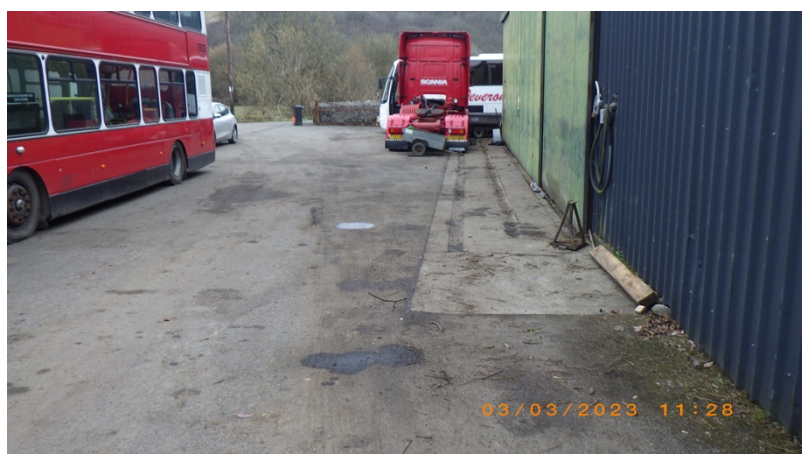
Various oil patches were seen on the impermeable surface in front of the de-pollution building which is very close to the surface water drain on site. It was not clear whilst we were on site where this oil had originated but there appeared to have been no attempt to clean this up. Oil was also seen in the surface water drain in front of the de-pollution building. This is in breach of permit condition 1.1 General Management - The operator shall manage and operate the activities in accordance with a written management plan that identifies and minimises the risks of pollution. The site EMS plans and procedures are clearly not being followed and this has been scored as a Cat 3 breach.

### Oil in front of de-pollution building

**Ensure the necessary containment measures are in place as detailed in your site EMS and they are used to clean up any spills.**

You must also ensure you have the correct spillage collection facilities on site at all times as per section 2.3.1 of your permit. We could not gain access to the de-pollution building to check if these were present.

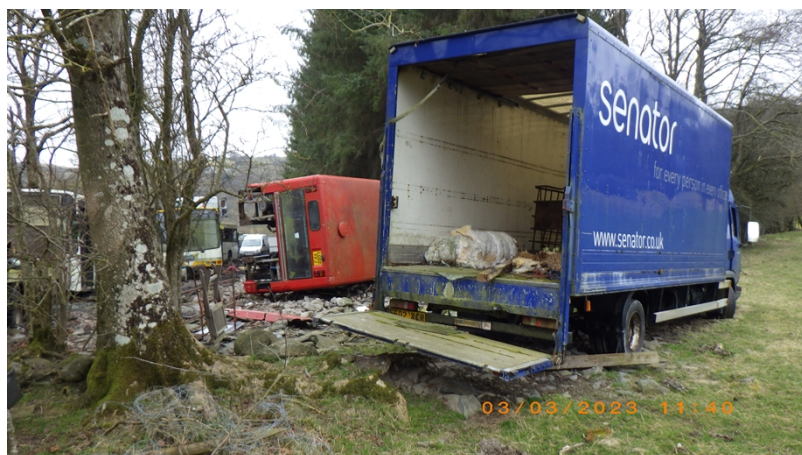
There were two vehicles at the rear of the site which were being stored outside the permit boundary. This is in breach of section 2.4.1 of your permit as it states the activities shall not extend beyond the site, being the land shown edged in green on the site plan attached to the permit. This has been scored as a Cat 3 breach of your permit.

### Vehicle stored outside the permit boundary

**You must remove these vehicles to a suitably permitted site or store them correctly as per your permit and site EMS.**

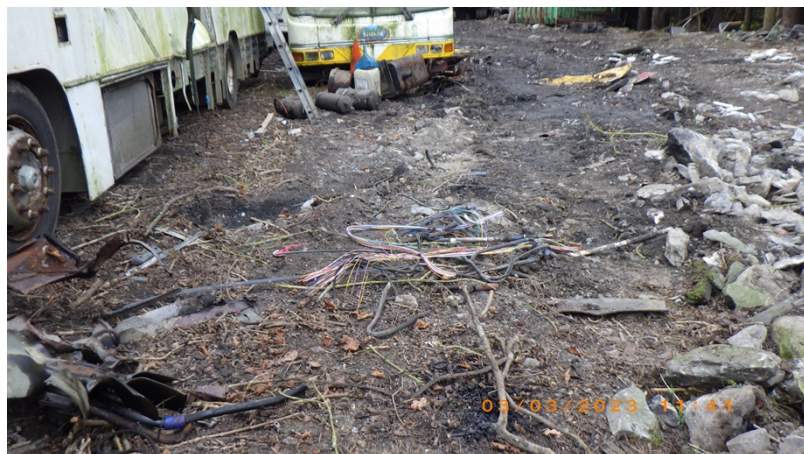
At the rear of the site there was a vehicle on its side of which there was evidence of work being done to this vehicle. This rear area of the permitted site beyond the gates is unmade ground which is heavily churned up. There was a distinct smell of oil in this area and what appeared to be oil patches on the ground. There were several vehicle parts scattered through this area. It has been explained in detail that work, such as brake release, was necessary to these vehicles to enable them to be moved safely to another permitted site for disposal to comply with the Section 59 notice.

### Unmade ground where vehicles were being dismantled

Any activities on vehicles that have not been de-polluted, where there is a risk of

**fluids causing pollution, must be done on an impermeable surface with a sealed drainage system.**

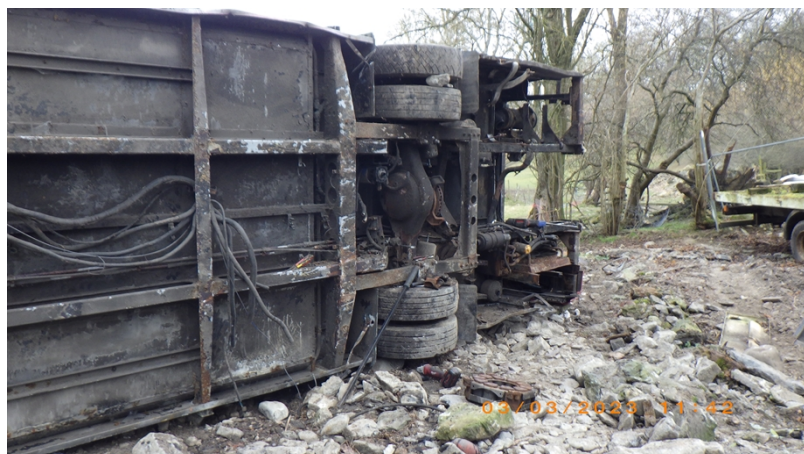
### Vehicle being dismantled

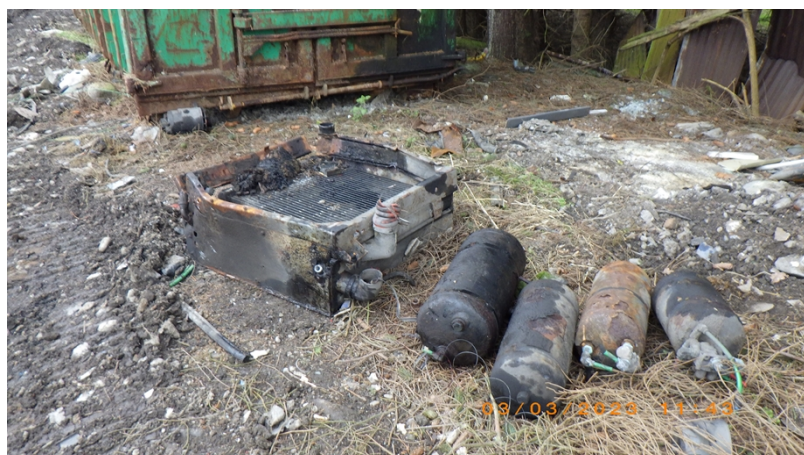
### Vehicle parts
