## Compliance Assessment Report CAR\_NRW0042126

**Permit being assessed:** AW1003801

For: LLANWRTHWL STW, held by DWR CYMRU CYFYNGEDIG

**Type of assessment carried out:** Site Inspection, Reason: Routine.

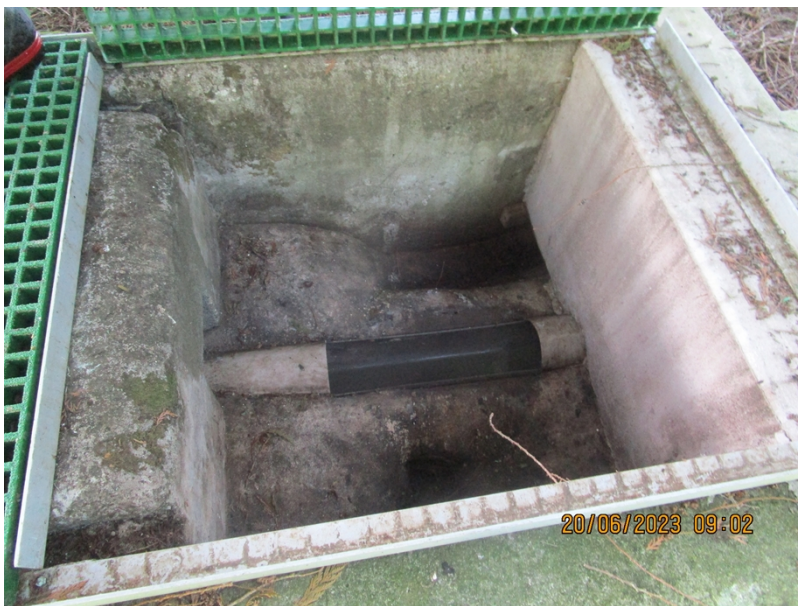
### Inlet

The incoming flow to the site is from a gravity sewer. There is no screening in place at the inlet before flows pass to primary settlement. At the time of the visit there was only a minimal flow entering the works, and no signs of solids or rags in or around the inlet. There is an open section of the inlet pipe which serves as a storm weir, which has no EDM monitoring in place and no additional storm screening. I recommended that it would be beneficial for EDM to be implemented and we discussed that lack of available power sources at the site is a potential barrier to this being possible. We also discussed if it would be possible to install a screen across the storm channels to prevent any rag passing through during a storm discharge. DCWW will investigate these options.

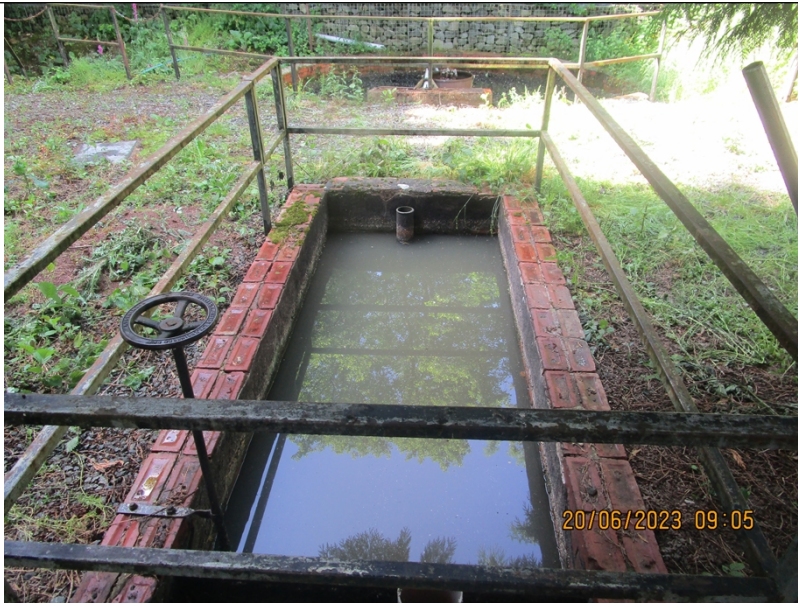
### Primary Settlement

The primary settlement tank at the works is an open rectangular shaped tank, with the outlet behind a set scum retaining board, for retaining solids.

Overall, the settlement system appeared to be operating effectively. There were no signs of significant solids passing through to secondary treatment.

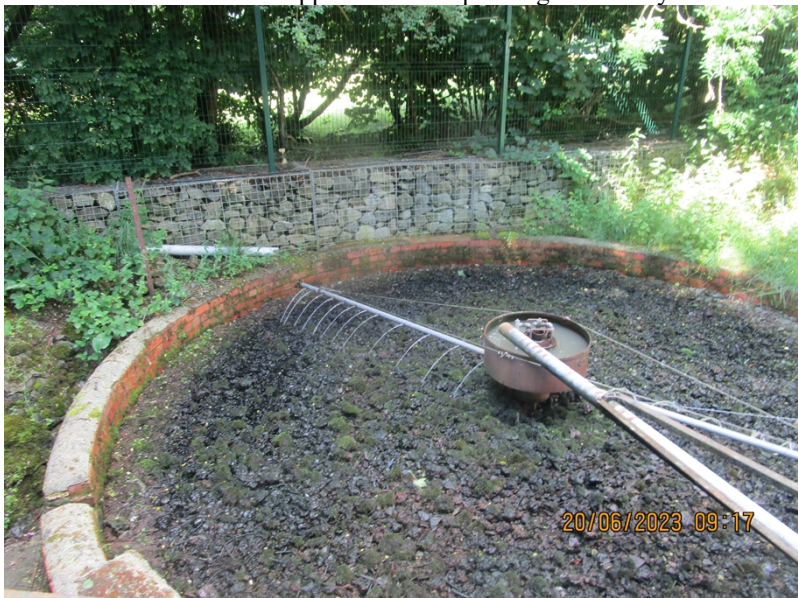
#### Filter Bed

The outfall from the primary settlement tank leads to a syphon in the centre of the single filter bed. The syphon is in place to allow water levels to build up to a suitable level before flows are sent through to the filter bed. This is due to the works being gravity powered and needing to make sure there is ample hydrological pressure for the filter bed arms to function correctly.

The works contains a single filter bed of stone media. On arrival at the works the filter arm was not rotating, as the syphon had not yet sent flow into the filter bed system. Once levels reached the set amount, flows were sent through to the filter bed. The rotation arm was moving free and unhindered. There were no signs of blocked outlets and the rotating arm appeared to be distributing effectively. There were no signs of ponding or dry patches across the filter bed and no excessive vegetation growth.

The filter bed at the works appeared to be operating effectively and the outfall channel appeared to be running clear.

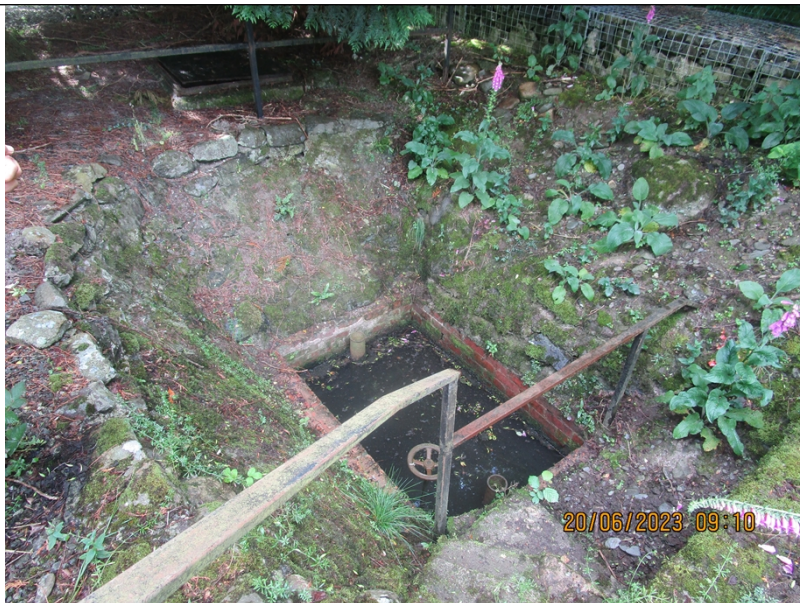
#### Final Settlement

There is a small square final settlement tank at the works, which is located down a set of steps with by a guard rail. The design of the tank appears to be similar in theory to a septic tank, where the outlet pipe is lower than in input pipe, which helps to hold back and settle out solids. It is not possible to see the outfall channel from this tank to assess if it is operating effectively. There was evidence that the tank was effectively holding back solids.

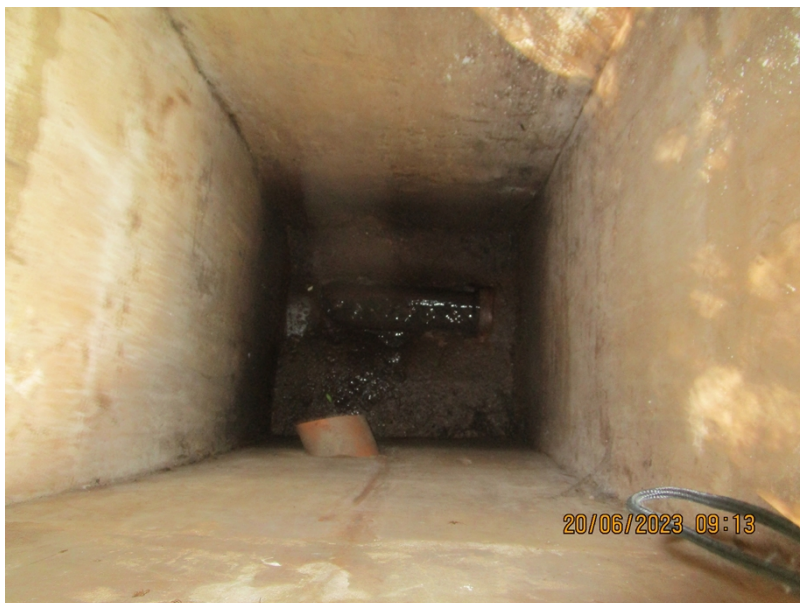
#### Outfall

The outfall of the works at the time of inspection was flowing with only a minimal amount of liquid, which appeared clear of solids or fungal growth. The outfall chamber is covered and in good working order and was opened by site operatives.

We checked the outfall into the watercourse, which can be accessed by walking outside the site fencing, through the adjacent field. The outfall pipe has a storm valve in place to prevent ingress into the works during flooding events. The watercourse was running clear and showed no signs of negative environmental impact around the outfall.

The storm discharge from this works needs to be covered with an appropriate permit under Environmental Permitting

(England and Wales) Regulations 2016. The storm discharge is currently an unconsented discharge.
