## Compliance Assessment Report CAR\_NRW0041920

**Permit being assessed:** AB3092FR.

For: Llantrisant Recycling, held by Llantrisant Recycling Centre Limited

**Type of assessment carried out:** Site Inspection, Reason: Routine.

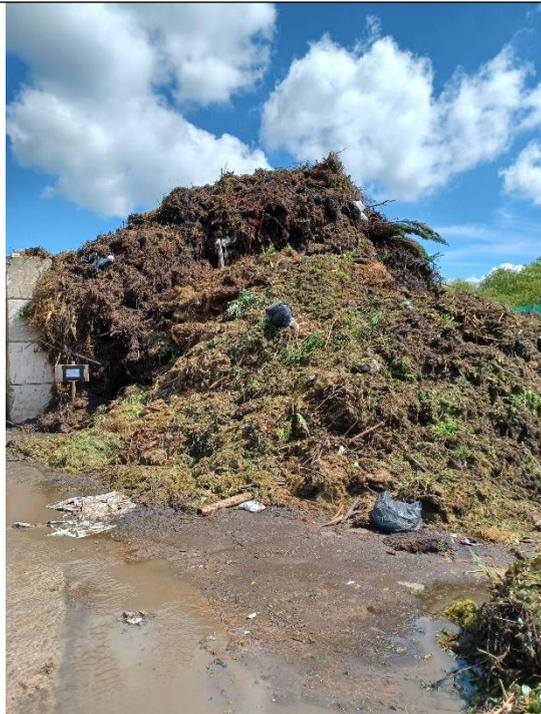
Large piles of un-shredded green waste were observed. CM stated these piles had been on site for several weeks.

The OMP submitted 18<sup>th</sup> March 2021 states that material will be shredded no longer than five days after waste reception.

- **Waste piles need to be reduced and compost managed properly in line with PAS and QP procedures.**
- **Complete an investigation into the causes of odour on site and submit to NRW by 22nd June 2023.**
- **Weather station data for the date of the inspection, 12<sup>th</sup> May 2023 to be submitted.**

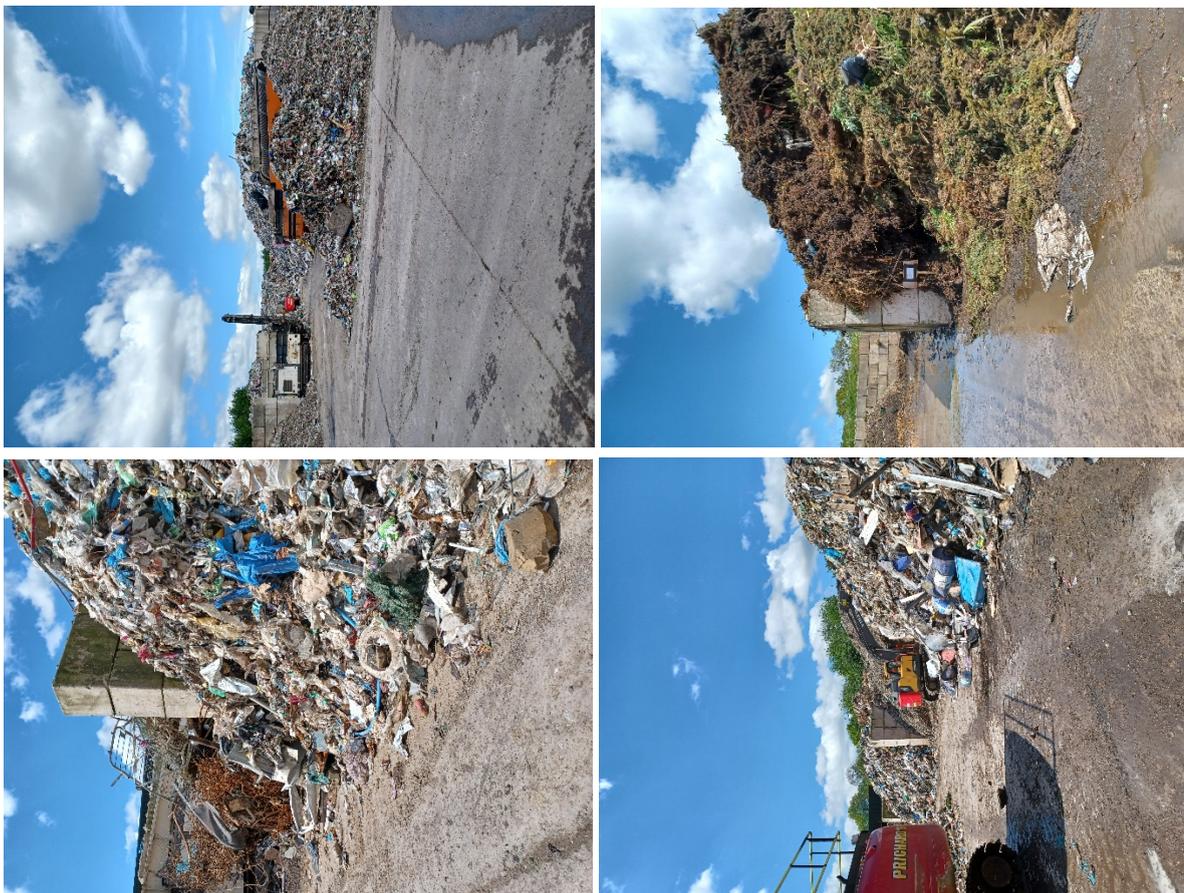
We observed waste being stored higher than the concrete storage blocks. There should be a minimum of 1 metre free board between the waste and bunker height. The slot drains that run along the bottom of the site were full and run-off was therefore able to by pass these drains, in the event of a fire this could lead to fire water run off.

**Action- All waste needs to be managed fully in line with FPMP guidance which includes ignition sources, water supplies, stockpile rotation, drainage, stack sizes and separation distances.**

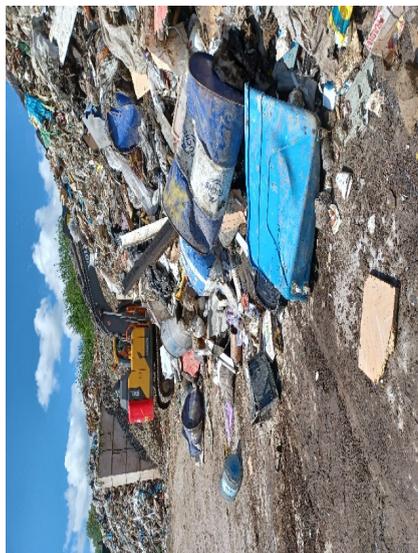
During the visit we observed metal drums in the waste stockpiles. This is in breach of the FPMP clause 5.2 which states 'The deposit of drummed waste will not be allowed at the site'

During the visit we observed gas cylinders being stored inappropriately which is in breach of the FPMP clause 4.3.h which states 'Flammable materials such as oils grease fuels paints will not normally be kept on site. Fuels for mobile plant are bought to site by self-propelled bowser. Any other flammable materials which are bought to site for the purposes of repair or maintenance of the facility shall be kept in a steel container located at least 10 metres away from any structures or combustible stacks of materials. This is also an unpermitted waste type.

**Action- Remove any drums on site in line with FPMP guidance.**

**Action- Remove any unpermitted gas cylinders on site in line with FPMP guidance.**
