**Cwm Environmental  
(Nantycaws)  
Composting Facility**

**Bioaerosols Monitoring**

**1<sup>st</sup> Half-Year Report 2023  
'Open Windrow Composting'  
(No IVC Compost Processing)**

Sampling date **3<sup>rd</sup> May 2023**  
Report date **21<sup>st</sup> July 2023**

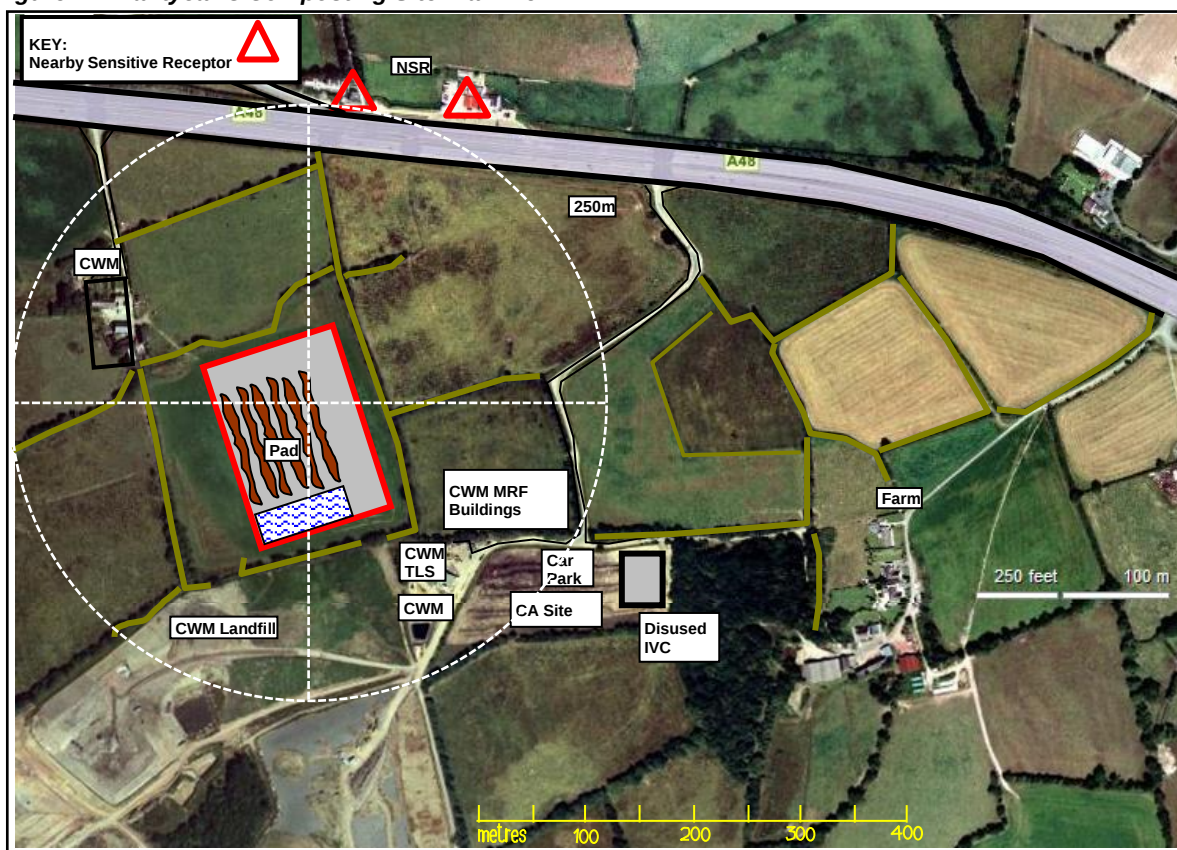
Figure 2: Nantycaws Composting Site Plan View

The open windrow Composting Facility at Nantycaws is situated within 250m of third-party workplaces and/or dwellings (see fig 2). These have been taken account of during monitoring.

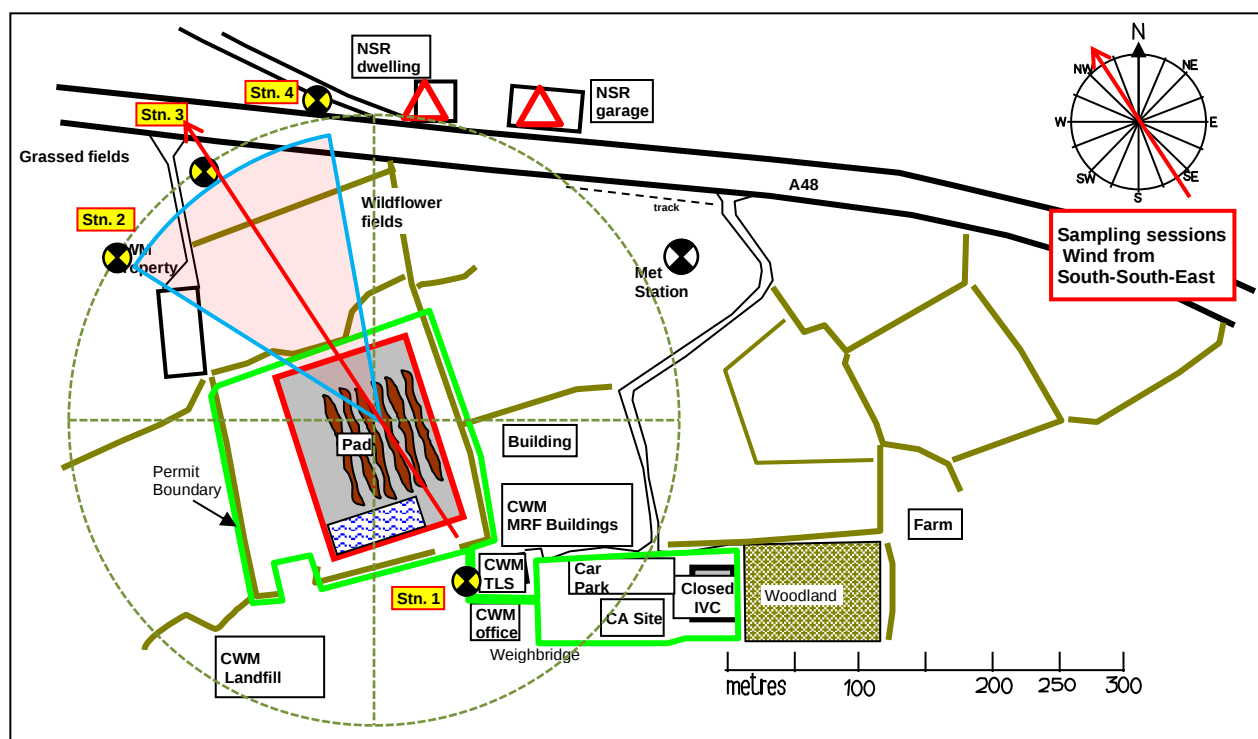
Figure 3: Sampling Station Locations – Open Windrow Composting Facility - SA 32 8BG

The following plan for sampling stations was utilised. The wind from the **South-East and South-South-East** was consistently towards the **North-West /North-North-West** throughout the sessions and the sampling stations were located to provide data in accordance with the 'upwind' and 'downwind'; at locations as shown in Figure 3.

| <b>Station 1.</b> | SN 47240 247240 | Located to the South East, 60m from the site 140m <b>UPWIND</b> of the activity. |
| <b>Station 2.</b> | SN 46930 17874 | Located <b>160m from the site to WSW</b> , 220m from centre of activity to provide the <b>DOWNWIND</b> sample to the <b>LEFT of the centreline</b> . |
| <b>Station 3.</b> | SN 47073 17950 | Located <b>160m from the site to West</b> , 220m from centre of activity to provide the <b>DOWNWIND</b> sample directly <b>DOWNWIND of the Composting Pad</b> . |
| <b>Station 4.</b> | SN 47197 17994 | Located <b>175m from the site to WNW</b> , 220m from centre of activity to provide the <b>DOWNWIND</b> sample to the <b>RIGHT of the centreline</b> . Distanced due to A48 access issue. |

The sampling station locations are shown at figure 3.
