## Compliance Assessment Report CAR\_NRW0042579

**Permit being assessed:** AW1000501

For: BEULAH STW BEULAH POWYS WALES, held by DWR CYMRU CYFYNGEDIG

**Type of assessment carried out:** Site Inspection, Reason: Routine.

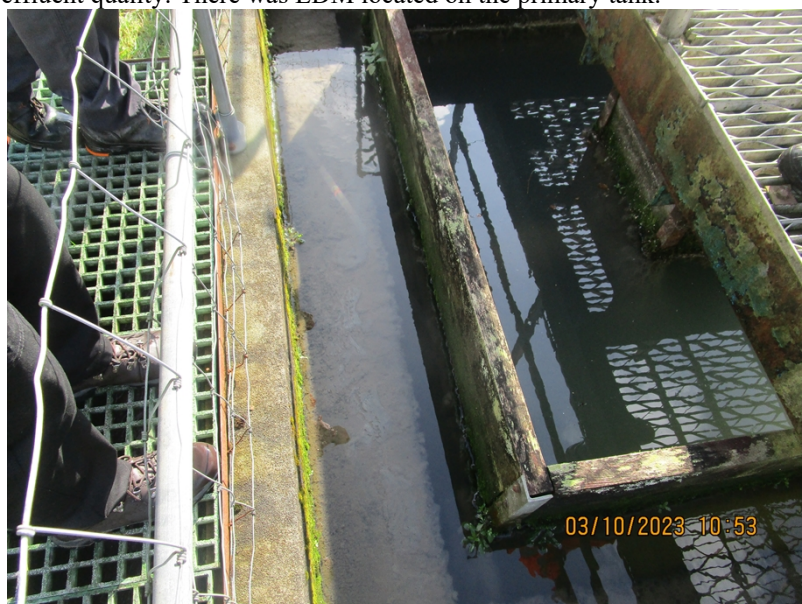
The primary settlement tank at the works is an older square shaped tank, with wooden scum boards for retaining solids. Overall, the settlement system appeared to be operating effectively. There were no signs of significant solids entering the outfall channel. Some sewage fungus was present on the outside of the scum boards; however, this does not likely affect effluent quality. There was EDM located on the primary tank.

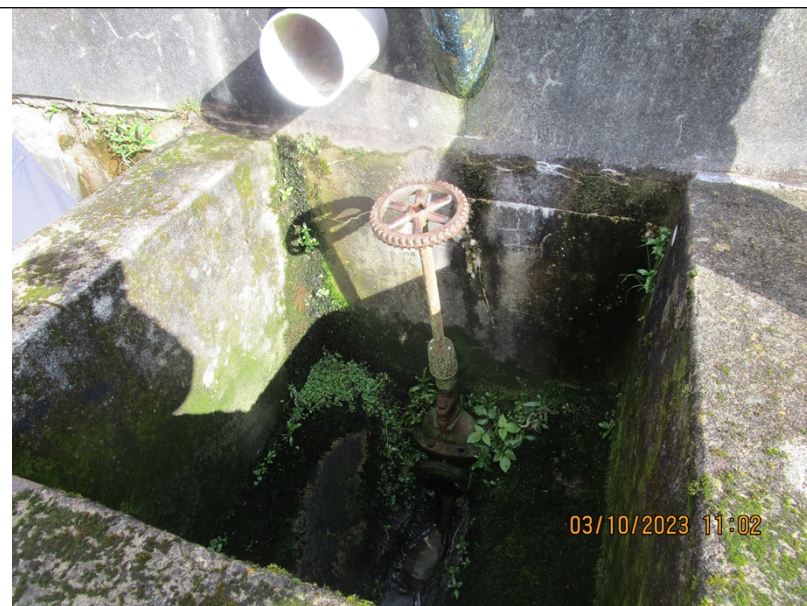
The outfall from the primary settlement tank leads to a syphon chamber, the purpose of which is to control flows so there is enough hydrological pressure for the rotating filter bed arms and final settlement to operate. This is because the works is gravity powered.

There is an overflow outlet at the works, the overflow is a pipe located on the side of the primary tank, once the water level reaches the pipe the works will start flowing through the overflow channel to overflow tanks onsite. The overflow channel is a shared channel with the sludge return channel. Leading into three separate brick tanks, with manually operated penstocks for directing flow to overflow storage or sludge storage.

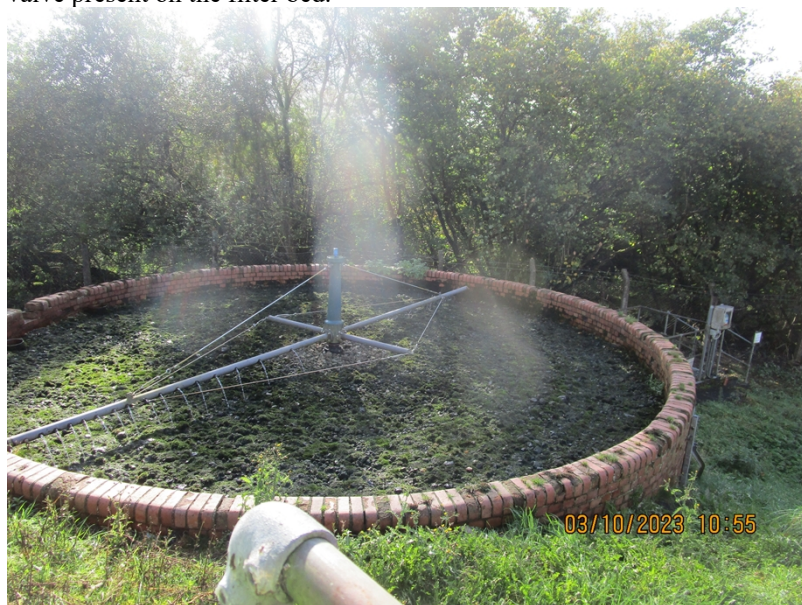
The works contains a single filter bed of stone media. The rotation arm was moving free and unhindered. There was one blocked distribution point on the arm, however the rotating arm appeared to be distributing effectively. The blockage was removed by DCWW operatives whilst on site. There were no signs of ponding or dry patches across the filter bed. There was some moss coverage on the filter bed, but not an excessive amount. A metal bund has been installed on the downhill side of the filter bed. I did not observe any leakage at the time of inspection. There is a centre column release valve present on the filter bed.

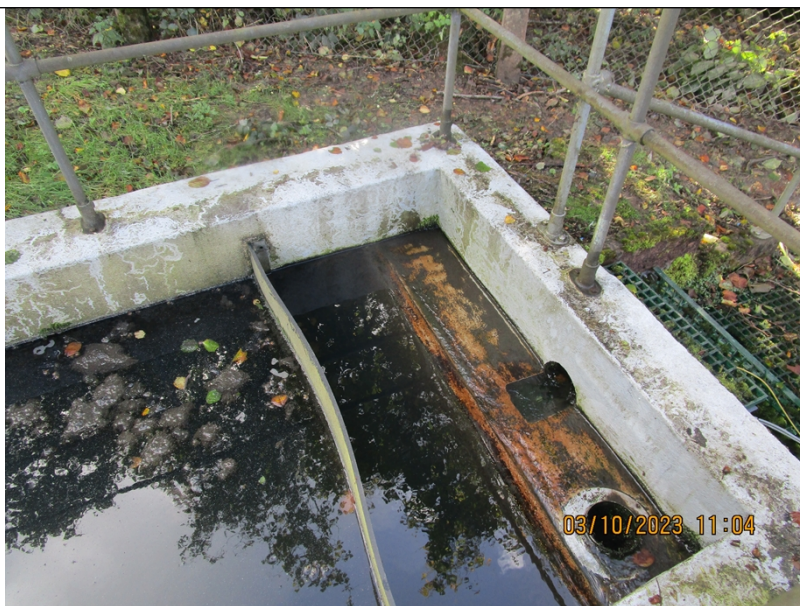
The humus tank appeared to be operating effectively and there were no signs of solids in the outfall channels. There was a build-up of foam present on the surface of the humus tank, however this contained within the scum boards. This may be a sign of high nutrient load within the effluent. The effluent within the outfall was clear, there were no signs of significant solids or sewage fungus around the outfall.

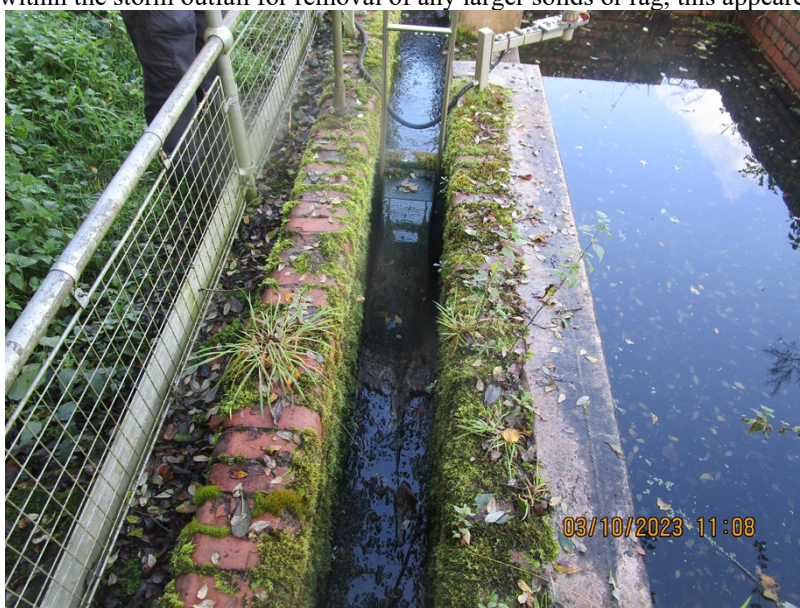
The overflow storage tanks, and sludge tanks are of an open brick construction. The flow is diverted to overflow, or sludge return manually by moving penstocks on the inlet channel, at the time of inspection the penstocks were diverting any flow towards the storm tanks. Concrete walls have been installed to prevent leakage from the tanks, as a results of actions from a previous inspection (2021). The additional concrete appears to be effectively preventing any leakage from the tanks into the storm channel.

The overflow tanks contained water but was well below the level where it would discharge via the storm channel. There is EDM within the storm outfall channel, to monitor when storm discharges are occurring. There is a COPA sack present within the storm outfall for removal of any larger solids or rag, this appeared clear of any blockages.
