## Compliance Assessment Report CAR\_NRW0042614

**Permit being assessed:** WB3993HE.

For: Gellia'r-gwellt Uchaf Transfer & Composting Station, held by Bryn Recycling Limited  
At: Gellia'r-gwellt Uchaf Transfer & Composting Station, Hengoed, Caerphilly, CF82 8FY.

**Type of assessment carried out:** Site Inspection, Reason: Routine.

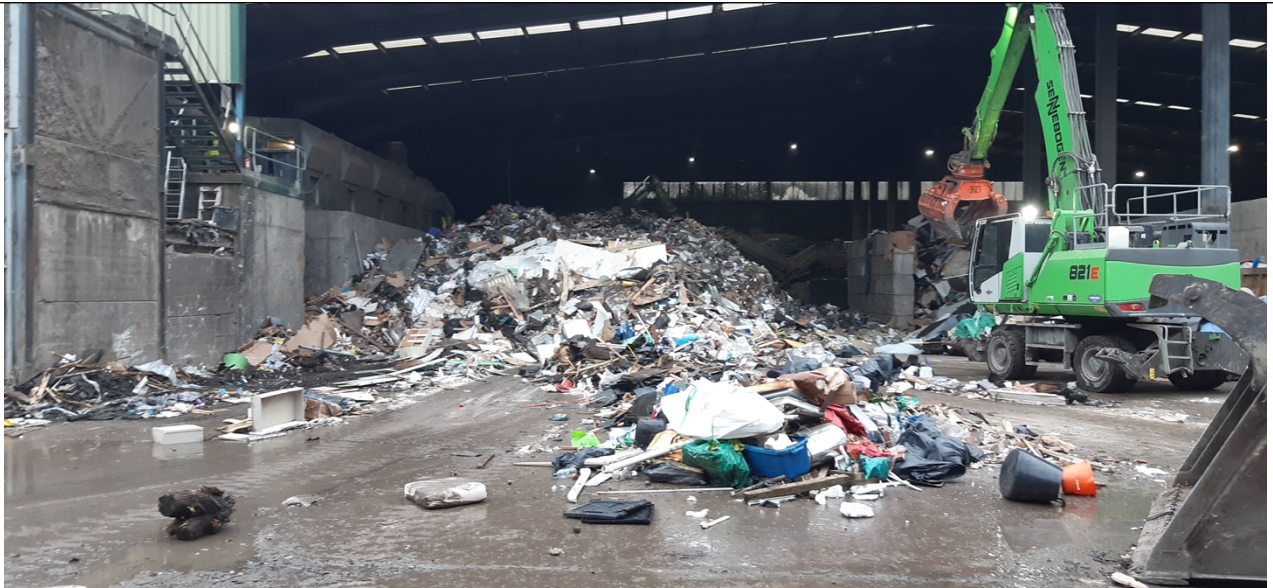
NRW personnel were escorted in and around the waste transfer station area - see photos 1-3. The waste transfer station area was operational at the time of the site inspection with stockpiles of various waste streams being processed. Housekeeping in the area was in acceptable condition with some excess loose debris present. Just as a reminder to the operator that even though this is a dynamic site with constant waste processing activities, always ensure that good housekeeping standards are maintained at all times. Flooring infrastructure within the operational areas in good condition with no visible damage present.

**Photo 1** - View inside waste transfer station building

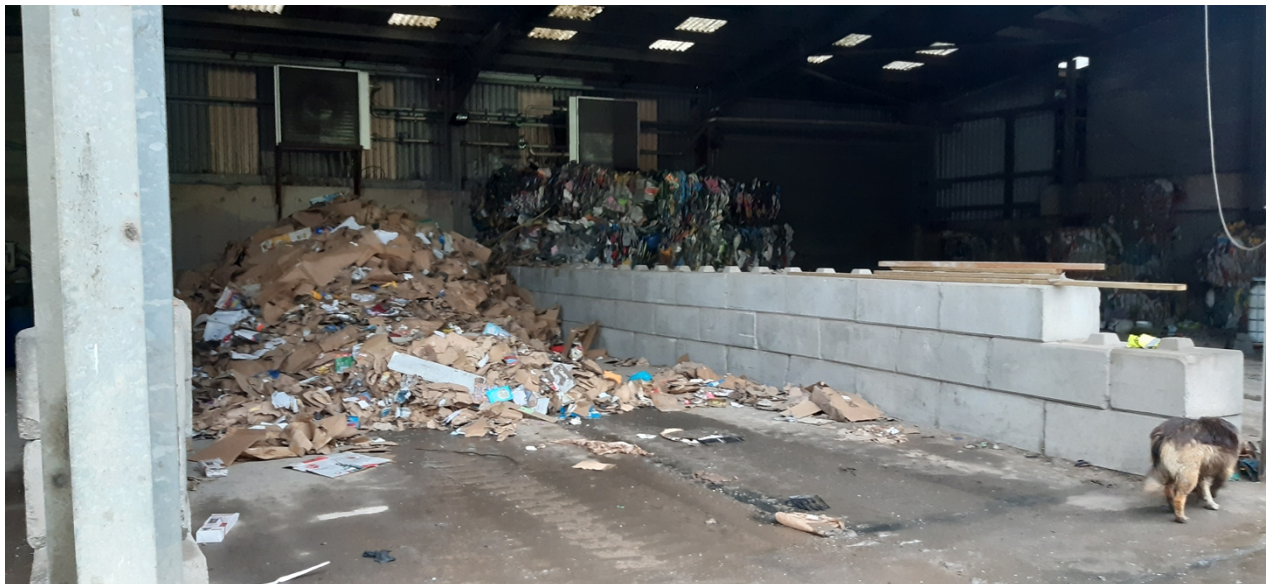
Waste(s) stored within the buildings were separated, not overlapping bays and not in exceedance of the sites Fire Prevention and Mitigation Plan (FPMP) - see photo 2. As a reminder to the operator, please ensure you remain within waste stockpile height / width limits as identified in your site FPMP. No offensive waste odours or excessive noises were noted by NRW personnel in this part of the site during the site inspection.

**Photo 2** - View inside waste transfer station building

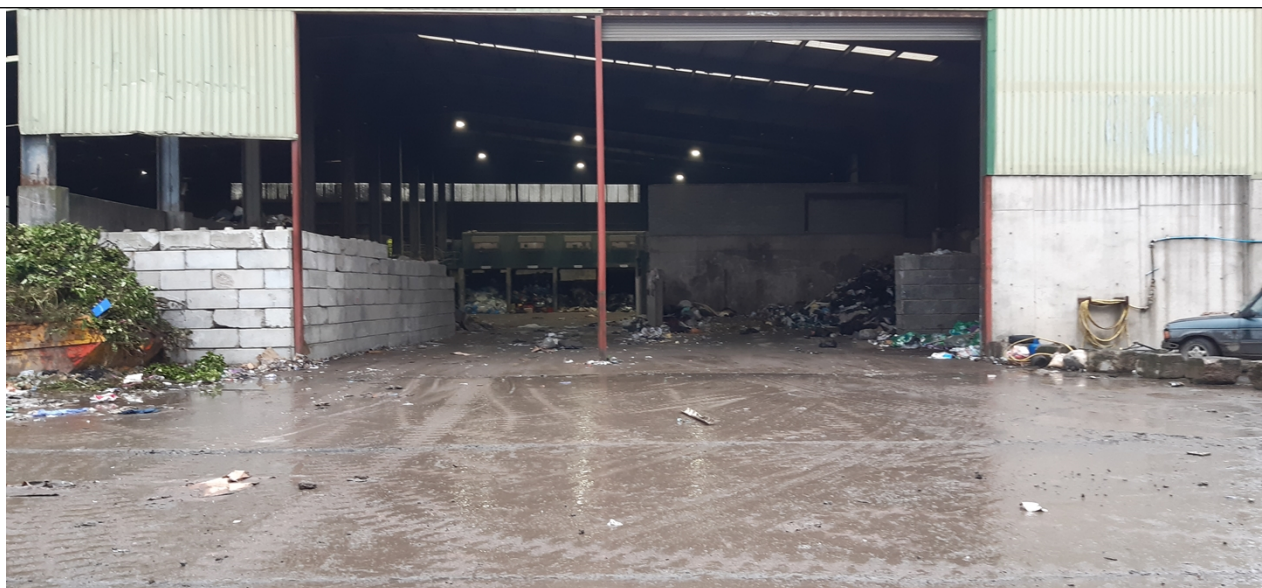
**Photo 3** - View inside waste transfer station building

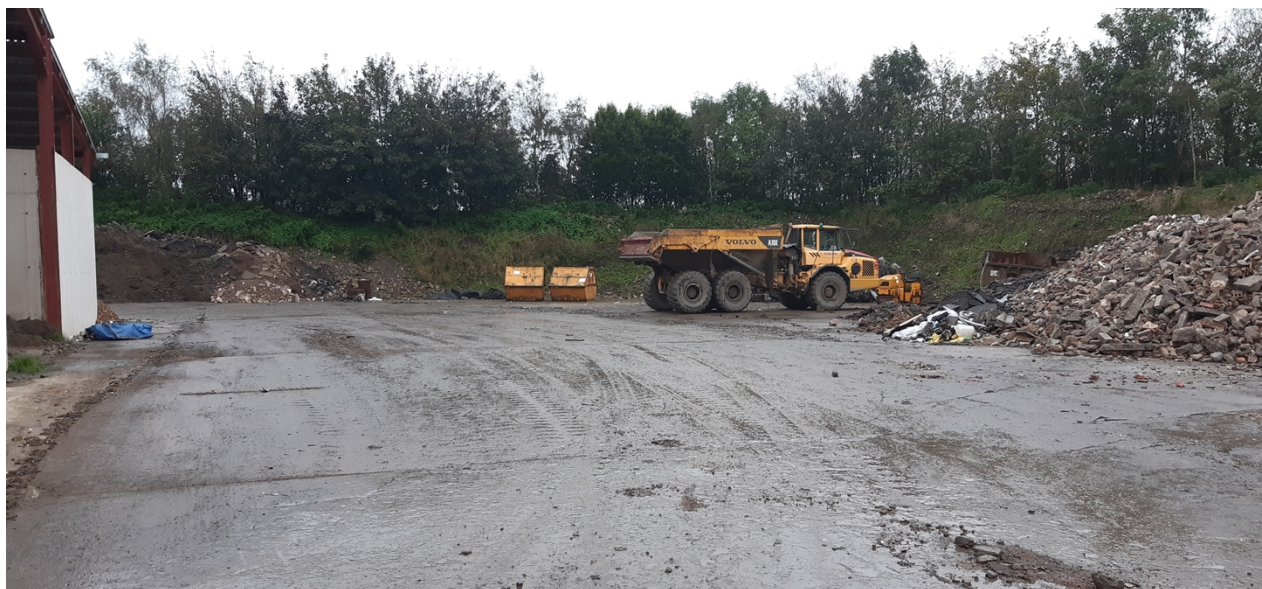
During the last site inspection (CAR\_NRW0042125), the infrastructure improvement works were being undertaken in the area where construction and demolition (C&D) wastes are usually stored. During this site inspection, those works had been completed with C&D waste(s) now being stored on an impermeable surface as per permit conditions, see photo 4. NRW personnel were satisfied with the improved infrastructure and witnessed further taken proactive steps by the site to improve flooring infrastructure conditions near the transfer station building to minimise environmental impact should a loss of containment occur. See photo 5.

**Photo 4** - Completed flooring infrastructure improvements at Bryn Recycling Ltd

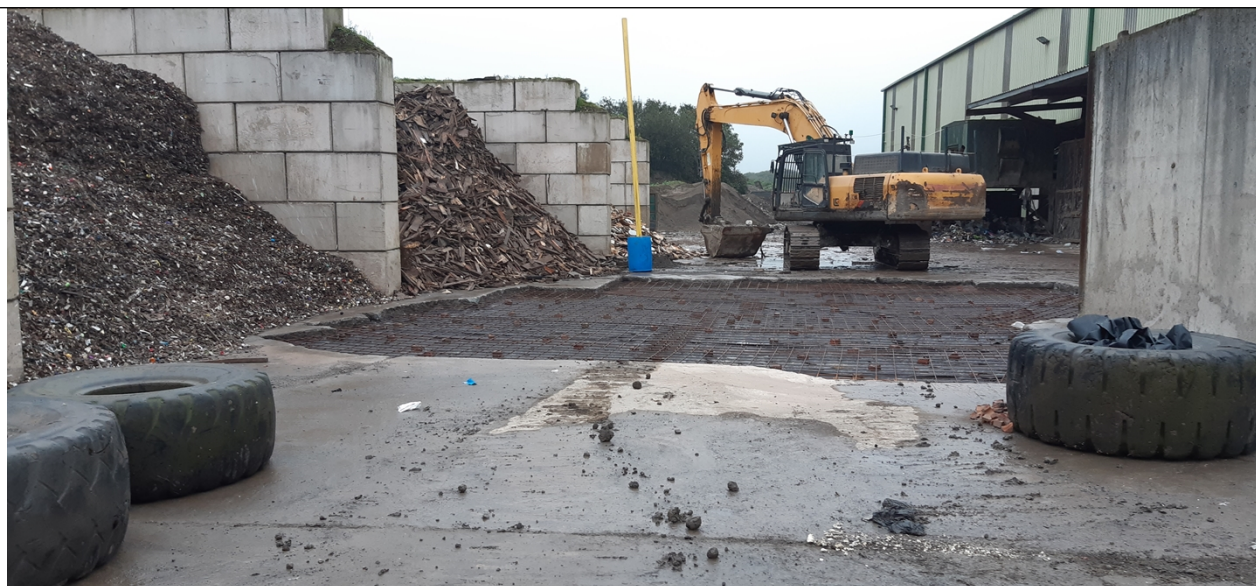
**Photo 5** - Ongoing flooring infrastructure improvements at Bryn Recycling Ltd

During this site inspection, it was assessed that the stockpile(s) of waste(s) and waste fines in the outside designated bays were within compliance of the FPMP guidance and the current site FPMP document. - see photo 5.

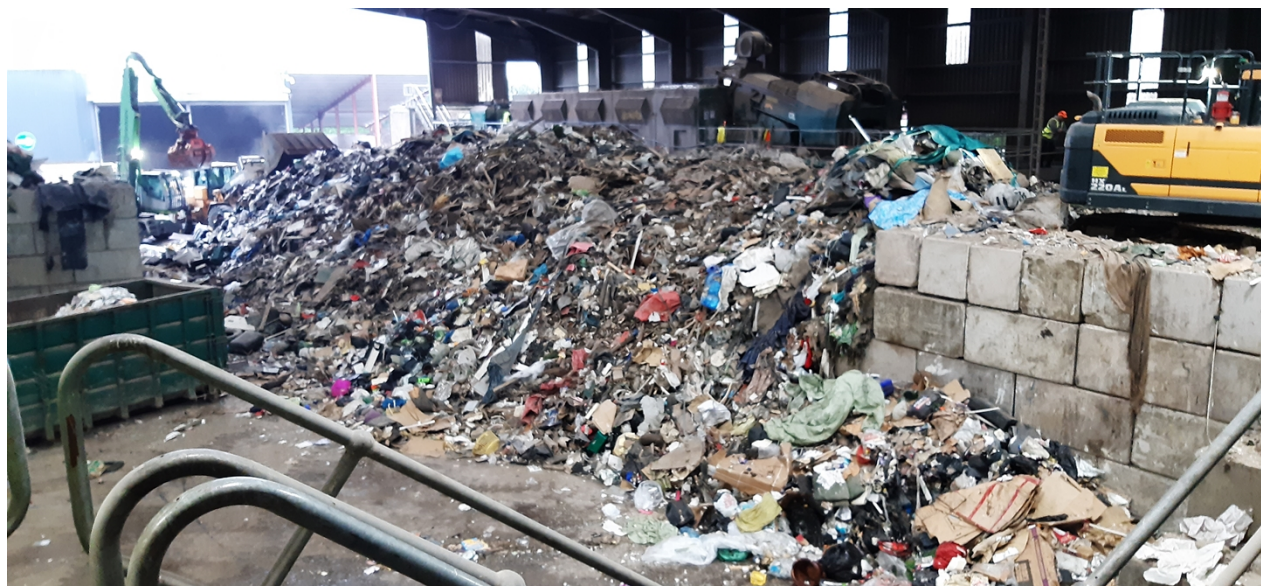
NRW personnel were then escorted to within the waste transfer station building which was undertaking waste processing activities. Stockpiles of waste(s) were within compliance of the FPMP guidance and the current site FPMP document. No offensive waste odours or excessive noises were noted by NRW personnel in this part of the site during the site inspection. Dust suppression techniques were available if required whilst within the transfer station building. See photo 6 and 7.

**Photo 6** - Stockpile of waste(s) within waste transfer station

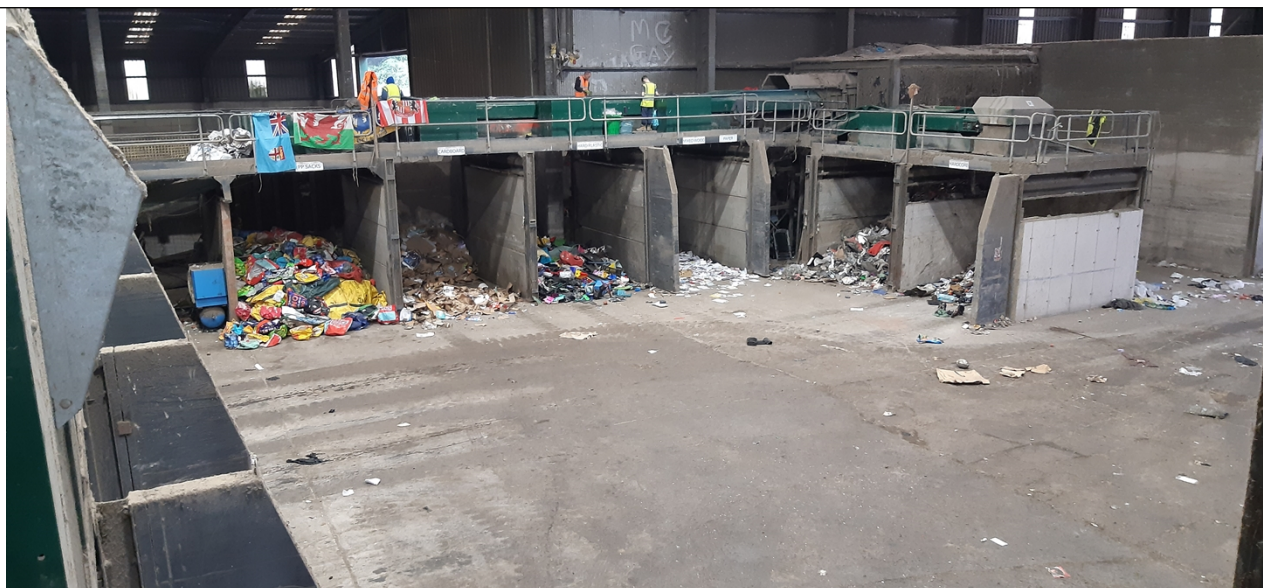
**Photo 7** - Stockpile of sorted waste(s) within waste transfer station

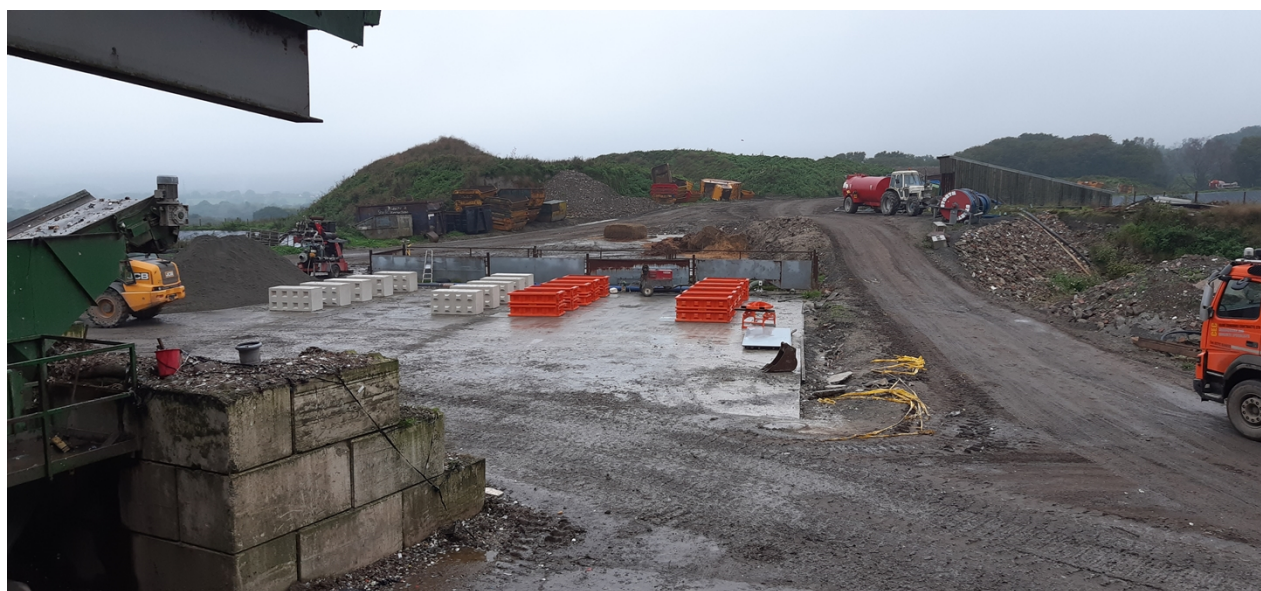
Prior to NRW personnel being escorted to the 'top yard', to the north of the waste transfer station buildings, it was noted that Bryn Recycling Ltd are proactively manufacturing concrete 'Lego blocks' - See photo 8. These blocks will be used to create segregated waste storage bays, as currently on site, to further assist with the sites FPMP in terms of separation distances and fire control management. On the 'top yard', the stockpiles of wood waste(s) and uPVC waste(s) were present with some of this wood benefiting from being stored within segregated concrete bays, see photo 9. No offensive waste odours or excessive noises were noted by NRW personnel in this part of the site during the site inspection.

**Photo 8** - Concrete 'Lego blocks' being manufactured at Bryn Recycling Ltd

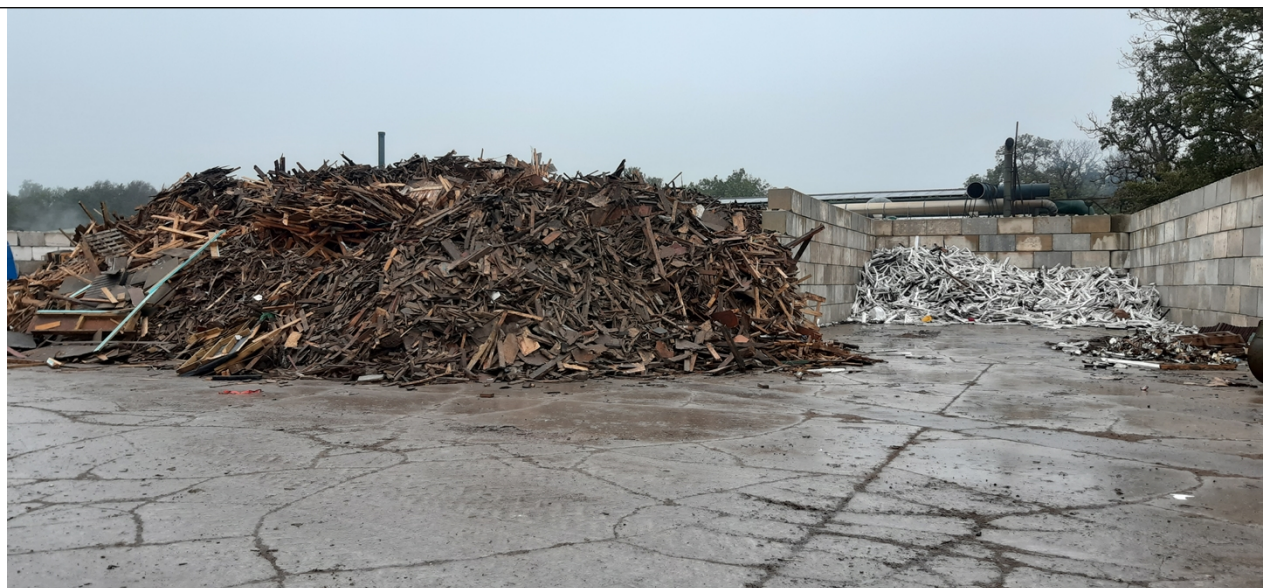
**Photo 9** - Waste storage on 'top yard'

Again, housekeeping in this area was in good condition with no excess loose debris present and the flooring infrastructure was in good working order. No offensive waste odours or excessive noises were noted by NRW personnel in this part of the site during the site inspection. As previously mentioned, please continue to ensure you remain within waste stockpile height / width limits as identified in your site FPMP.

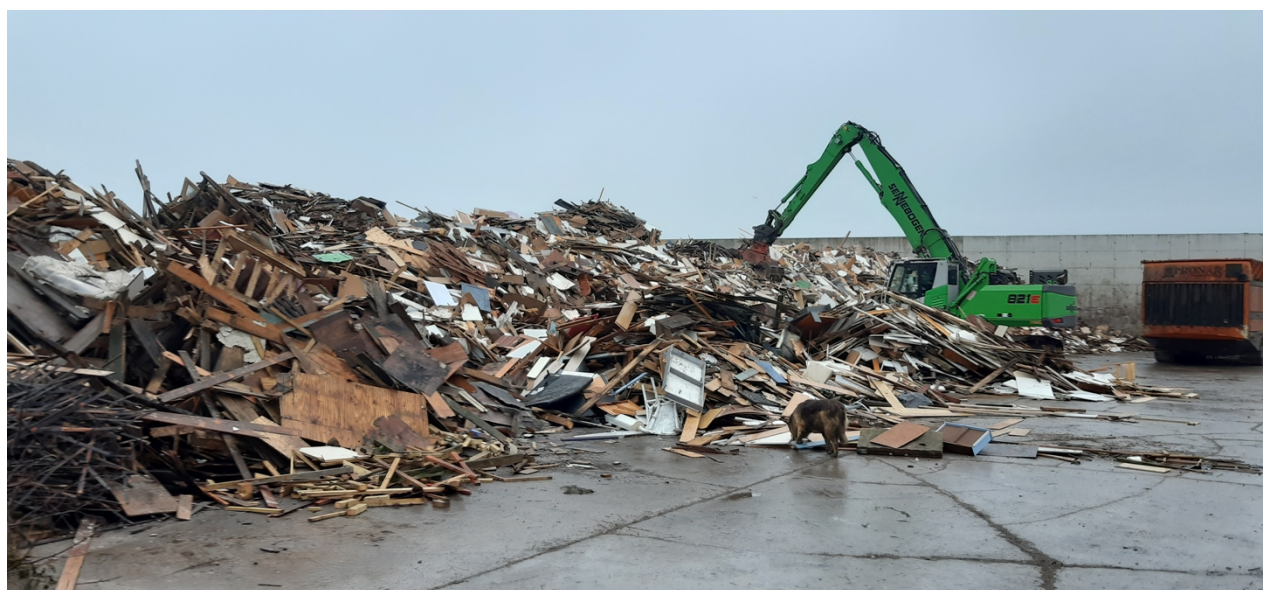
On the previous site inspection (CAR\_NRW0042125), Bryn Recycling Ltd were breached on their permit for non-compliance with their FPMP for their stockpile of unprocessed. During this site inspection, the stockpile of unprocessed wood material was brought back into compliance with the FPMP guidance and sites current FPMP document - See photo 10.

**Photo 10** - Waste unprocessed wood storage on 'top yard'

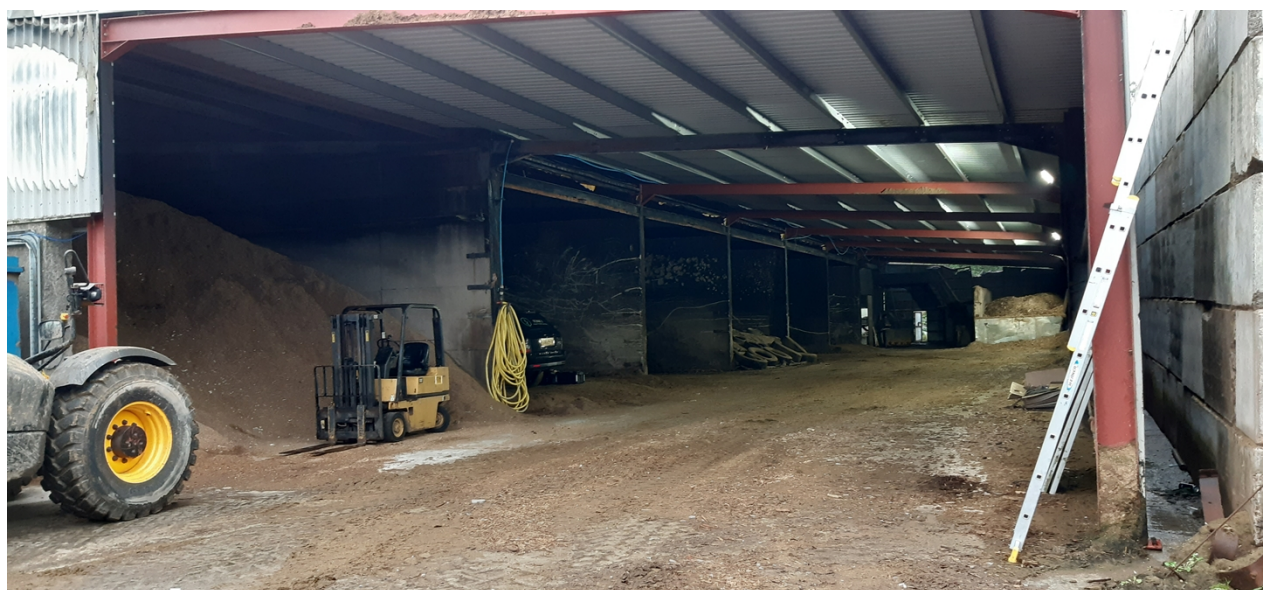
The drying sheds area were inspected with further infrastructure improvement works that were identified previously (CAR\_NRW0042125) now completed.- see photo 11. Bryn Recycling Ltd have installed a new dryer located in the nearby cattle sheds to assist with

drying wood chip for animal bedding.

**Photo 11** - Drying sheds area with infrastructure improvements taking place

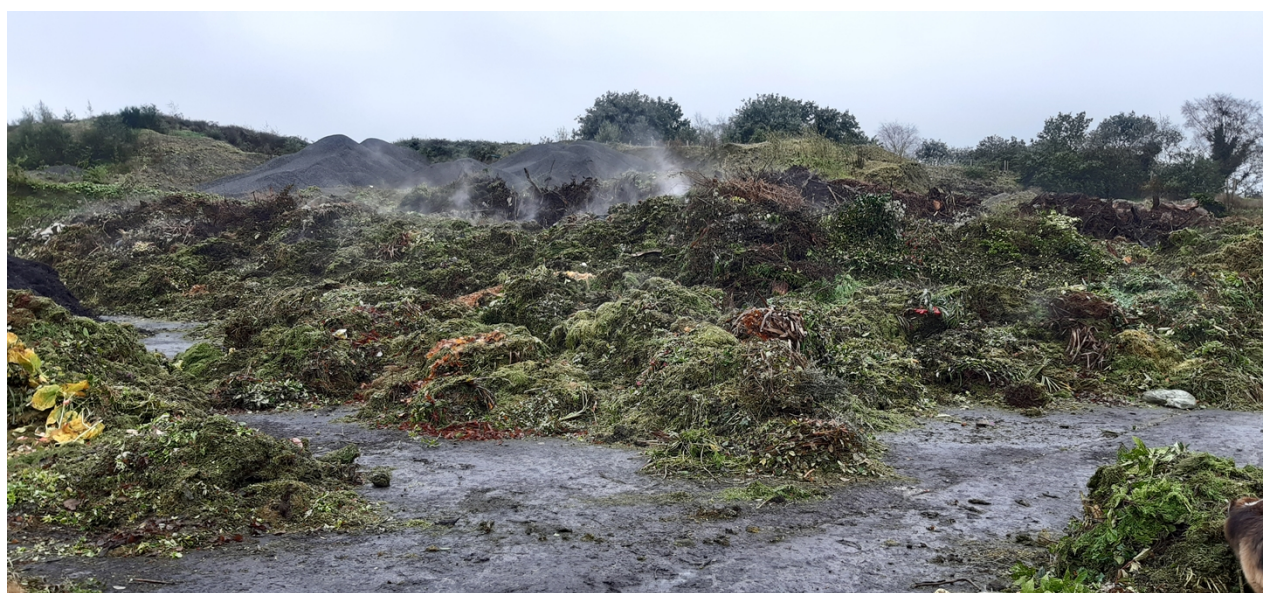
NRW personnel were then escorted to the composting station area. There was no treatment of green waste taking place at the time of the site inspection - see photos 12-14. During this site inspection all composting stockpiles / windrows were within the compliance of the sites FPMP document.. As previously mentioned, please continue to ensure you remain within waste stockpile height / width limits as identified in your site FPMP.

**Photo 12** - Unprocessed green waste in composting area

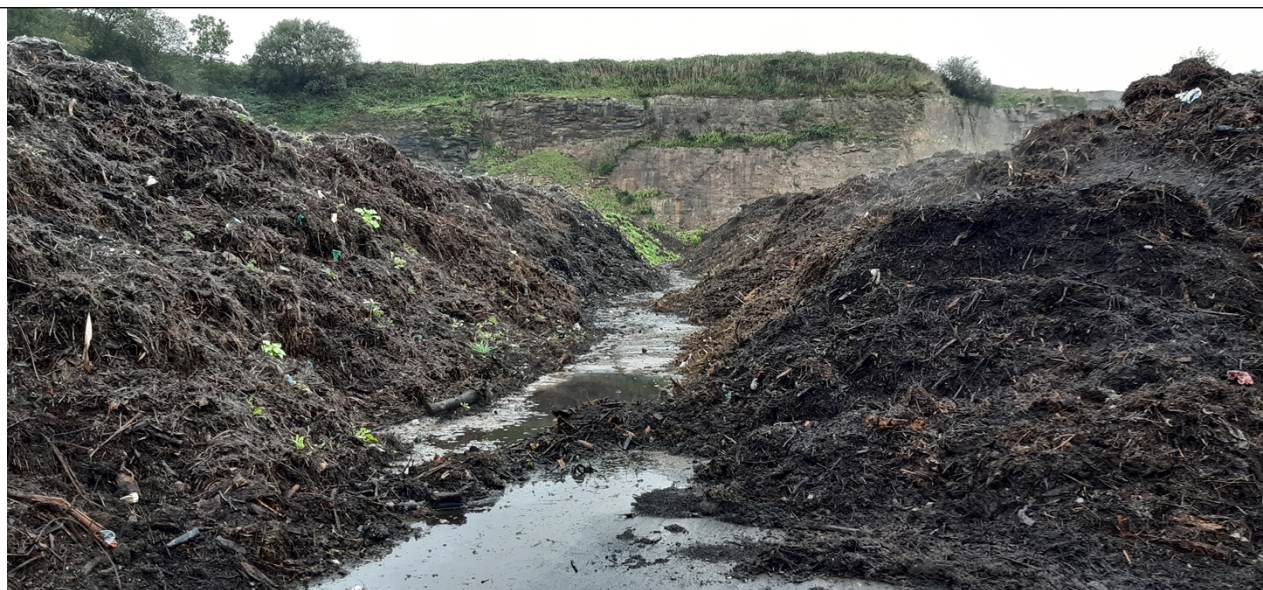
During the inspection of the composting area it was noted that the flooring infrastructure was in good working order with no excess loose debris present. There was also no offensive composting odours or excessive noises witnessed by NRW personnel in this part of the site during the site inspection.

**Photo 13** - View of the composting station area

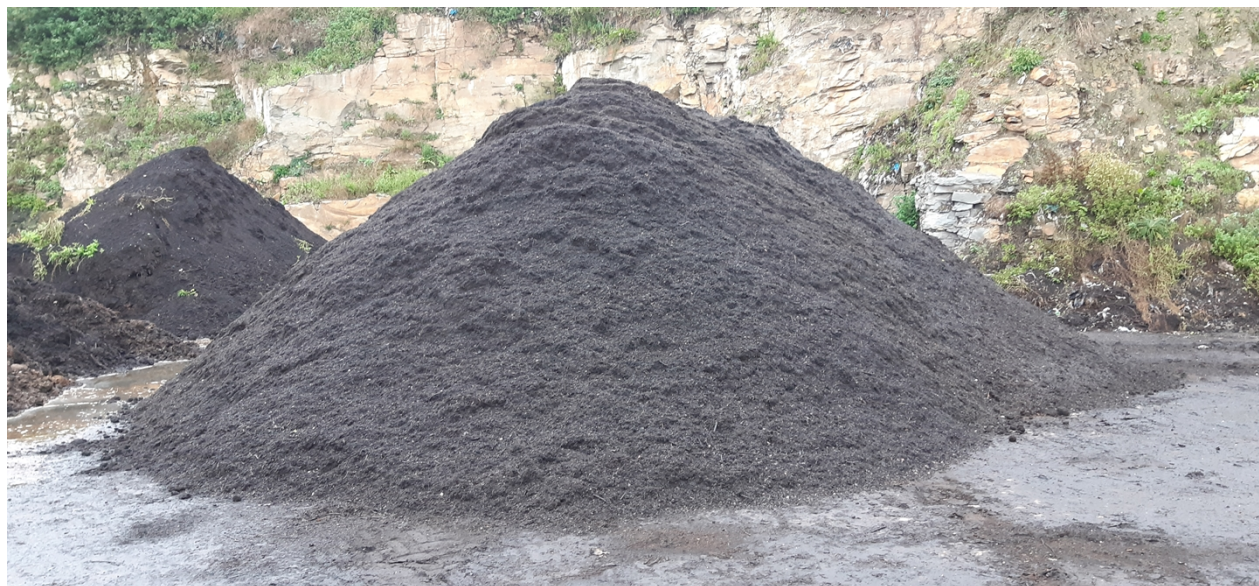
**Photo 14** - View of the composting station area
