Compliance Assessment Report CAR_NRW0042640

Permit being assessed: AD0000901

For: Trecastle Wastewater Treatment Works, held by DWR CYMRU CYFYNGEDIG
At: Trecastle, Brecon, Powys, LD3 8UG.

Type of assessment carried out: Site Inspection, Reason: Routine.

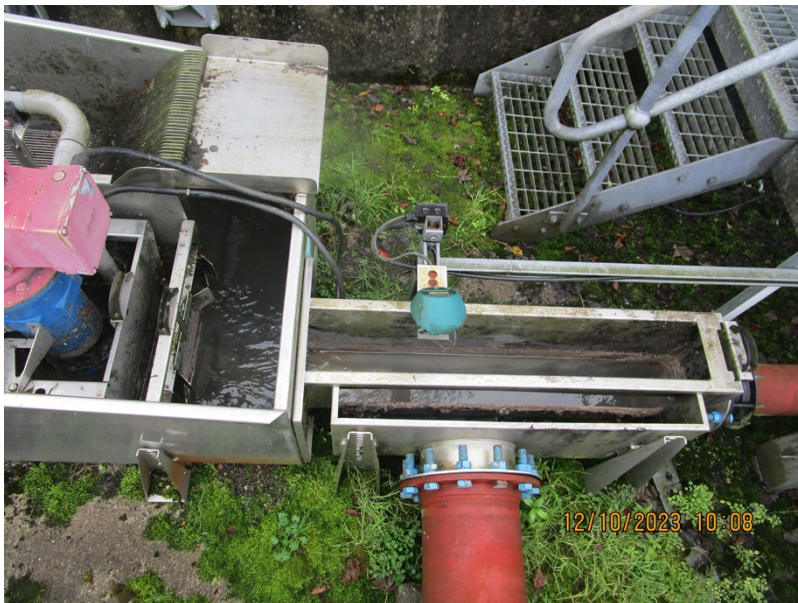
Inlet and Storm

The incoming flow comes into the works via a gravity sewer. The works is a powered works however does not have a backup power source in place. The incoming flows to the works pass through a macerator within the inlet. The macerator was clearly operation at the time of visit, and there were no signs of significant rag or solids passing through to the next stage of treatment. There is an additional bypass channel with a fixed 6mm bar screen, which can be used when undertaking macerator maintenance or in the event of a macerator failure.

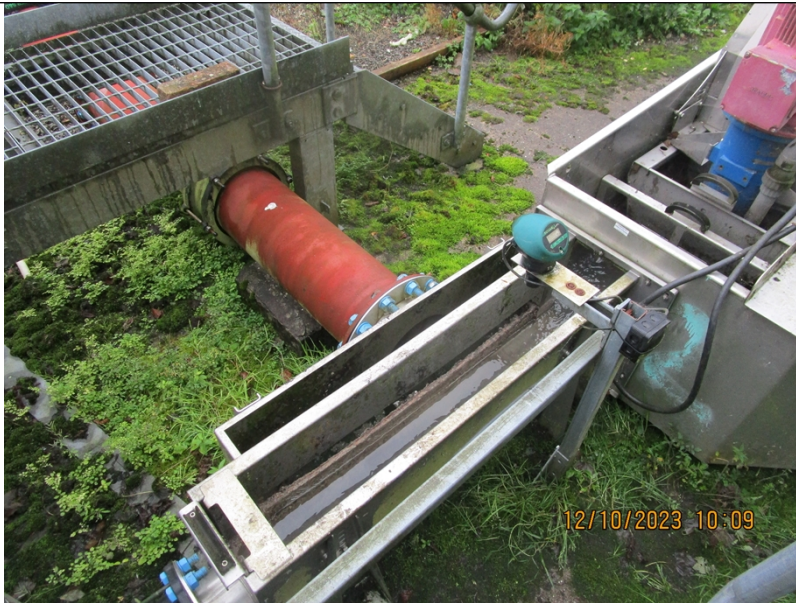
The storm weir in place is a hard-set weir at the side of the inlet, following the macerator and bypass channel. The storm discharge can only discharge when flows reach the level of the weir. The storm channel has no screening in place, as all flows pass through the macerator or bar screen beforehand. The incoming flows were well below the weir height, and no storm discharge was occurring. There is Event Duration Monitoring spill meter in place to monitor storm discharges.

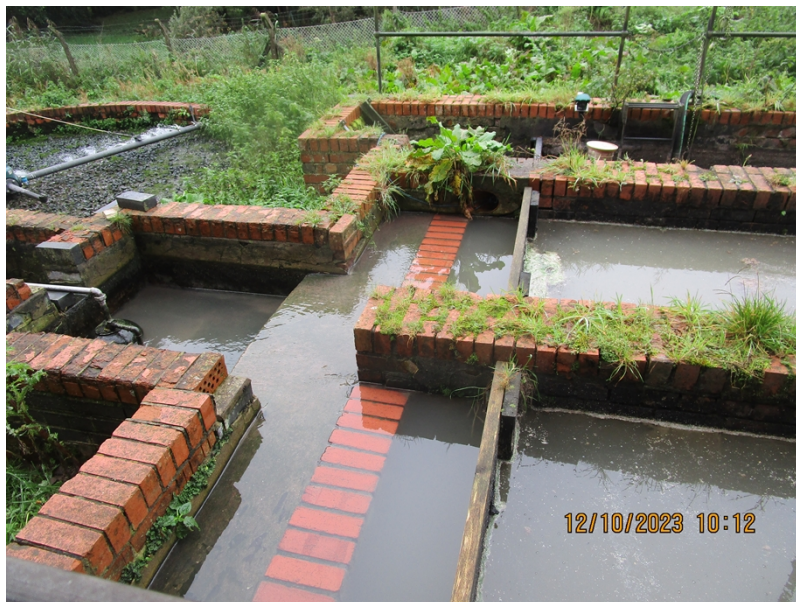
Primary Settlement

There are two primary settlement tanks at the works are rectangular brick housed tanks with retention boards in place to hold back solids. There is a third rectangular tank in place, which is the storm tank for the works. The primary settlement tanks appeared to be operating effectively and there were no signs excessive carry over in the outfall channels of the tanks.

The joint outfalls from the primary settlement tanks lead to a syphon chamber, which fills ups before discharging to the two filter beds on site. This is to ensure there is enough water pressure to rotate the filter bed arms. The syphon was clearly operational at the time of the inspection.

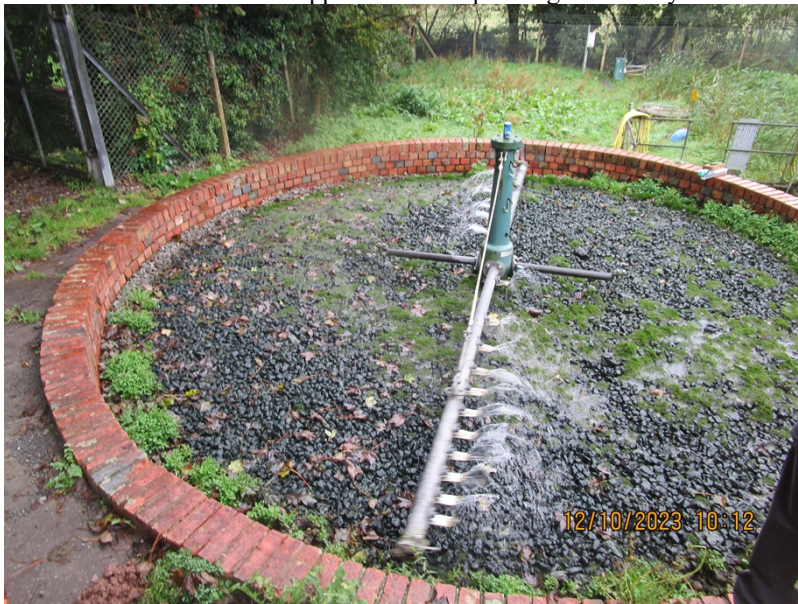
Filter Beds

The works contains a two filter beds of stone media. The rotation arms were moving free and unhindered. There were no signs of blocked outlets and the rotating arms appeared to be distributing effectively. The filter beds had some coverage of moss growth on the surface of the filter. Although not excessive this did show signs of creating some pooling on the surface of the filter beds where moss was present. At the time of inspection this did not appear to be a problem, however, should be monitored and managed to ensure excessive moss growth does not prevent influent entering the filter media.

The filter beds at the works appeared to be operating effectively and the outfall channel appeared to be running clear.

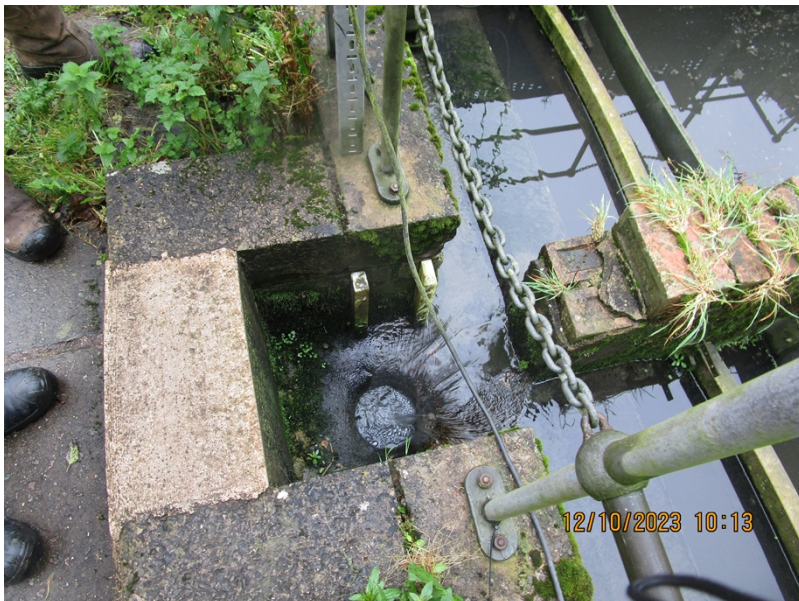
Humus Tanks

The final settlement tanks on the works are two small rectangular tanks with retention boards to slow the flow down and prevent solids passing over. The final settlement system appeared to be operating effectively. The outfall channel tank appeared clear and free flowing with no signs of significant solids passing through.

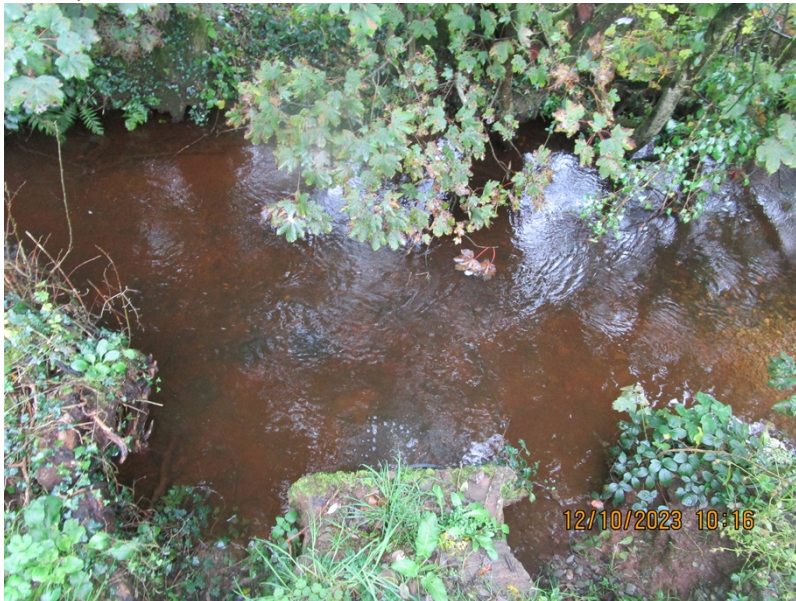
Outfall and Sampling point

The Final effluent sampling point was clearly marked and easily accessed. There is a raised outlet at the top of the pipe with a v notch to allow sample to be easily collected. The chamber appeared clear, and effluent was flowing freely. There were no signs of solids within the effluent.

There is an MCERTs flow meter in operations at the works, which was clearly operation at the time of inspections. The meter display was easily visible and appropriate signage was in place displaying the meter serial numbers and verification dates.

The outfall on the works discharges via an outfall pipe into Nant Logyn. The pipe is slightly set back from the main

channel of the watercourse; however, this did not appear to be causing any issues with effluent mixing within the watercourse. There were no signs of contamination or discolouration to the receiving watercourse and no signs of sewage fungus around the outfall. The watercourse at the time of inspection appeared slightly red suggesting a high iron content, this was evident above the outfall location.

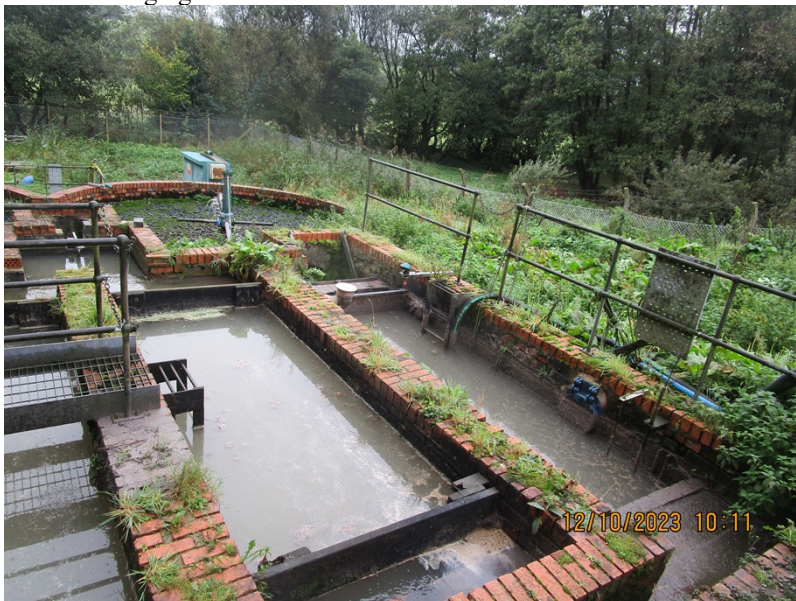
Strom Tank and Storm Outfall

The storm tank on site is located next to the two primary settlement tanks. It is a brick built open rectangular tank. At the time of inspection, the storm tank was partially filled, and there was indication that the level was higher (evident through scum marks on the brick housing). The storm tank when filled is pumped back to the head of the works on a set timer. There is monitoring equipment present within the storm tank. At the time of inspection there were no signs of the storm tanks discharging via the storm channel.

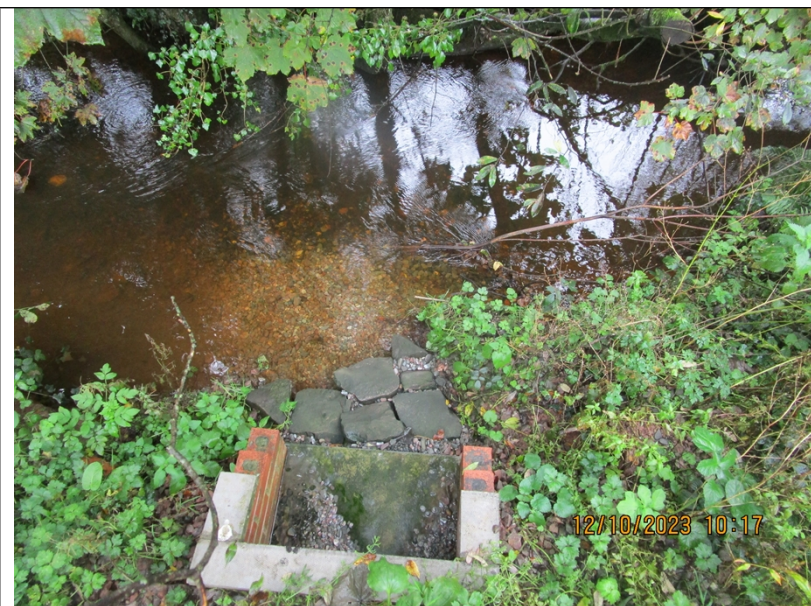
The storm tanks lead to a reed bed before being discharged to the receiving watercourse. The storm outfall is located slightly upstream from the works outfall and has a brick housing. The storm outfall was not discharging at the time of inspection and there were no signs of any discolouration or fungus growth around the outfall location.
