Natural Resources Wales

Salmon for Tomorrow 2 - Llanfair Talhaiarn

Flooding Technical Note

Reference: 290013-ARP-CP-LF-RP-CX-0004

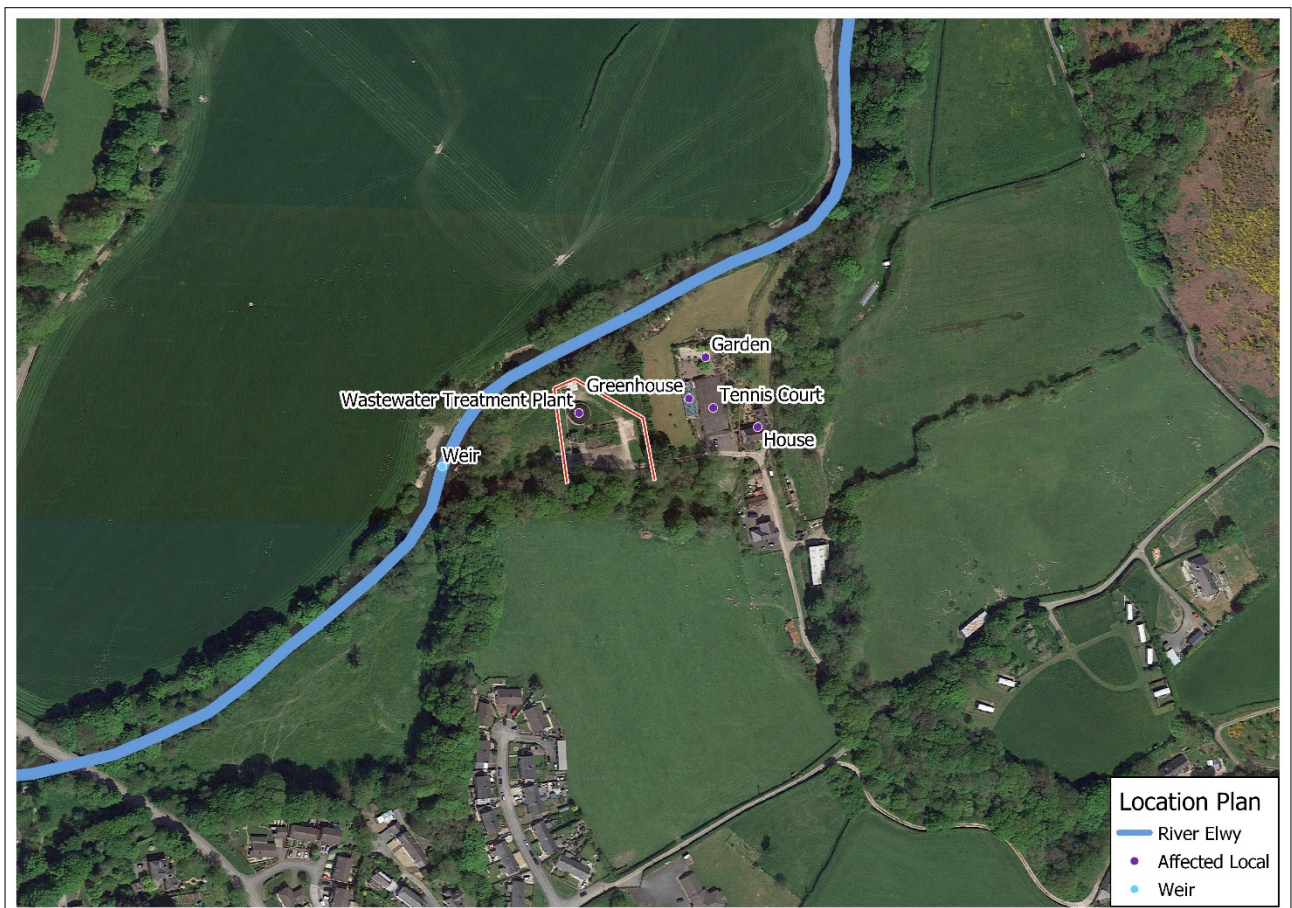
Figure 1: Site plan showing the Wastewater Treatment Plant and private property

The weir is situated on the River Elwy, downstream of the School Lane Bridge and the A544 Road Bridge, at Ordnance Survey National Grid Reference (NGR) SH 93052 70474. On the left bank of the River Elwy is a public footpath alongside agricultural fields that are regularly inundated during flood events. On the right bank, immediately upstream of the weir is a disused leat which has been blocked off. A wastewater treatment plant and private residential property are also located on the right bank

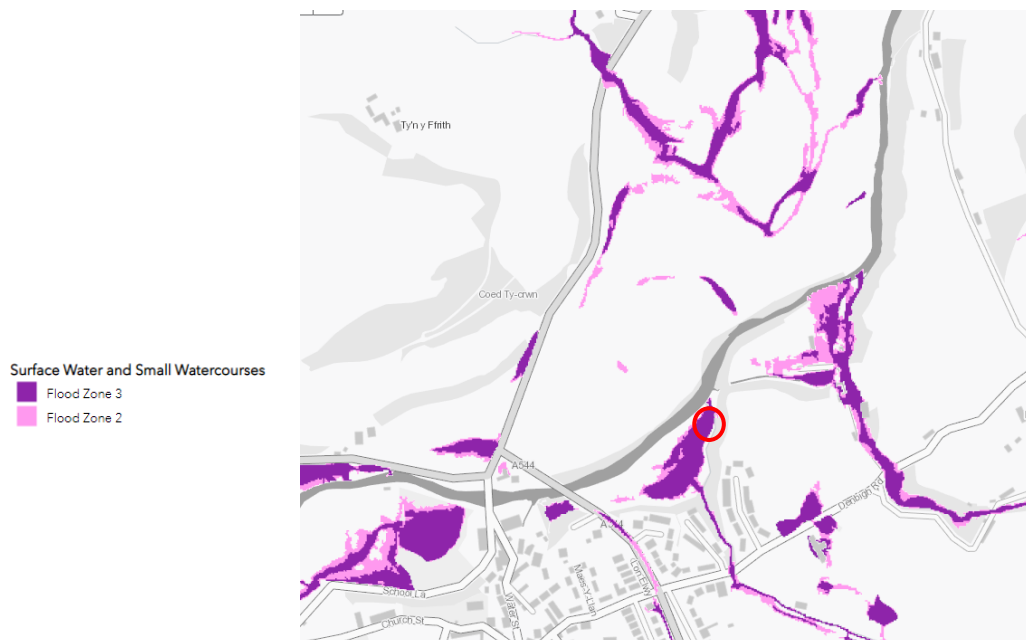
Figure 3: Surface water and small watercourse flood extents around the weir (circled in red) extracted from NRW mapping [1]

The area surrounding Llanfair is in both the fluvial and surface water Flood Zones 2 and 3. Mapping illustrates this in Figure 2 and Figure 3 for fluvial and surface water respectively. Flood risk at this location is summarised in Table 1.

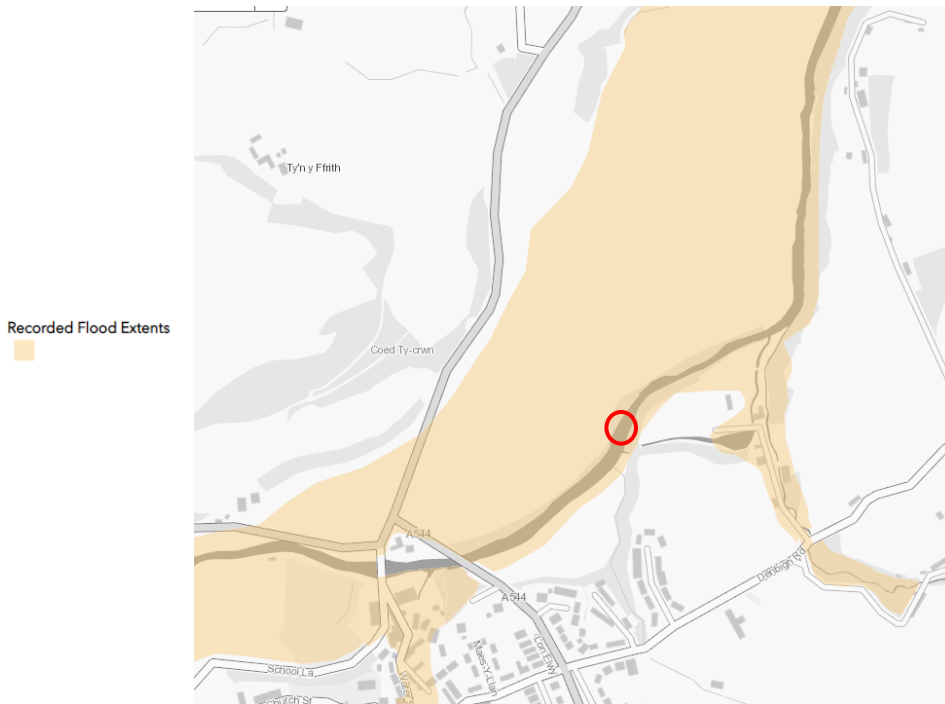
Figure 4: Recorded flood extents around the weir (circled in red) extracted from NRW mapping [1]

Llanfair has historically flooded to the extents shown in Figure 4. This flooding would have arisen from fluvial and surface water/small watercourse sources.

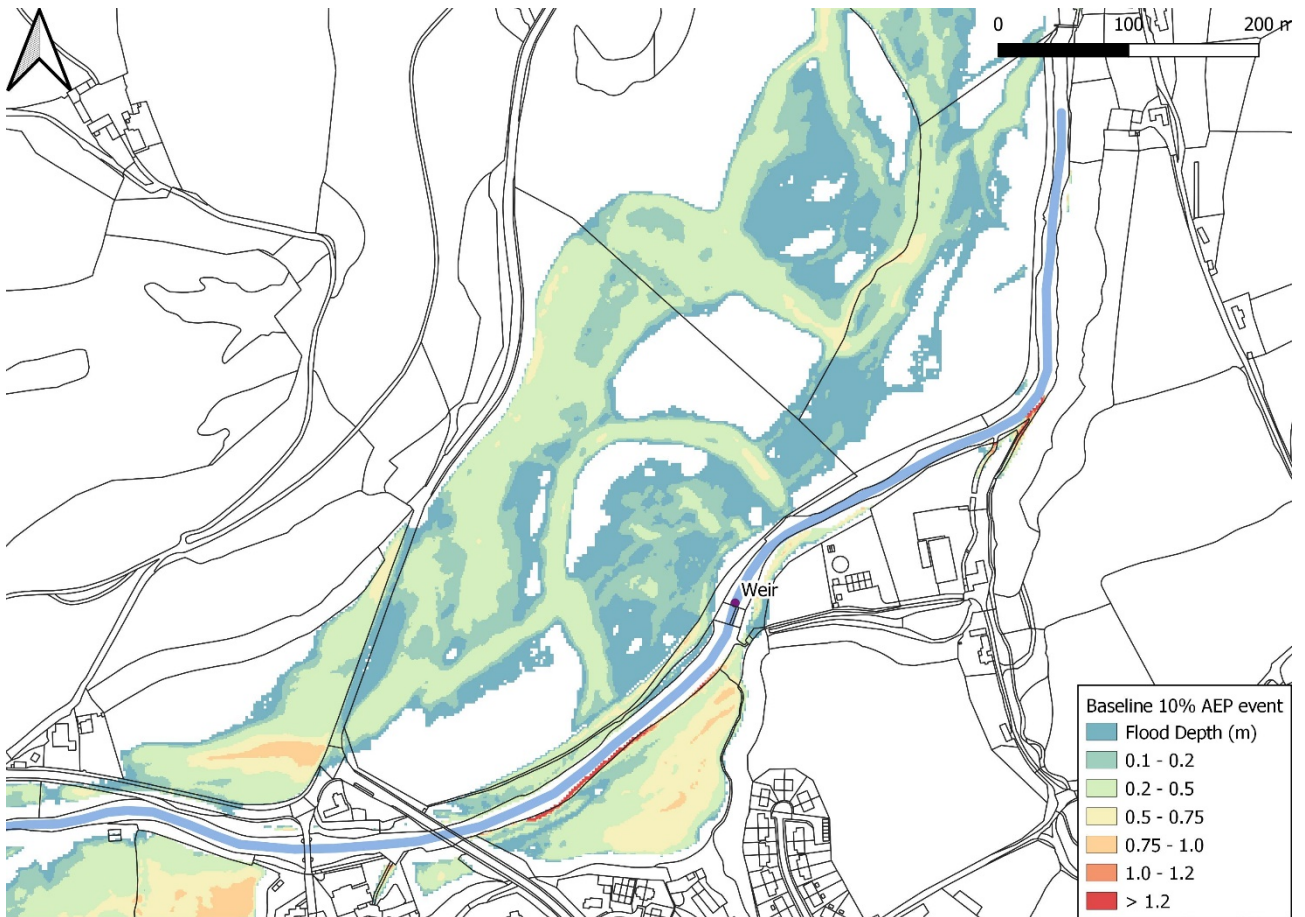
Figure 5: Baseline flood depths in the 10% AEP event

The flood model was run for a range of return periods, from a 0.1% to 50% AEP. Full results are given in Appendix A. Figure 5 shows the baseline flood depths at the 10% AEP (illustrating the onset of flooding to the property garden on the right-hand bank) and Figure 6 shows the baseline 0.1% AEP event. The 0.1% AEP event causes more flooding of greater depth and extent on both banks. on the right bank, notably at the wastewater treatment works (at NGR SH 93148 70506) and the private property (at NGR SH 93244 70504) on the right bank.
