## Compliance Assessment Report CAR\_NRW0042997

**Permit being assessed:** AW1004201

For: LLYSWEN STW CHURCH ROAD LLYSWEN, held by DWR CYMRU CYFYNGEDIG

**Type of assessment carried out:** Site Inspection, Reason: Routine.

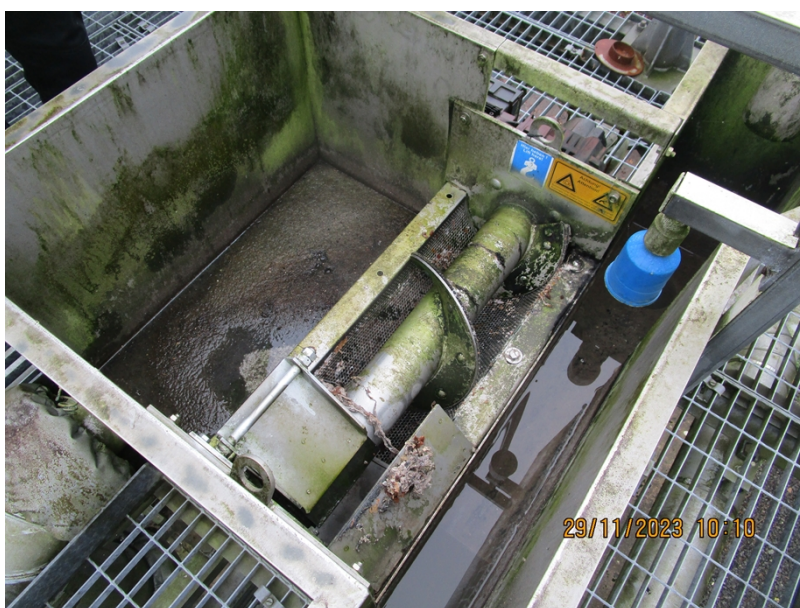
The incoming flow to the site is pumped up to the inlet point, where telemetry is in place to monitor flows. The inlet is clearly marked and was clear of blockages, there is no screening in place on the main flow channel, as the incoming flows are macerated at nearby the pumping station. Whilst on site some flow entered the works and it appeared macerated and clear of any large solids or rag.

There is a 6mm aperture screen in place for the storm channel with a rotating brush to clear debris/rag from the screen by returning it into the inlet channel. There is EDM equipment in place to monitor storm discharges. The flows were well below the storm weir setting in place and there were no flows entering the storm channel. The storm filter showed signs of debris but was clear of any blockages. There is a single storm tank, which was empty at the time of inspection. The storm tank has an automatic return to the head of the works.

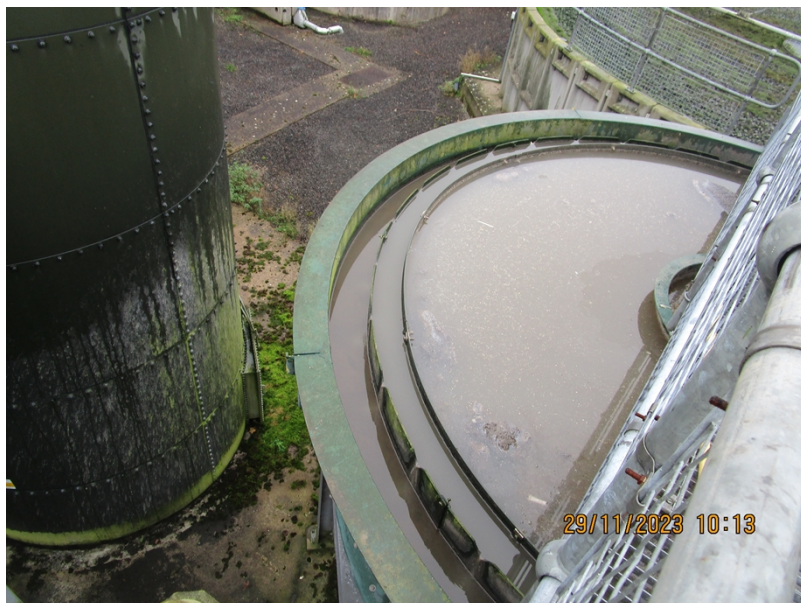
The primary settlement tank at the works is a radial settlement tank with retention boards to retain solids within the main chamber. appeared to be operating effectively. There were no signs of significant solids passing into the outfall channel as the scum boards were clearly keeping solids contained. The outfall channel appeared clear of any debris and water was flowing freely. There is a COPA sack in place on the outfall between the primary tank and filter bed. There was material gathered within the sack and the flows were not being hindered from flowing, to the next stage of treatment.

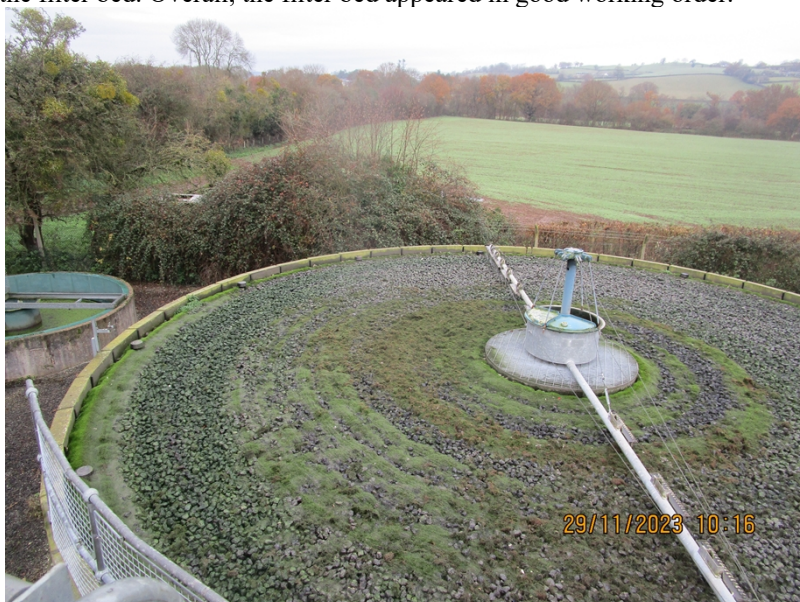
There is a single filter bed which containing stone filter media. The rotation arm was moving in a free and unhindered. The distribution points on the arm were clear of debris and water was flowing freely. The filter had some moss growth present on the surface of the filter bed in certain areas; however, this was not hindering the flow of liquid into the filter media. There were no signs of pooling present, and it was clear that efforts have been made to remove moss build from the filter bed. Overall, the filter bed appeared in good working order.

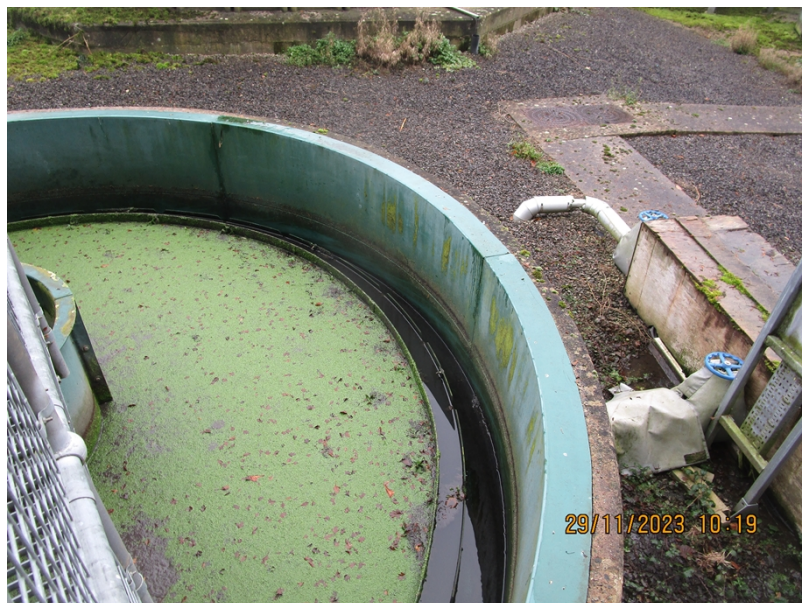
The humus tank is a radial settlement tank with retention boards to retain solids, which appeared to be operating effectively. There were no signs of solids in the outfall channels. There is a thin covering of duckweed present on the surface of the humus tank, however this does not appear to be hindering its operation and is contained within the scum board. The outfall channel appeared to be flowing clear with no signs of concern.

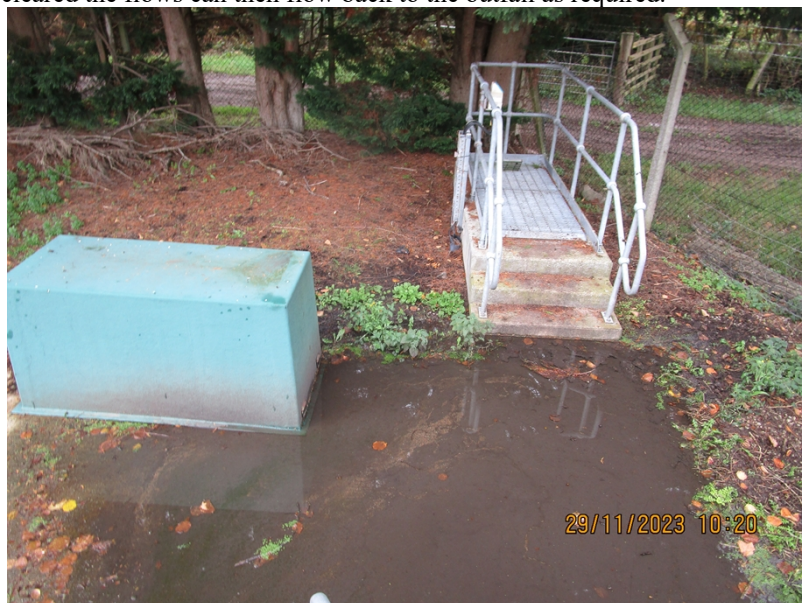
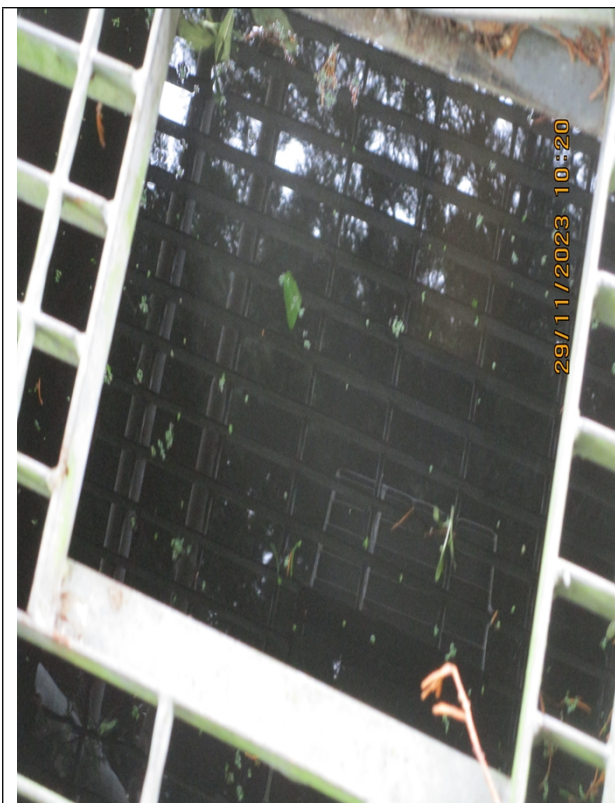
The final effluent from the humus tank passes through a MCERT Magflow flow meter, which was operational at the time of inspection (visual check of the meter display). The sample point is clearly marked with appropriate signage including the NGR. A list of permitted limits was always present for operatives to check whilst on site.

The inspection chamber at the time of inspection was full of effluent and there was some surface flooding on site present near the outfall chamber. We were advised that there is a reoccurring issue with the pipe between the works and the river, which occasionally becomes blocked below the farmer's field. This blockage of the outfall pipe causes effluent to back up into the works into the final effluent sample chamber and a nearby manhole. The MCERTS at the time was underwater, however was still showing flow passing through as required, I believe the MCERTS chamber has filled from above and is not affecting the MCERTS operating as required. To remedy this issue DCWW crews attend the site to jet out the line and remove the blockages. The jetting work was planned for the following day (30/11/2023). Once the line is cleared the flows can then flow back to the outfall as required.

As a result of the blockage to the downstream line, effluent has spilt onto the site compound and discharged on to the ground within the works. It is not possible to reasonably assure that all of the spilt effluent will return to the outfall and be discharged at the consented point. This therefore is a breach of permit condition 2 which states.

This has been classified as a category 3 noncompliance, as this could potentially have a minor impact on the receiving environment. As the effluent hasn't been discharged at the consented point.

DCWW should now investigate the root cause of the repeated blockages to the pipe and assess possible solutions to prevent further backfill into the works. The results of the investigation should be provided to NRW by 30/04/2024
