## Schedule 5 – Notification

| Permit number | EPR/CB3091HY |
| Name of operator | United Petfoods UK Ltd |
| Location of Facility | Tywi Valley Food Park<br>Station Road<br>Llangadog<br>Carmarthenshire SA19 9LN |

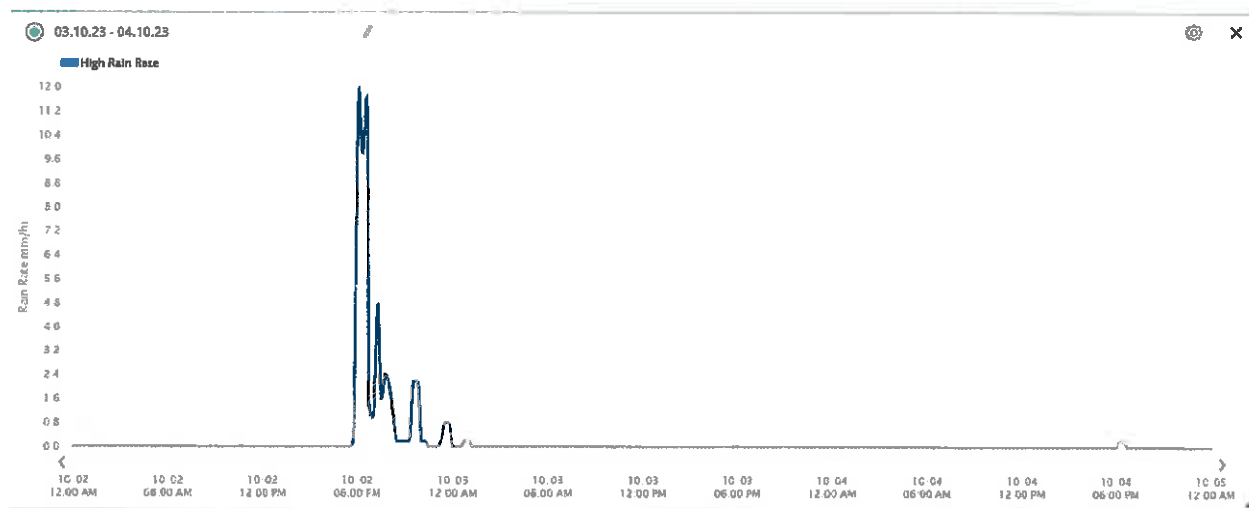
| | <p>20.10.23 Prolonged heavy rainfall, added to the excess clean-up water that was waiting to be sent out caused the limit to be breached.</p> <p>24.10.23 Prolonged heavy rainfall on 24.10.23.<br/> 26.10.23 Prolonged heavy rainfall on 26.10.23.<br/> 30.10.23 Prolonged heavy rainfall from 29.10.23<br/> 31.10.23 Prolonged heavy rainfall from 29.10.23</p> <p>All site drainage water enters the Effluent Plant in addition to process and washdown water. Graphs produced from the on-site Weather Station show the rainfall during the exceedance periods. (See below)</p> |

October rainfall data taken from the on-site weather station:
