## Compliance Assessment Report CAR\_NRW0042775

**Permit being assessed:** AN0246001

For: LLEWELLYNS GARAGE, held by KIRAPENANTHAN

**Type of assessment carried out:** Site Inspection, Reason: Routine.

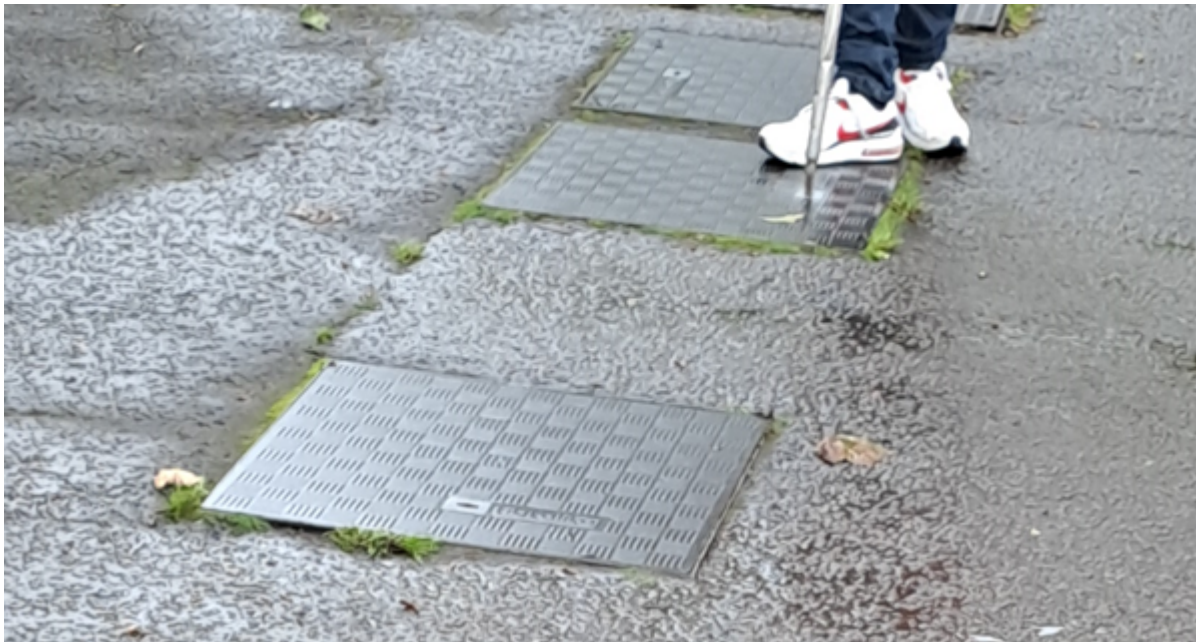
We located and inspected the interceptor chambers (Fig. 1-4). All three chambers contained oil. In the primary chamber, the oil was heavily concentrated and in the secondary and tertiary chambers there was a gradual decrease. However, there was still a substantial amount of oil

Figure 1. Location of the three interceptor chambers.

- The accurate NGR of the soakaway point needs to be updated on the permit. This can be done by following this link: [Natural Resources Wales / Apply to vary \(change\) a permit for installations](#)
- A full service and inspection of the interceptor, chambers and soakaway system needs to be conducted by a certified servicing contractor and a report needs to be submitted upon completion to NRW.
- No car washing activity is to be discharged through this system. Provide a report of alternative means of discharge.

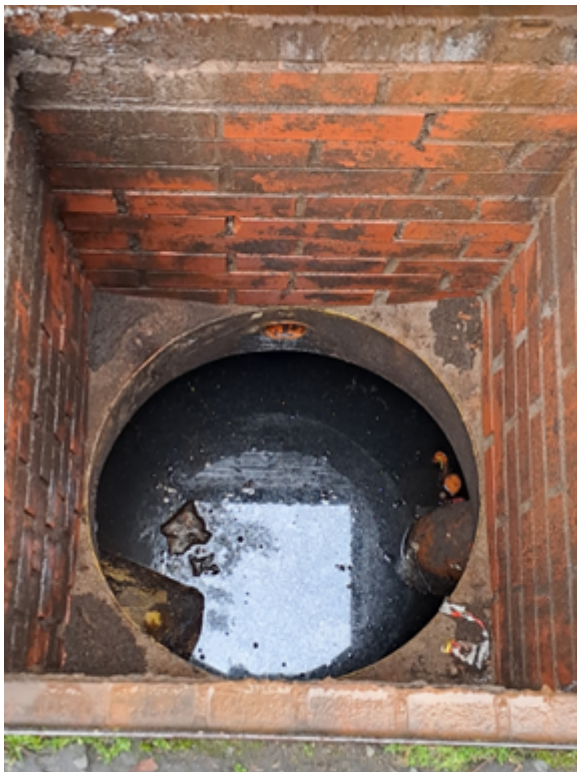
Figure 2. Contents of the primary interceptor chamber.

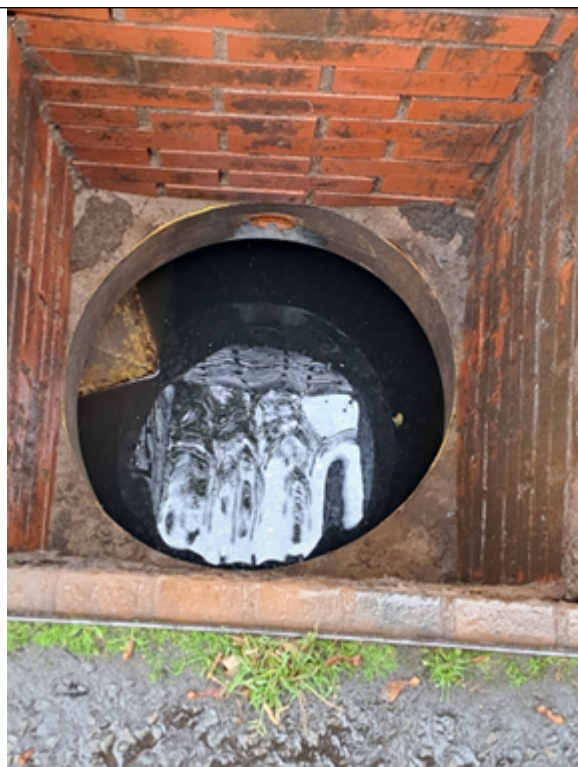
Figure 3. Contents of the secondary interceptor chamber.

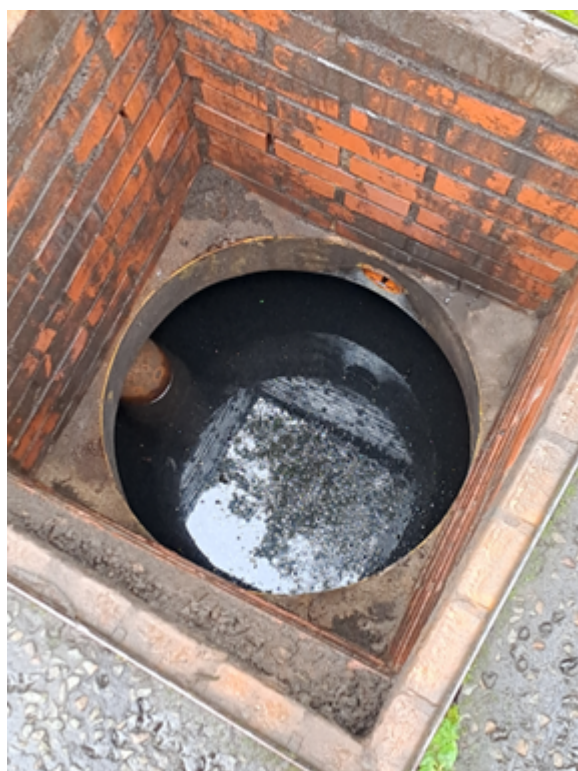
in the tertiary chamber before it passes on into the soakaway.

Figure 4. Contents of the tertiary interceptor chamber.

**Justification: The interceptor is not working sufficiently otherwise oil would not be discharging into the soakaway. In addition, effluent containing detergents are entering the soakaway system without treatment. Detergents enable oil to pass through the interceptor without being captured by the interceptor.**

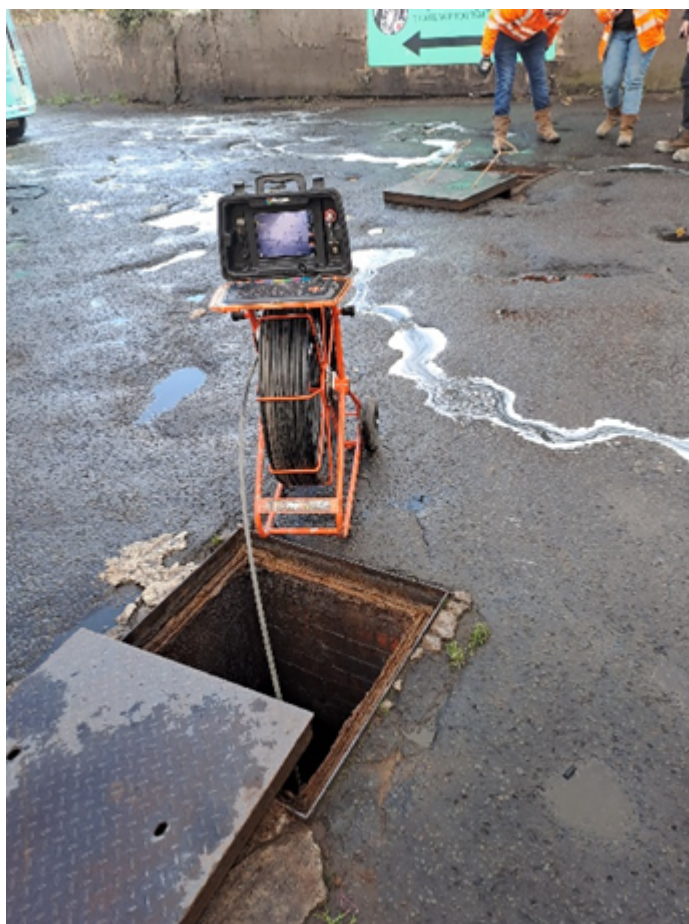
We then located the area where the interceptor enters the soakaway system, the NGR as stipulated on the permit (ST 15400 98200) was not reflective of the actual location of the

soakaway system on site (ST 15403 98249).

The first time we attended we were unable to open the manhole on the soakaway system. Whereas on the second visit, we were able to open both the interceptor outlet/soakaway inlet to inspect the effluent before discharging into the soakaway and the manhole covering the soakaway to inspect the effluent within the soakaway (Fig. 5). We inspected the interceptor outlet/soakaway inlet effluent and found it was being contaminated with blue detergent that was being run-off from the carwash (Fig. 6). Due to the amount of soap suds it was unclear whether the effluent was contaminated with oil at this point. However, when inspecting the effluent within the soakaway, it was evident that oil as well as detergent was present (Fig. 7). We took some of the water out of the soakaway and it was evidently contaminated with the blue detergent from the car wash (Fig. 8). The presence of detergent within the soakaway system is not permitted as these detergents can emulsify oil present within the soakaway system. Furthermore, these detergents in themselves pose a significant risk to the environment (Fig. 9). When requested, the material data sheets were not supplied.

Figure 5. Location of the oil interceptor outlet/ soakaway inlet in the foreground, with the manhole over the soakaway in the background.

***Justification: The NGR on the permit is not the NGR of the soakaway system on site. The NGR of the soakaway as stipulated on the permit is ST 15400 98200 however, the***

**actual NGR of the soakaway is ST 15403 98249.**

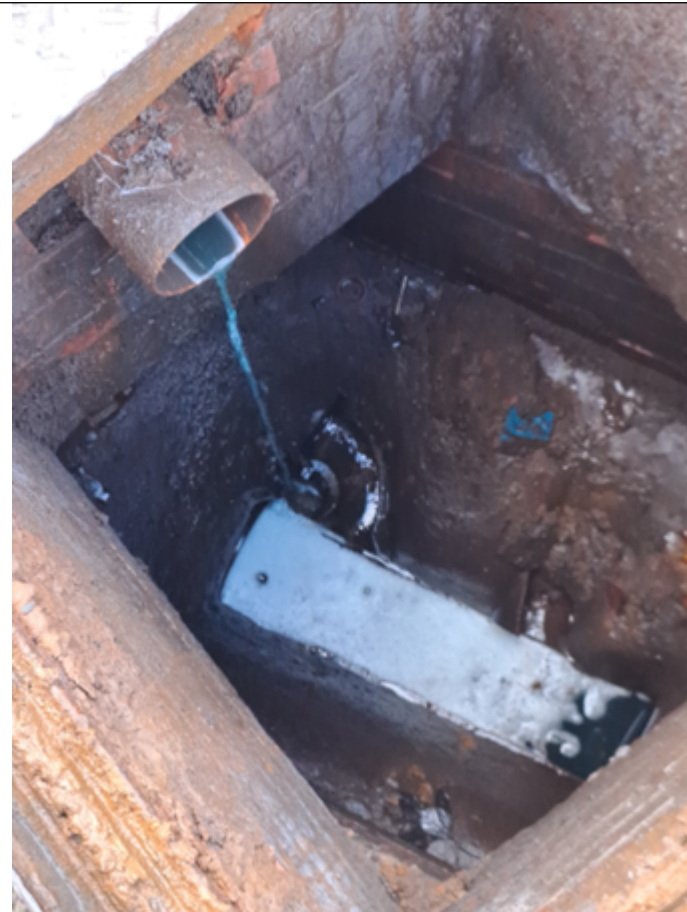
Figure 6. Evidence of blue water contaminated with detergent and soap suds coming from the carwash entering the soakaway system inlet.

A historical Compliance Assessment Report was issued (20.10.2015) that stated that the drainage needed to improve to stop water from the carwash entering the interceptor/ soakaway system and this has not been completed as the issue is still occurring. The current discharge from the car wash into the soakaway system is not permitted by NRW and is discharging illegally.

- The carwash is currently illegally discharging, this needs to cease immediately.

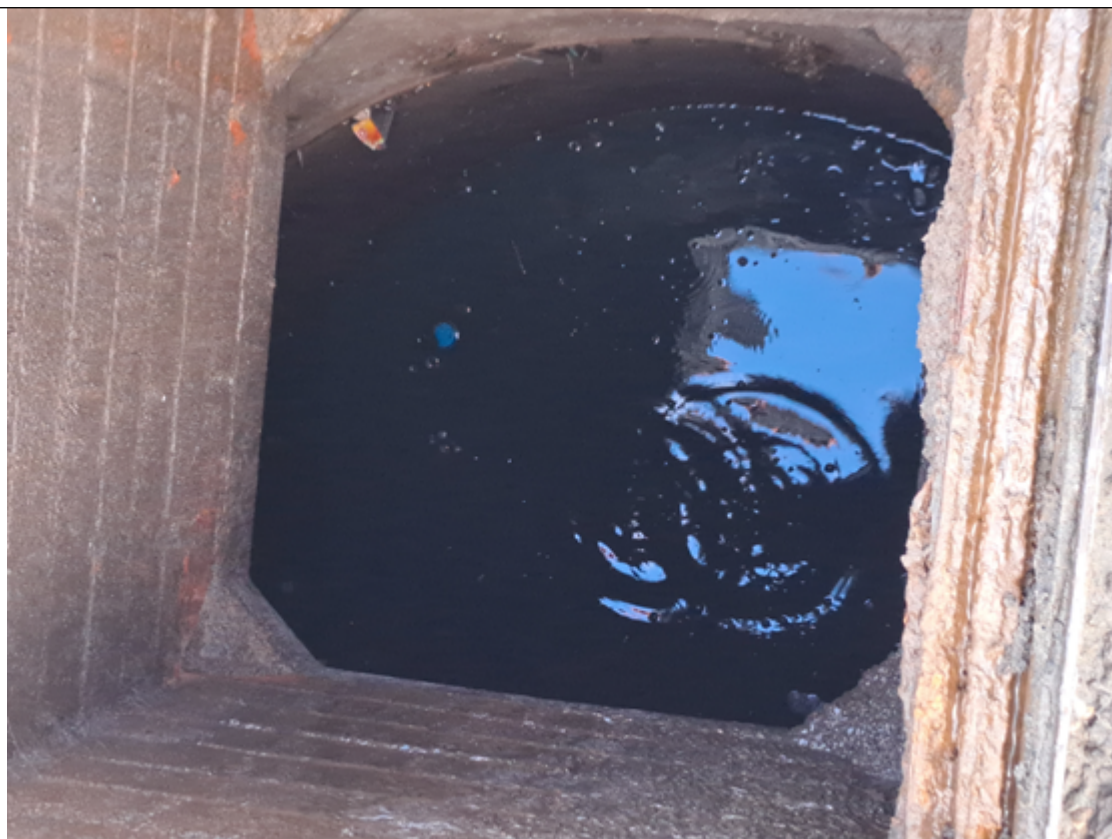
Figure 7. Contents of the soakaway system where oil and detergent can be observed.

**Justification: Visible oil and blue detergent was observed in the pipework before discharging to the soakaway and in the final chamber which consisted of concrete with permeation holes, which percolates to ground.**

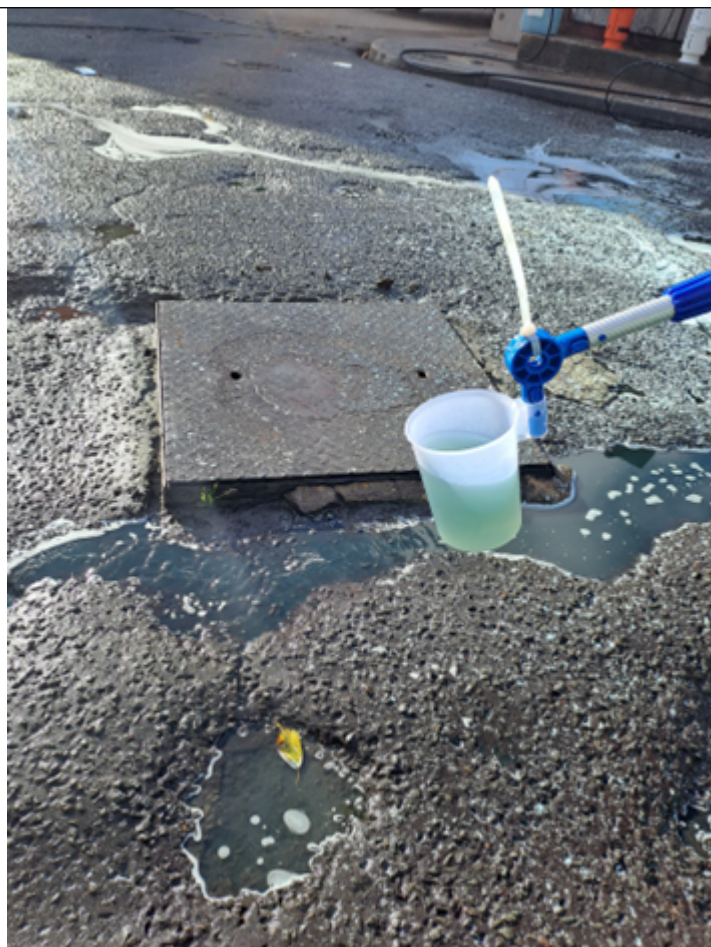
Figure 8. Blue liquid present within the soakaway system.

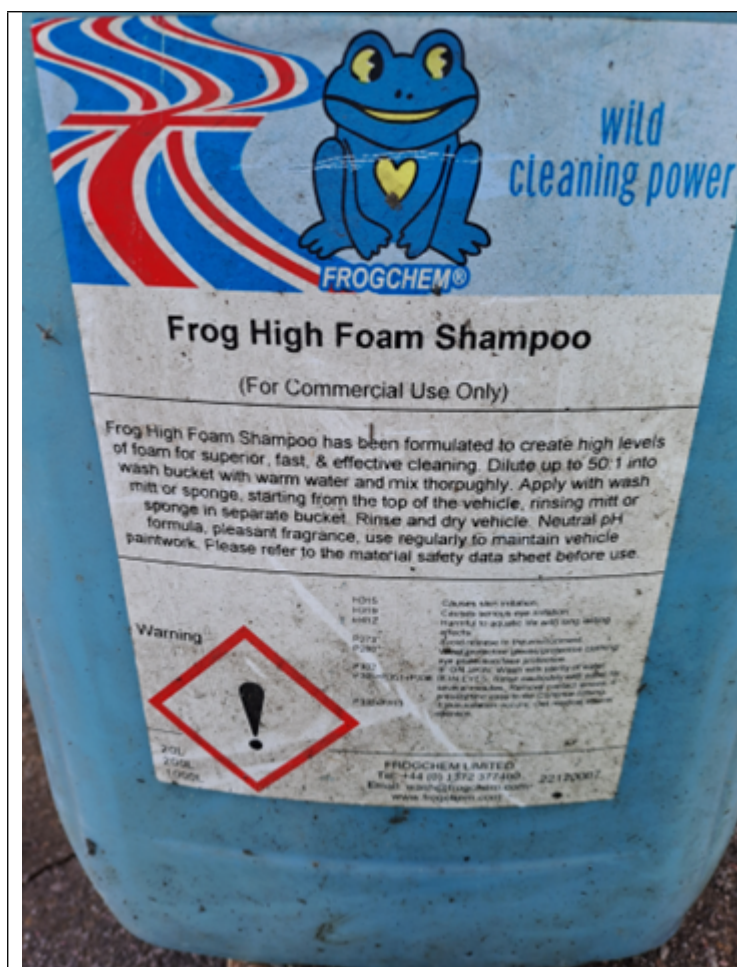
Figure 9. The label on the detergent that is being used to wash the cars in the car wash.

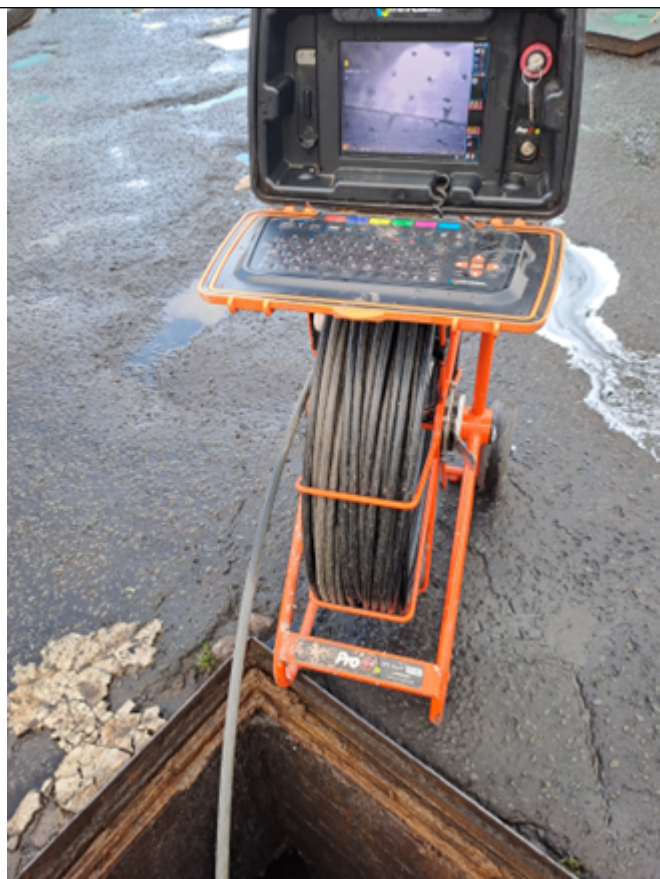
When we attended the site the second time, Dwr Cymru attended with us to identify whether the soakaway was connected to the foul sewer and it was identified that it was not through CCTV investigations of the network (Fig. 10).

Figure 10. Evidence that the interceptor was connected to the soakaway system.
