CHAPEL REEN

SHEET PILE  
TYPICAL CROSS SECTION

| Drawing no.<br>4021359-BUK-ZZ-00-DR-C-00010 | | Revision<br>P02 | |

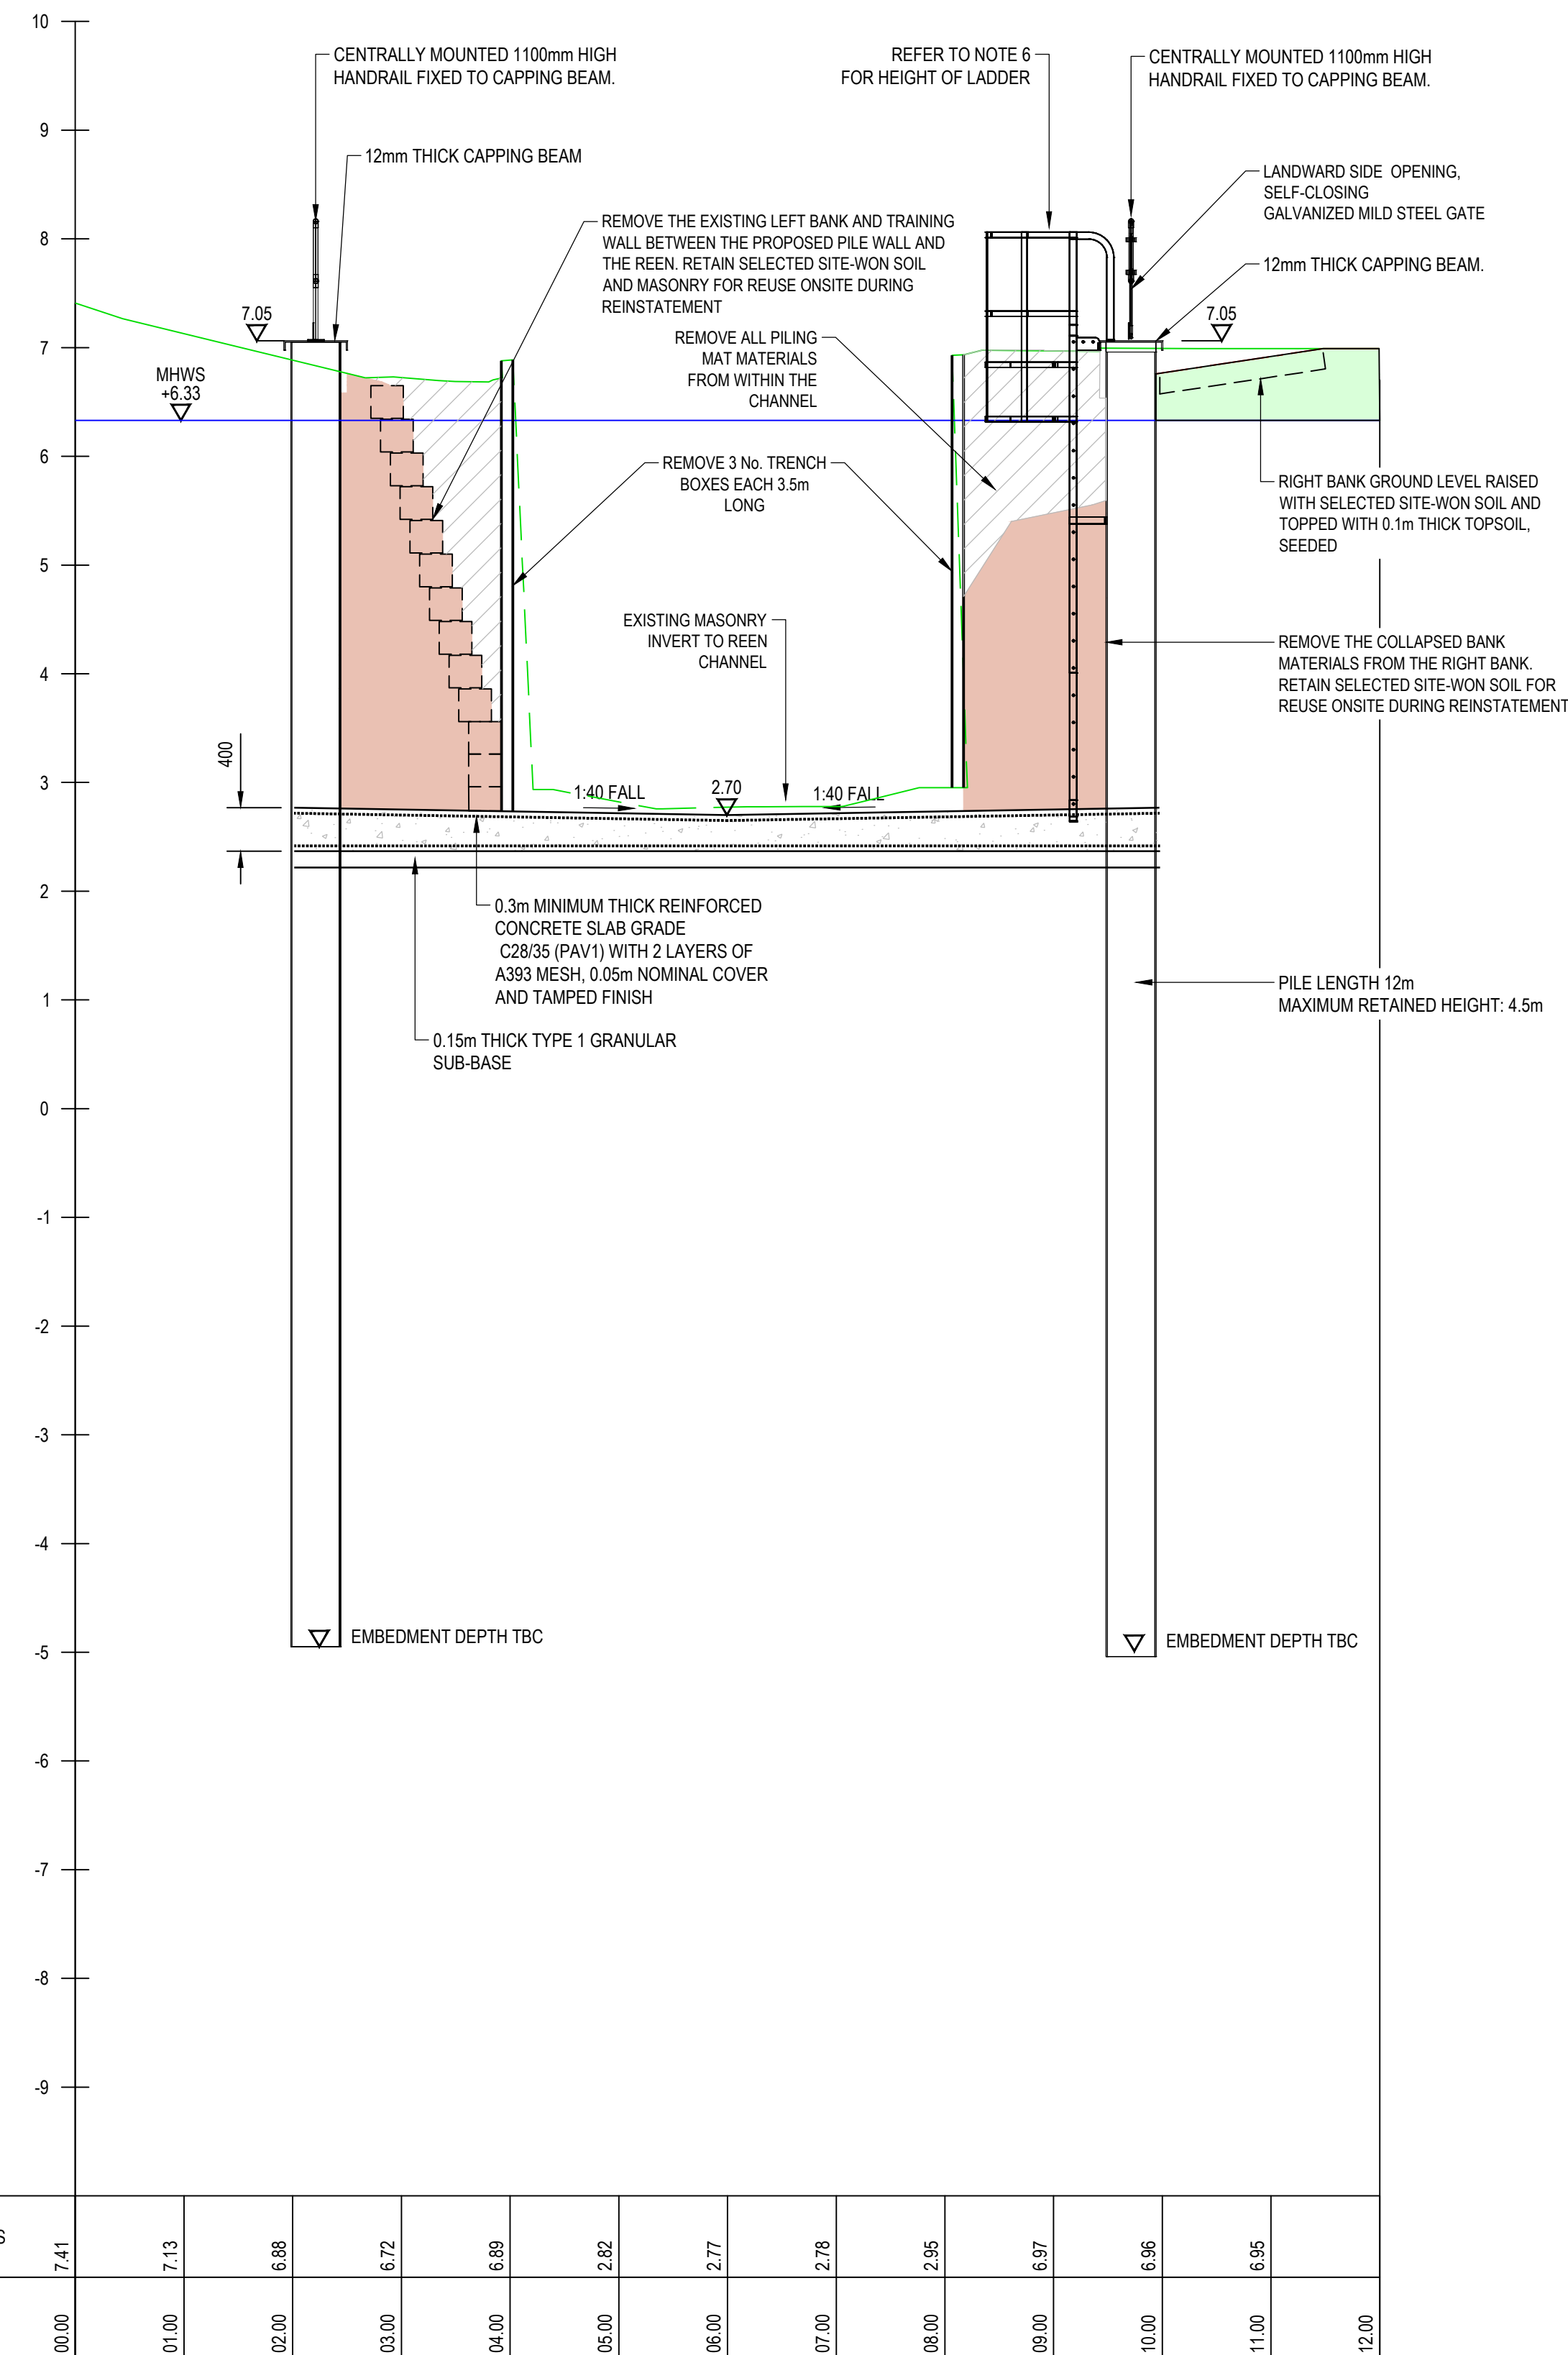
| S.1 Unstable river banks - Ground behind watercourse walls has failed. |
| S.2 Potentially unstable river defences. |
