Compliance Assessment Report CAR_NRW0043513

Permit being assessed: AW1002001

For: Garth Wastewater Treatment Works, held by DWR CYMRU CYFYNGEDIG

Type of assessment carried out: Site Inspection, Reason: Routine.

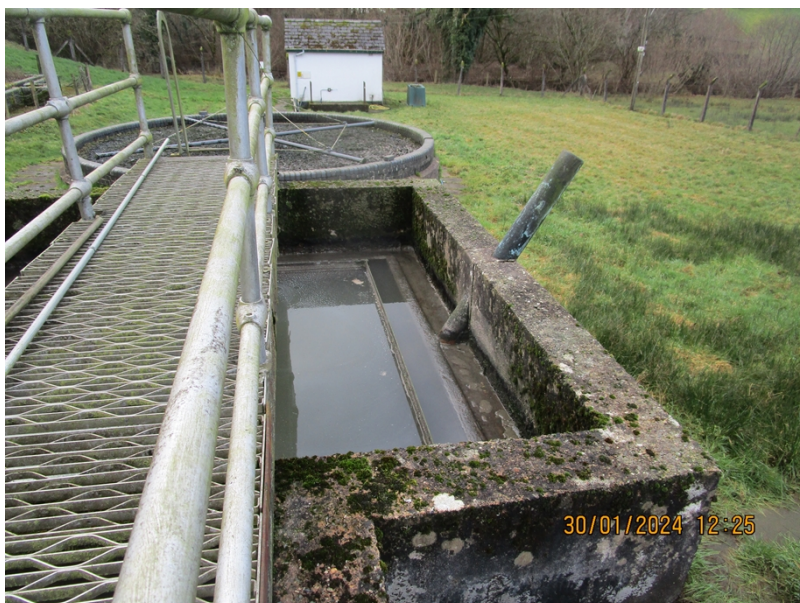
The primary settlement tank at the works is a square shaped tank, with scum boards for retaining solids. Overall, the settlement system appeared to be operating effectively. There were no signs of significant solids entering the outfall channel and solids were being retained behind the boards.

The outfall from the primary settlement tank leads to a syphon chamber, the purpose of which is to control flows so there is enough hydrological pressure for the rotating filter bed arms to rotate and operate effectively. The syphon was operating as required during the inspection.

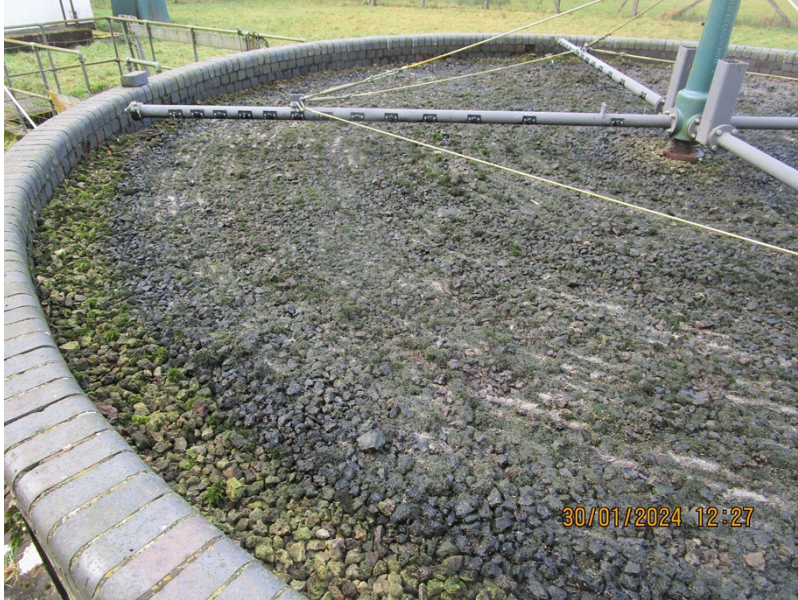
The works contains a single raised filter bed coating stone media. At the time of inspection, the filter arms were rotating intermittently, discharging when the syphon discharged. There were a couple of blocked outlets on the filter arms, however these were not excessive in number, and did not appear to be preventing distribution across the filter media. There was some ponding present on the surface of the filter bed whilst the arms were distributing flows. This may be as a result of recent heavy rainfall in the area but should be monitored if the ponding persists.

The filter bed at the works appeared to be operating effectively and effluent flowing from the filter, appeared clear at the time of inspection. The outfall of the filter bed is directly into the Humus/Final settlement tank of the works.

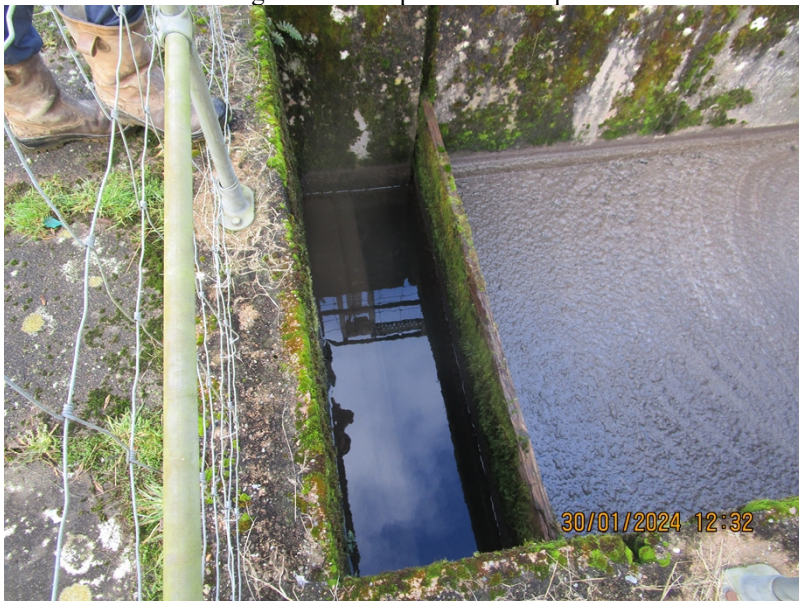
The final settlement tank on the works is a small rectangular tank with a retention board on the outfall end to slow down flows and prevent solids passing over. The final settlement system appeared to be operating effectively and foam present within the tank was being held back from the outfall. The outfall channel had a slight presence of sewage fungus around the edges and on the base of the outfall channel, this may indicate a high ammonia content. This was not excessive and was not considered a sign of noncompliance at this point. There are currently no ammonia limits in place for this works.
